**RAILWAY INVESTIGATION REPORT**  
**R08T0158**

**CROSSING COLLISION AND DERAILMENT**

**VIA RAIL CANADA INC.**  
**TRAIN NUMBER 60**  
**MILE 138.21, KINGSTON SUBDIVISION**  
**MALLORYTOWN, ONTARIO**  
**15 JULY 2008**

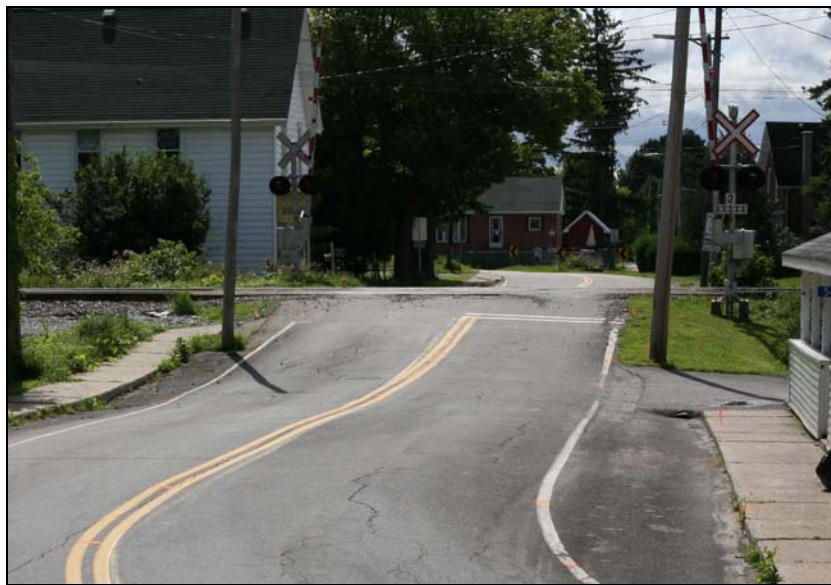
**Photo 2.** View of the Quabbin Road crossing looking south

The three vehicles proceeded westward, then northward across the railway tracks to Quabbin Road, where they turned right and proceeded eastward. On the approach to the Quabbin Road level crossing (see Photo 2 and Figure 2), the driver reduced speed to negotiate a 90-degree turn in the road approximately 155 feet from the crossing. As the driver entered the crossing, the lowboy trailer became immobilized.

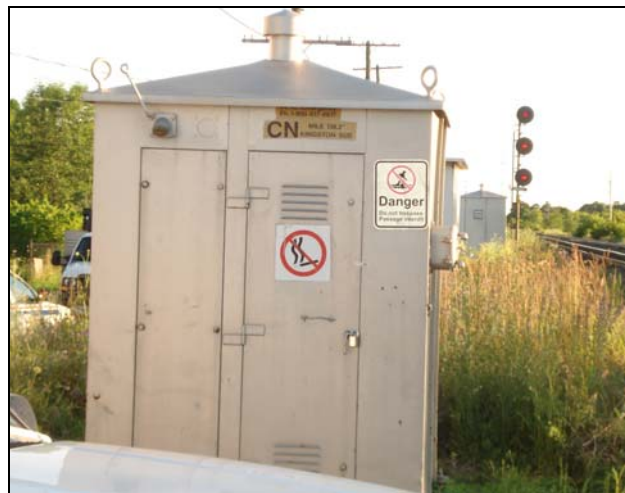
**Photo 3.** Signal bungalow with emergency signage

The driver attempted unsuccessfully to reverse. Then, the following 20-ton water truck was moved close to the lowboy truck. A chain was attached and another unsuccessful attempt was made to move the truck. These actions took approximately seven minutes. None of the vehicle drivers had noticed the 1-800 emergency number posted on the signal bungalow (see Photo 3).

The Quabbin Road crossing has existed since the construction of the Kingston Subdivision in 1856. The crossing was equipped with flashing lights, a bell and gates. Stop lines were painted on the road surface approximately 24 feet from each side of the crossing. A 1-800 emergency number was posted on the signal bungalow; however, the words "24 Hr. Emergency 1 800 617 6617" on the emergency signage were at least partially obscured by the overhang of the roof.

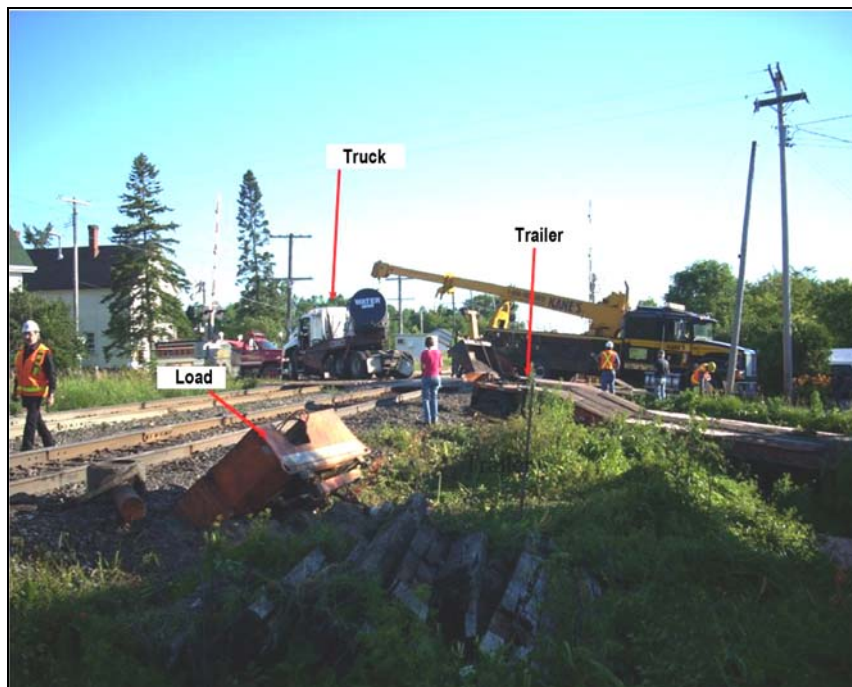
**Photo 4.** Damage to lowboy truck and load

The tractor-trailer was struck by the front of the locomotive between the rear axle and the front portion of the trailer. The tractor separated from the lowboy trailer and remained on the roadway south of the crossing. The trailer was pushed into the roadway embankment beside the north track. The cold-planer slid off the trailer, and came to rest beside it (see Photo 4). The 270 kg connector between the trailer and the tractor was torn off and became lodged under the locomotive, causing it to derail. The connector then began to roll under the train, derailing the baggage car behind the locomotive and slicing open its floor. The train came to a stop approximately 2700 feet (823 m) east of the crossing.

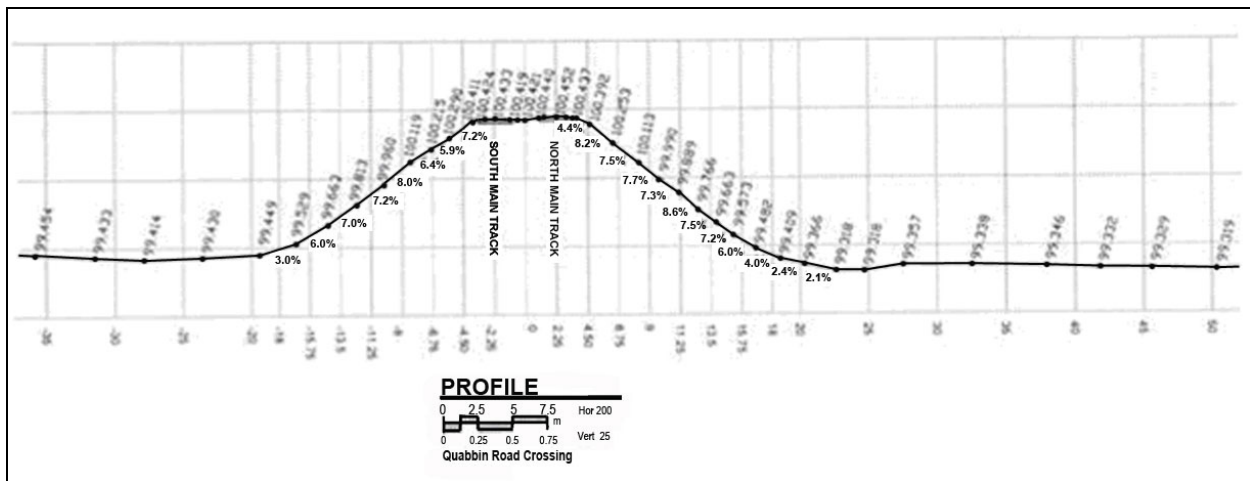
Figure 3. Quabbin Road crossing profile (Source: CN Engineering)

The crossing angle was approximately 65 degrees. The crossing surface between the most northerly and southerly rails consisted of asphalt and wooden planks and was in good condition. When measured after the accident, the crossing gradients on the southbound and northbound approaches were 7.0 per cent and 7.4 per cent respectively (see Figure 3).

In 1966, the Engineering Branch of the Board of Transport Commissioners for Canada (BTC) documented the average approaching grades as 8.0 per cent ascending from the north, and 7.5 per cent from the south. On 16 January 1967, the BTC forwarded to the United Counties of Leeds and Grenville and to CN an Engineering Branch recommendation to improve the approach grades to 5 per cent. CN track maintenance records indicate that the crossing had been surfaced several times between 2002 and 2008, but there is no indication that this work significantly changed the profile of the crossing. Transport Canada (TC) records the approaching grades for this crossing as 5 per cent.

The regulations make no reference to signage requirements apart from signboards at public crossings. The Quabbin Road crossing did not meet the gradient requirements of the 1980 regulations, which apply to crossings constructed or reconstructed after those regulations came into force. The majority of railway crossings in Canada were constructed before 1980.

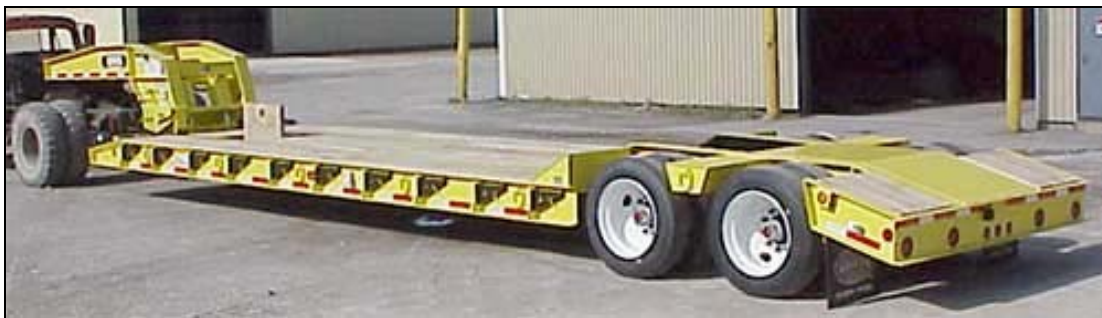
**Photo 5.** Typical model TC3 Rogers Bros. Corp. trailer

The lowboy trailer (see Photo 5) was a 1976, 48-foot, model TC3, manufactured by Rogers Bros. Corp., and licensed by the Province of Ontario. The overall length of the tractor/trailer combination was approximately 60 feet (18.28 m). A full mechanical inspection had been performed 12 months before the accident, and a post-accident examination was conducted on site. In addition, the required pre-trip inspection had been conducted. No deficiencies were noted.

The trailer was designed to be lowered and raised for the purposes of loading and unloading equipment while disengaged from the tractor. A small engine mounted on the trailer produced the power necessary to operate its hydraulic lifting mechanism. The design vertical ground clearance for the underside of the unloaded trailer involved in the accident was 7 inches (17.8 cm) minimum.

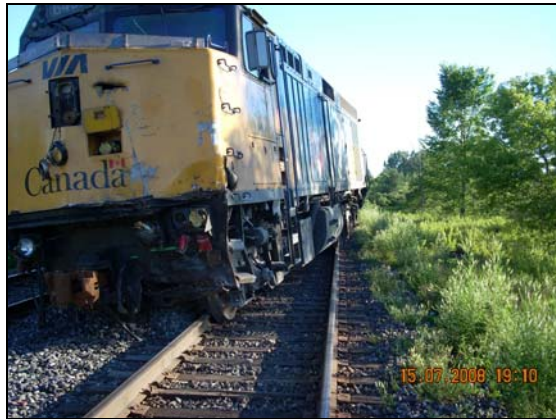
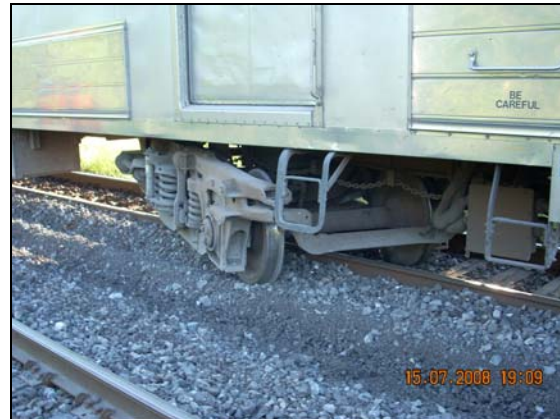
Photos 6a and 6b. Damage to rail equipment

Approximately 2500 feet of the north main track was damaged, resulting in the replacement of around 600 ties. The locomotive sustained severe damage to its front end, and its running gear (see Photo 6a). The baggage car sustained damage to its lead truck (see Photo 6b) and to its interior flooring.
