## **RAILWAY INVESTIGATION REPORT**

**R09T0057**

### **RUNAWAY AND NON – MAIN-TRACK DERAILMENT**

**SOUTHERN ONTARIO RAILWAY  
0900 HAGERSVILLE SWITCHER  
MILE 0.10 AND MILE 1.9 HYDRO SPUR  
NANTICOKE, ONTARIO  
11 FEBRUARY 2009**

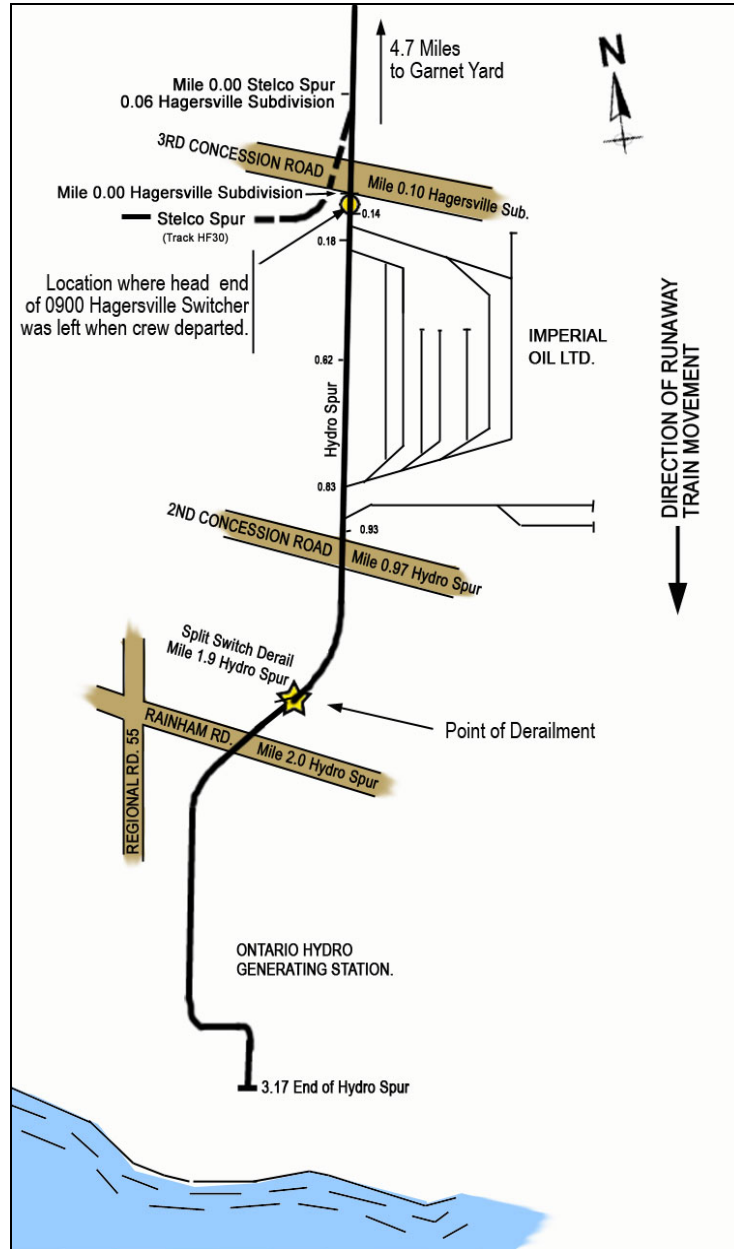
Figure 2. Hydro Spur diagram (not to scale)

At 2114, the assistant conductor brought the train to a controlled stop just south of the crossing (see Figure 2) with the locomotives coupled, the brake pipe connected, and the engines running. The plan was to secure the train and to change locomotives by setting lead locomotive RLK 4057 into the controlling position<sup>3</sup>. In preparing for the change of control, the assistant conductor set the MU2A valve on the control stand of RLK 3873 to the "Trail" position and the automatic brake cut-off valve to the "Cutout" position. The assistant conductor then detrained and departed the site without placing lead locomotive RLK 4057 in the controlling position. It is not known whether, or how many, handbrakes were set.

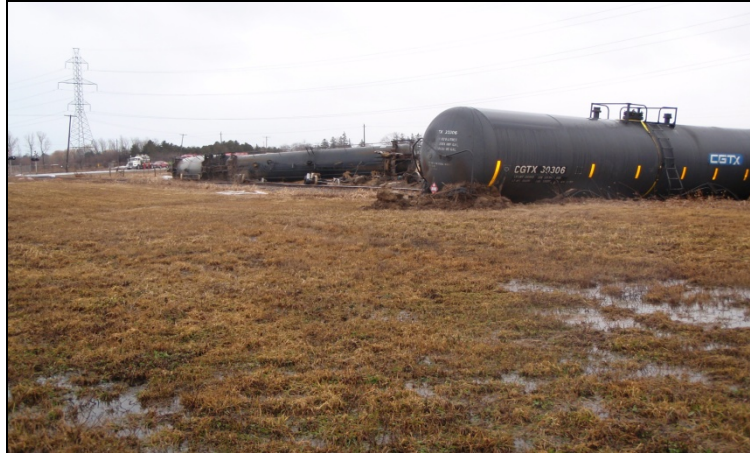
The nine tail-end cars of the train (35th to 43rd) derailed at a split-switch derail located at Mile 1.9 of the Hydro Spur, about 100 feet north of Rainham Road (see Photo 1). The derailed cars came to rest in various positions. These nine DG tank cars included seven loads of gasoline (UN 1203) and two loads of fuel oil (UN 1202). Three tank cars loaded with gasoline, the 38th, 40th, and 42nd cars respectively, were damaged and released product.

**Photo 1.** View of damaged cars north of Rainham Road.  
(Source: Southern Ontario Railway)

Approximately 31 000 L of gasoline were released from three cars. About 10,000 L of the released product entered the surface water system in ditches adjacent to the track and were lost to the environment. Approximately 300 feet of track was destroyed.
