RAILWAY INVESTIGATION REPORT
R09V0219

CROSSING COLLISION

VIA RAIL CANADA INC.
PASSENGER TRAIN 198 SOUTH
MILE 75.68, VICTORIA SUBDIVISION
NANAIMO, BRITISH COLUMBIA
14 OCTOBER 2009

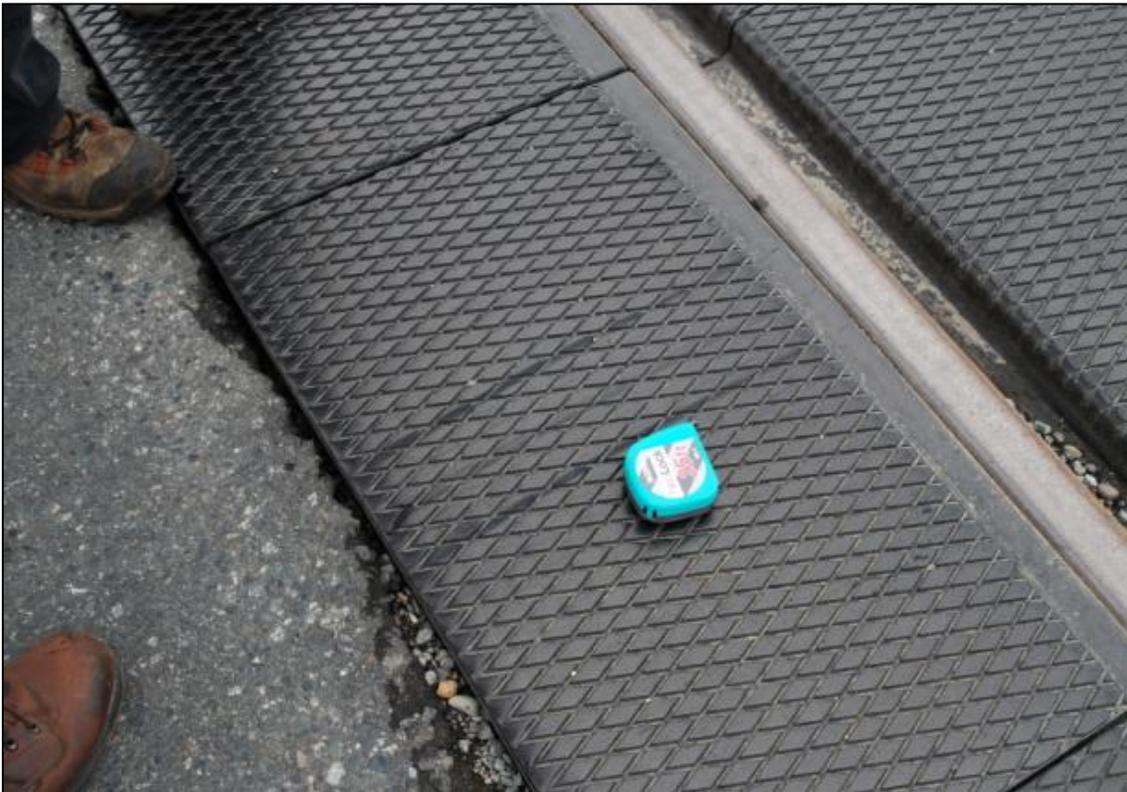
The windows of the vehicle were closed at the time of the collision. An examination of the site revealed a tire mark on the rubberized crossing surface on the field side of the west rail. This mark was attributed to one of the front driving wheels of the vehicle spinning as the driver attempted to exit the crossing forward. The mark was about two feet long (see Photo 1).

Photo 1. Tire marks on the west side of crossing

the available braking capacity of the vehicle should have been able to bring it to a stop. The report does not list the brakes as a contributing factor to the accident. There is no indication in the RCMP report that the mechanical condition of the vehicle contributed to the accident. Regarding the tire marks seen in Photo 1, the RCMP report identifies them as acceleration tire marks from the accident vehicle.

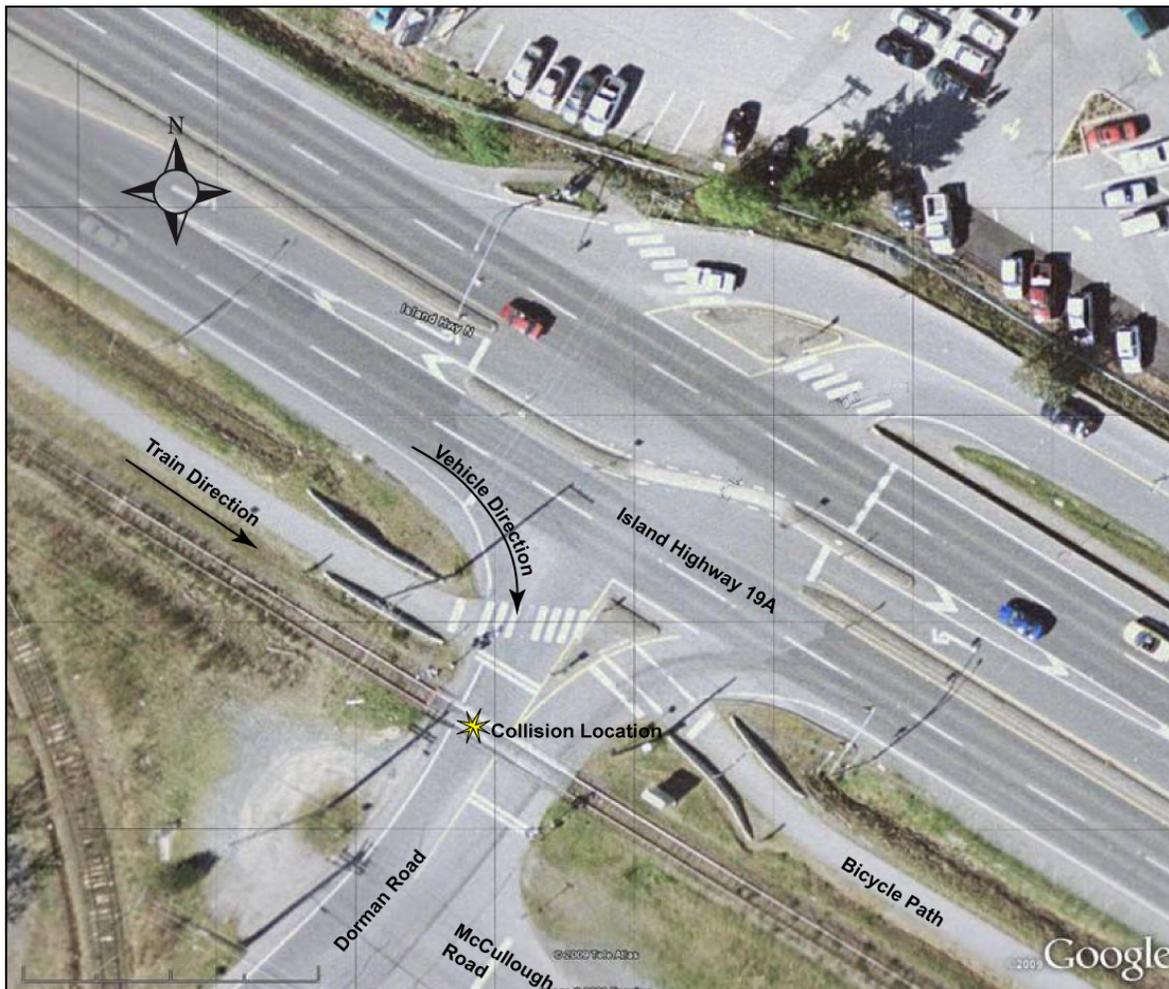
Dorman Road is a two-lane arterial road that crosses the Victoria Subdivision at a near 90-degree angle (see Photo 2). The crossing is located immediately adjacent to the highway, approximately 22 m west of its centreline. This highway is a four-lane highway with raised traffic islands (in the vicinity of the occurrence) and acts as a main north/south route through Nanaimo. The intersection with Dorman Road is not controlled by traffic signals.

Photo 2. View of the Dorman Road public crossing (note: railway timetable direction (north/south) is not necessarily consistent with true geographic directions)

For vehicle speeds greater than 16 km/h, the available SSD at Dorman Road for southbound vehicles exiting the highway (14 m) did not meet the minimum requirements of draft standard RTD 10.

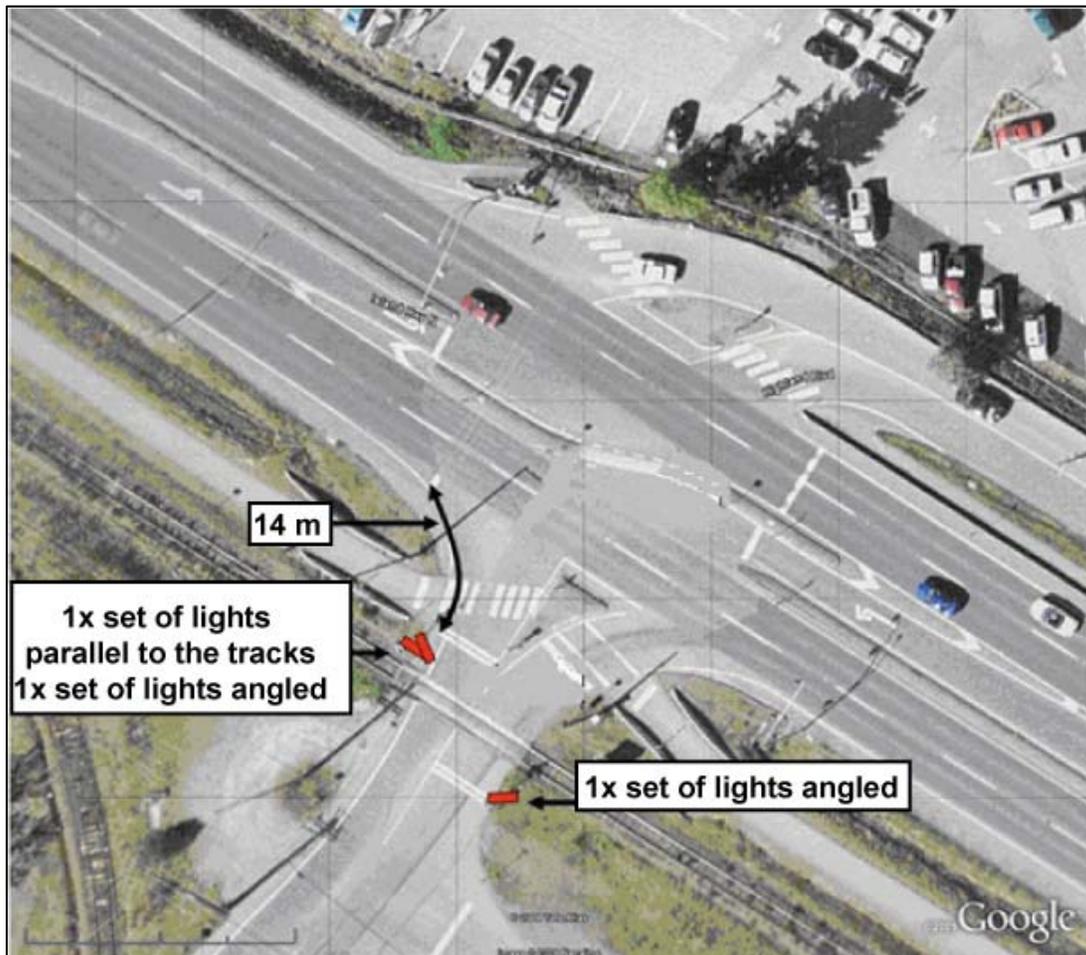
Photo 3 presents an overhead view of the Dorman Road public crossing, depicting road geometry, locations of crossing lights facing east and approximate orientation of these crossing lights. In comparison, Photo 4 presents the overhead view of the Waddington Road public crossing, located approximately 2 km south of the Dorman Road public crossing.

Photo 3. View of the Dorman Road public crossing

- At Waddington Road, two sets of crossing signals are angled for southbound traffic.
- At Dorman Road, one set of crossing signals is angled for southbound traffic and is situated on the southwest side of the tracks 30 m from the point at which an operational signal comes into view for a southbound driver exiting Island Highway 19A. The other set of crossing signals is positioned parallel to the track (that is, angled perpendicular to Island Highway 19A) and not directed at approaching traffic for any specific lane.

When positioned on the highway looking south, crossing signals are significantly more visible at Waddington Road as compared to the crossing signals at Dorman Road although, in part, this is because of differences in the geometry of the two crossings.

There are three sets of signal lights at the Dorman Road crossing for traffic exiting the highway: one set angled for northbound traffic, one set angled for southbound traffic, and a third set angled perpendicular to Island Highway 19A and not directed at approaching traffic for any specific lane. Observations of a similar crossing in the area (Waddington Road) noted that the orientation of the signals is more favourable to southbound traffic exiting the highway (that is, two sets of signal lights are angled for southbound traffic).

While both the Dorman Road and Waddington Road crossings are equipped with the same number of signal lights for traffic exiting the highway, the extra set of lights angled for southbound vehicles at Waddington Road provides improved conspicuity of the active crossing signals. When crossing signal lights are not oriented in an optimal manner to maximize visibility to approaching vehicle traffic, there is an increased risk that drivers will not see the warning lights and respond appropriately.

Although the installation of LED grade crossing signal lights is not required by legislation, Southern Railway of Vancouver Island Limited is in the process of changing the crossing signal lights throughout its Vancouver Island trackage to LED type lights as crossings are upgraded.

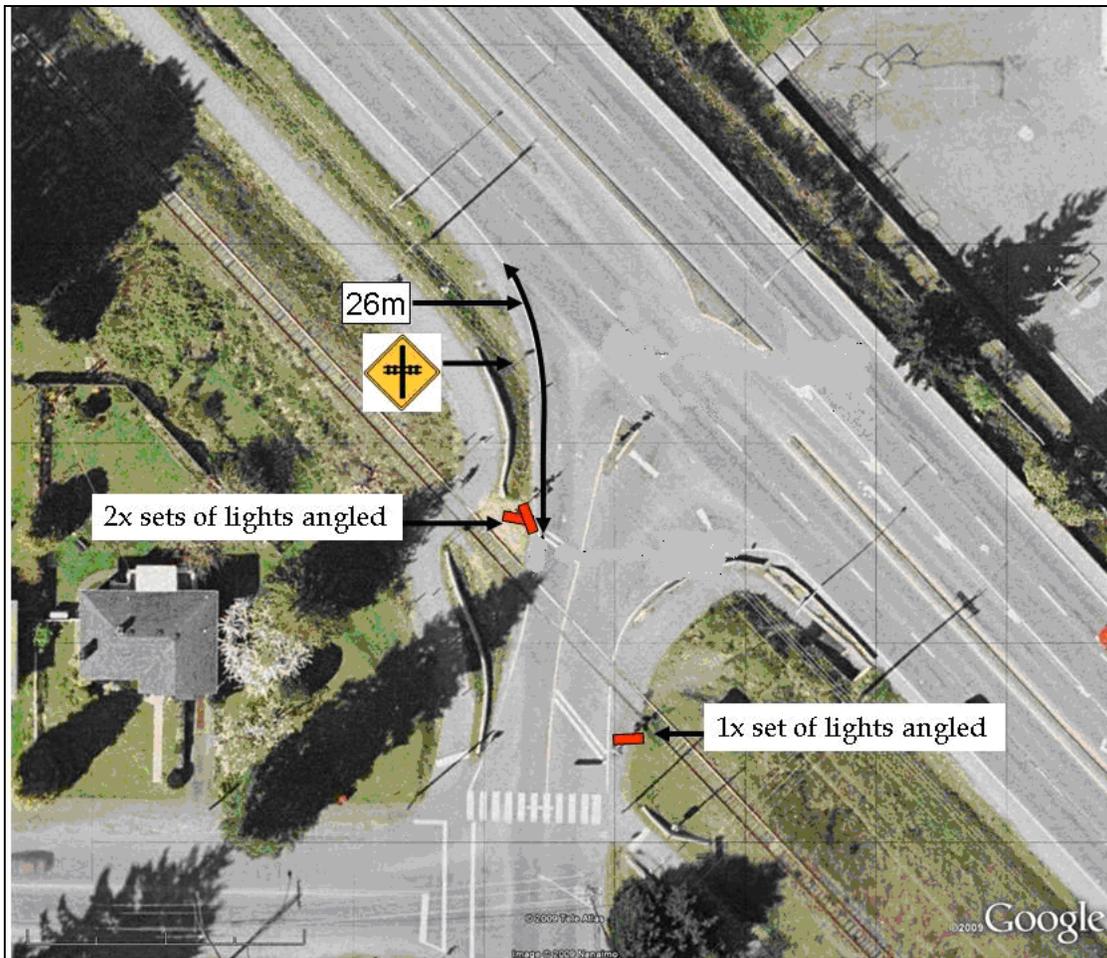
Photo 4. View of the Waddington Road public crossing

The maximum road speed on the highway at the Dorman Road exit is 70 km/h and, at the Waddington Road exit, 60 km/h. Before the Waddington Road exit, there is a railway crossing warning sign for southbound vehicles. No such sign is installed at Dorman Road. At both crossings, there are three sets of incandescent crossing signal lights, with one set of signal lights being angled for northbound traffic exiting the highway.
