**RAILWAY INVESTIGATION REPORT
R10C0086**

MAIN-TRACK DERAILMENT

**CANADIAN PACIFIC RAILWAY
FREIGHT TRAIN 2-269-02
MILE 21.4, RED DEER SUBDIVISION
AIRDRIE, ALBERTA
03 AUGUST 2010**

Report Number R10C0086

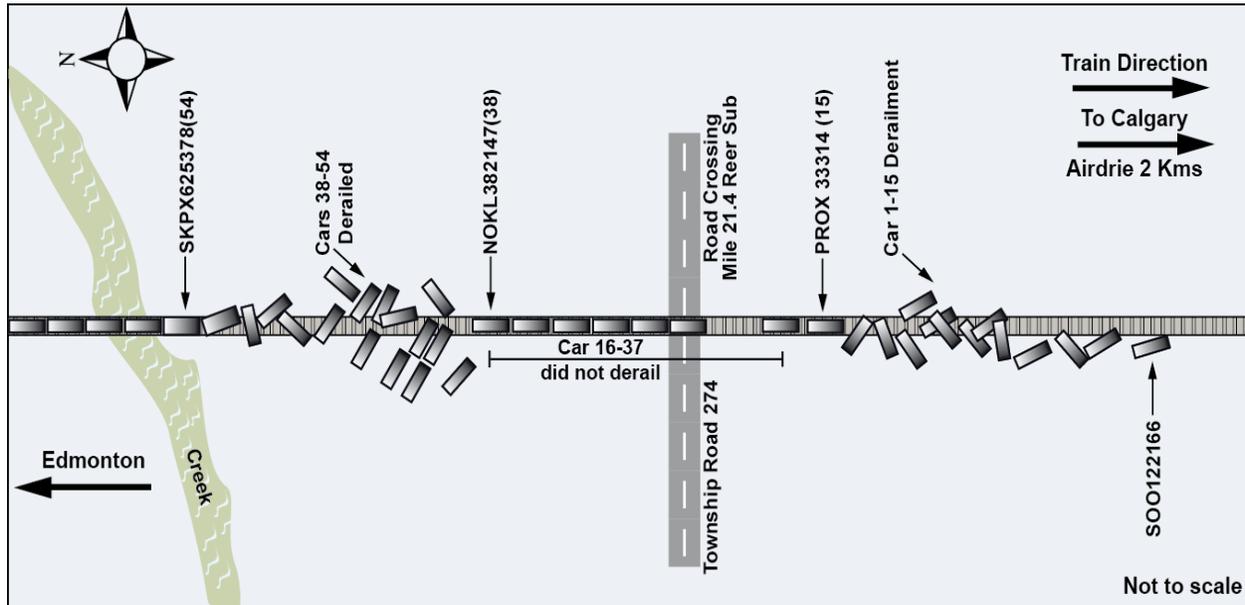
Figure 2. Derailment Site Diagram

After making the necessary emergency broadcast and notifying the rail traffic controller (RTC), the conductor performed an inspection and determined that 15 cars, the 1st to 15th, had derailed behind the locomotives. Knowing that dangerous goods cars were marshalled near the head end (i.e., 27 of the first 30 cars contained anhydrous ammonia, UN 1005),³ the crew moved the locomotives southward to a safe location. Further inspection revealed that another 17 cars, the 38th to 54th, had derailed towards the middle of the train near Mile 21.7 (see Figure 2). There were no injuries, no dangerous goods were released and no product was lost.

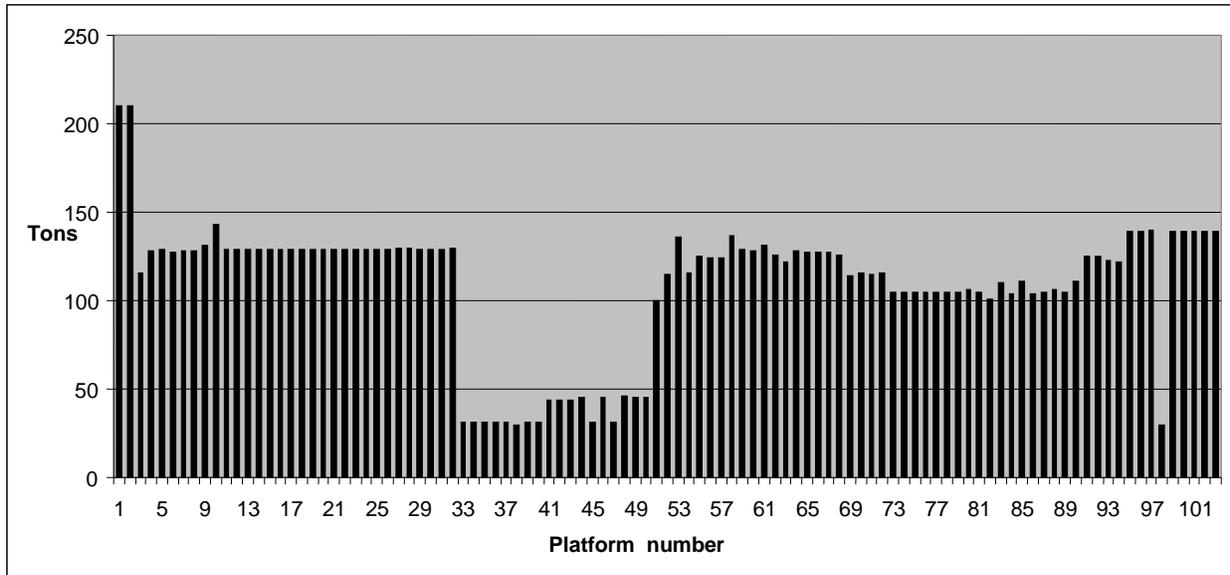
Figure 3. Tonnage Profile for Train 2-269-02

The 49th to 101st cars were loaded grain hopper cars, except for the 96th car, which was an empty grain hopper car. The tonnage profile for the train is included (see Figure 3).

CP's network is divided into 6 TrAM areas. The Red Deer Subdivision is categorized as TrAM Area 1. Despite having a group of 18 empty cars marshalled ahead of the loaded grain hopper cars, the occurrence train had no reported TrAM Area 1 violations. TrAM is designed to keep in-train forces in check when train handling and other relevant inputs are maintained within the normal operating range. As such, TrAM may reduce, but is not designed to fully mitigate, the extraordinary in-train forces that can be generated during a derailment or during an emergency brake application.

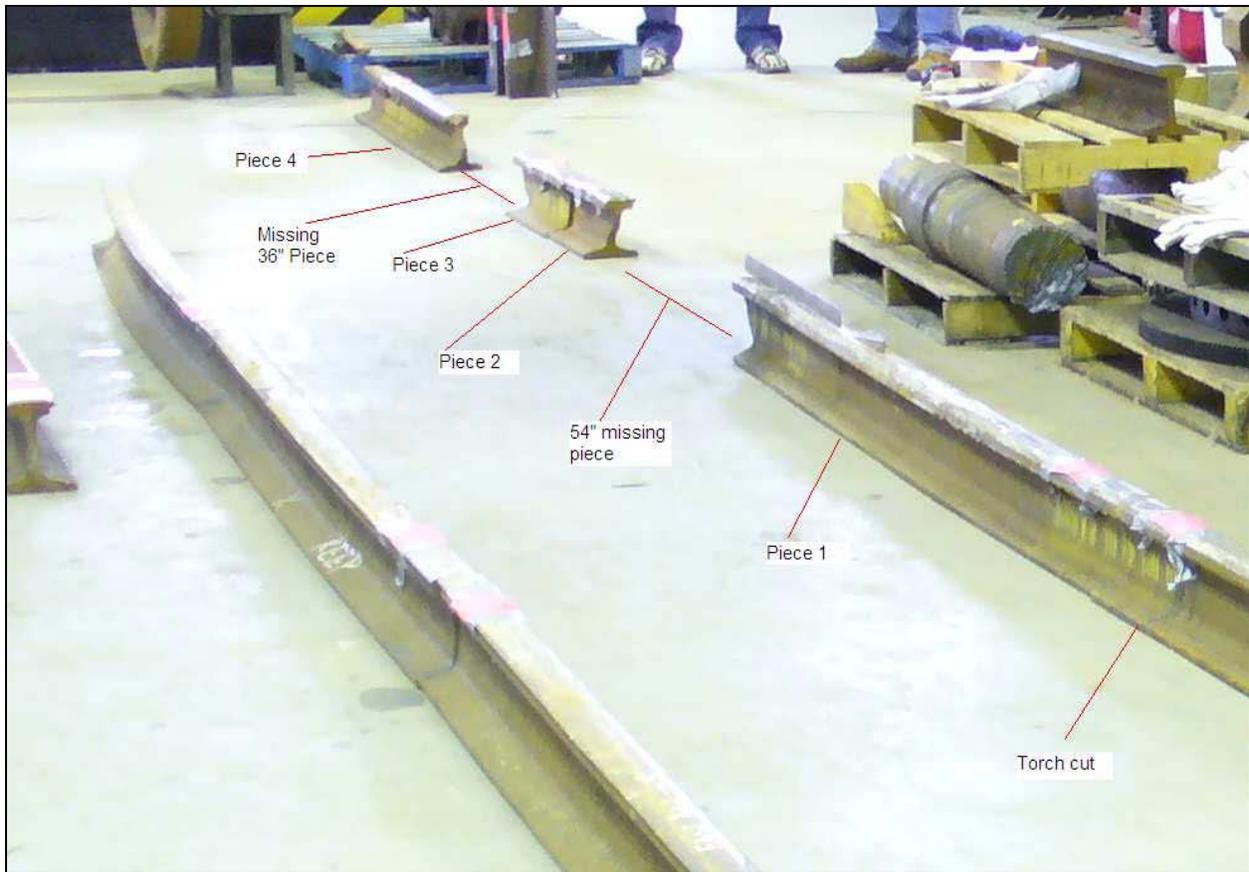
Photo 1. Layout of the east rail (left) and the west rail (right)

A total of 825 inches (68 feet- 9 inches) of rail (358 inches of the east rail and 467 inches of the west rail) was subject to failure analysis. Both rails had vertical wear and gauge wear of approximately $3/32$ inches and $5/16$ inches, respectively. This amount of rail wear is under the line A wear limit for 115-pound rail (ref.: CP's *Red Book of Track Requirements* dated May 15 , 2010; Section 17).

The 467 inch long section of the west rail consisted of 6 recovered pieces and 2 voids (see Photo 1). From north to south, there were 3 mating pieces (including Piece 1) measuring 272 inches long followed by a void of 54 inches. Then, 2 mating pieces 44 inches long (Pieces 2 and 3), another void measuring 36 inches long and then a piece of rail 61 inches long (Piece 4). The 3 pieces recovered south of the 1st void (i.e., Pieces 2, 3 and 4) and the POD displayed batter consistent with the train's direction of travel.

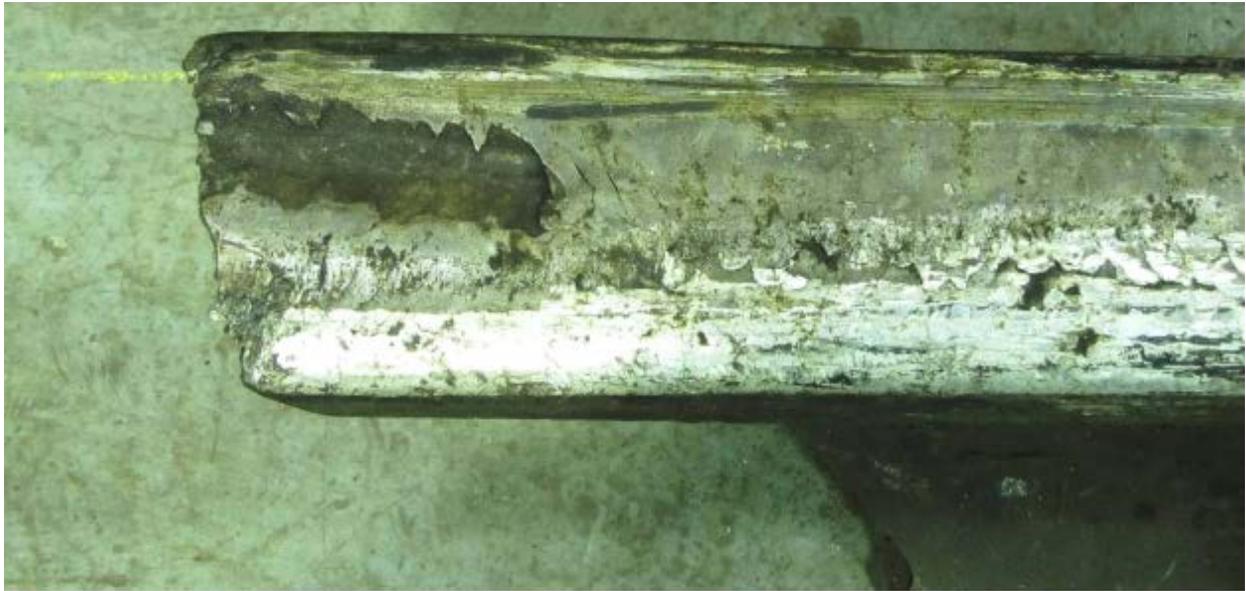
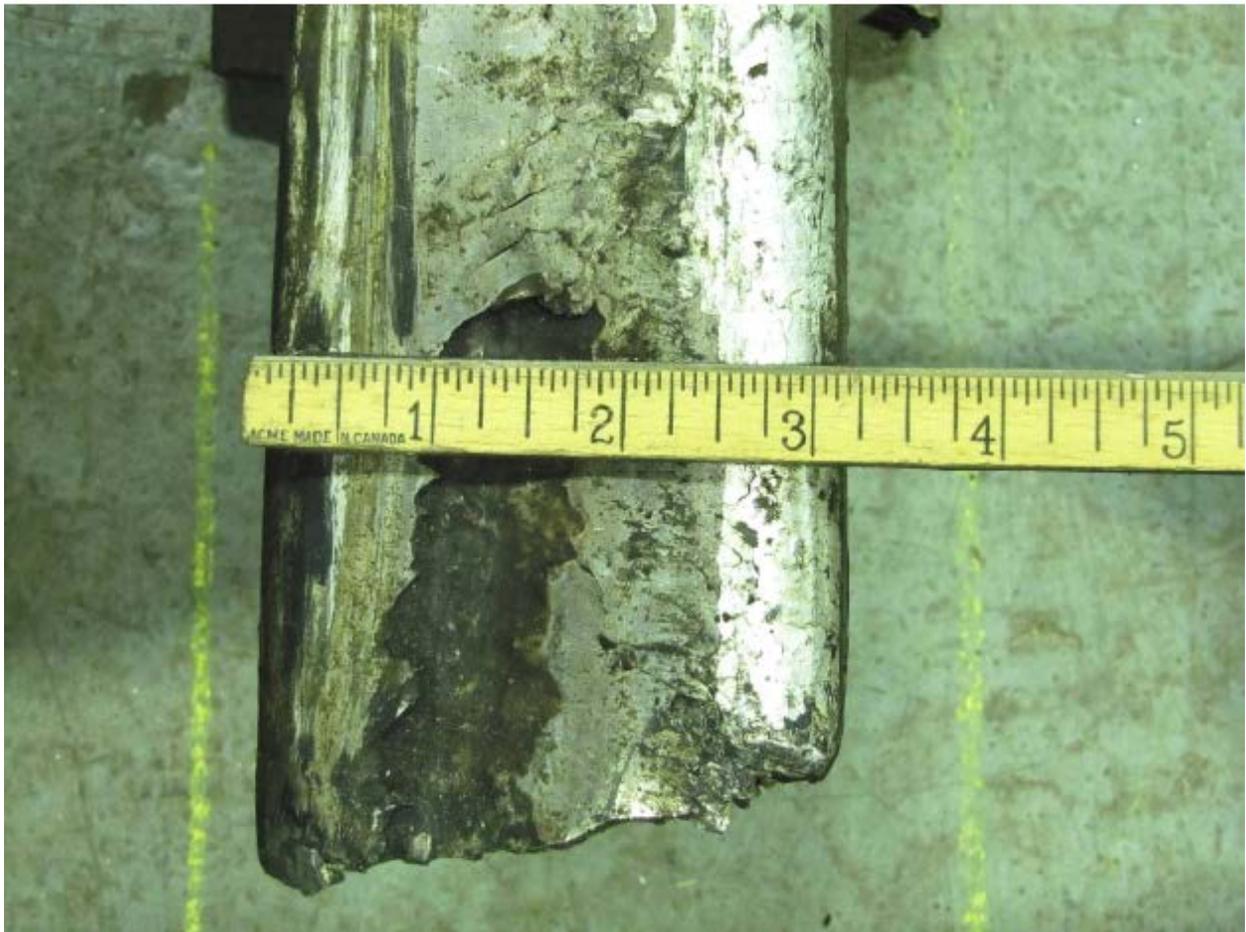
The running surface at the south end of the 3 mating pieces showed material flow and heavy checking on the gauge corner. A 10 inch long section of rail head was crushed, measuring approximately $7/16$ inches at it deepest point. Corresponding shelling was also observed on the running surface at the fractured south end (see Photos 2 and 3). This fracture surface revealed a crystalline texture typical of a catastrophic 2nd failure. The width of the rail head at the fracture was $3- 3/16$ inches compared to a width of $2- 7/8$ inches, approximately 12 inches away.

Photos 2 and 3. Fracture at the south end of the 3 mating west rail pieces showing material flow and heavy checking on the gauge corner. A 10 inch long section of rail head was crushed measuring approximately 7/16 inches at it deepest point. Corresponding shelling was also observed on the running surface at the fractured south end.

CP's *Red Book of Track Requirements*, Section 16.4.4, defines 2 types of crushed head defects. A crushed head defect is classified as CRO (crushed rail head) when the rail surface is flattened out ¼ inches or greater at the lowest point. For CRO defects, trains are restricted to 40 mph. Crushed head defects are not considered serious defects, but are generally removed from track because they can cause rough riding of rolling stock and are points of concentrated loading that may develop additional defects.

Although hand surfacing at the track defect locations had been performed prior to the derailment, the surface and cross level conditions persisted to the point where an internal rail defect may have developed at a crushed head. Although not as serious as a battered joint, a crushed head in CWR is subject to repeated impact loads that eventually will cause the rail to break due to fatigue. Rail failure would have been accelerated had an internal defect developed, but poor rail surface conditions at this location would likely have masked any defect and prevented its ultrasonic detection during the 07 June 2011 test.

1. CP's Alberta Region and Saskatchewan Region reviewed its requirements regarding the correction of track twist geometry defects with concomitant ballast and rail surface conditions.
2. Rail defect testing frequency was increased. An additional ultrasonic inspection will be performed on this corridor each year.
3. Effective December 2010, a revised rail testing protocol was implemented. Any section of rail up to 3 feet long that provides an equipment response due to observed poor rail conditions must be hand tested. For rail sections longer than 3 feet, the operator will complete a Rail Detection Exception Report to ensure the location is ground and retested on a subsequent cycle.
