RAILWAY INVESTIGATION REPORT
R10V0038

MAIN-TRACK TRAIN COLLISION

CANADIAN PACIFIC RAILWAY
TRAINS 300-02 AND 671-037
MILE 37, MOUNTAIN SUBDIVISION
KC JUNCTION, BRITISH COLUMBIA
03 MARCH 2010

Report Number R10V0038

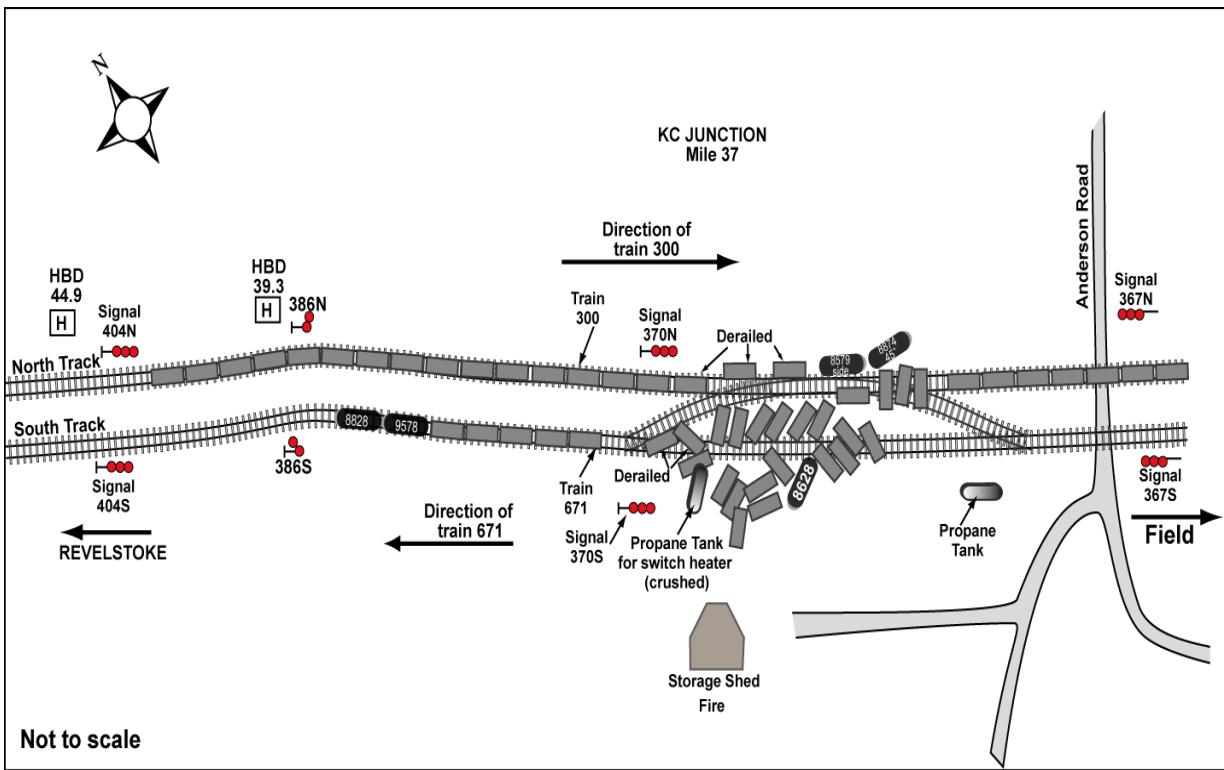
Figure 2. Track and Signal Layout at KC Junction

At about 1410,¹ train 300 was lined to controlled block signal² 370N at KC Junction (Mile 37) on the north main track of the Mountain Subdivision (see Figure 2). The Centralized Traffic Control (CTC) system had set signal 370N to display a "Stop" indication. Westward train 671 had just finished fuelling on the north main track at Golden (Mile 36) and was departing through the crossover to the south main track. Train 300 was scheduled to stop for fuel at Golden after train 671 cleared the north main track. At this location, it was common practice to fuel locomotives from the north main track. The crew on train 300 did not have a train line-up³ and were not aware that train 671 had fuelled in Golden and was crossing over at KC Junction to continue westward on the south main track.

300 on the north track up to signal 370N at KC Junction. Train 671 was lined westward at signal 367N to depart KC Junction through the crossovers from the north to the south main track.

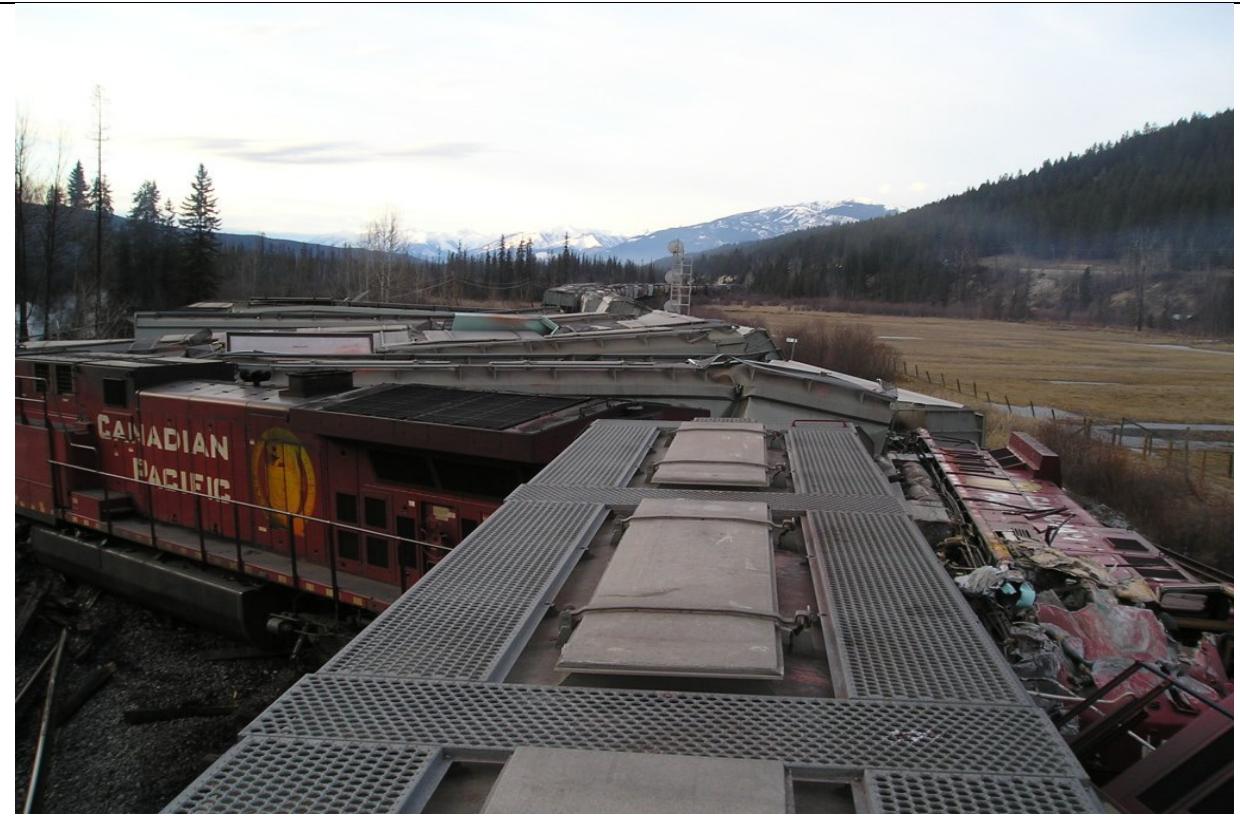
Train 300's lead locomotive and second locomotive (8874 and 8579) along with 3 empty hopper cars derailed. Train 671's mid-train locomotive (8628) and 23 loaded potash cars derailed (see Photo 1). Six additional loaded potash cars from train 671 were damaged but did not derail. A punctured 4500 litre propane tank used to fuel a switch heater at the crossover caused a fire resulting in a nearby tool/storage shed being destroyed. The propane tank was situated within 15 feet of the track. The railway right-of-way at that location was about 100 feet wide. Several nearby residences and businesses were evacuated.

Photo 1. Derailment damage of cars from train 300 and train 671

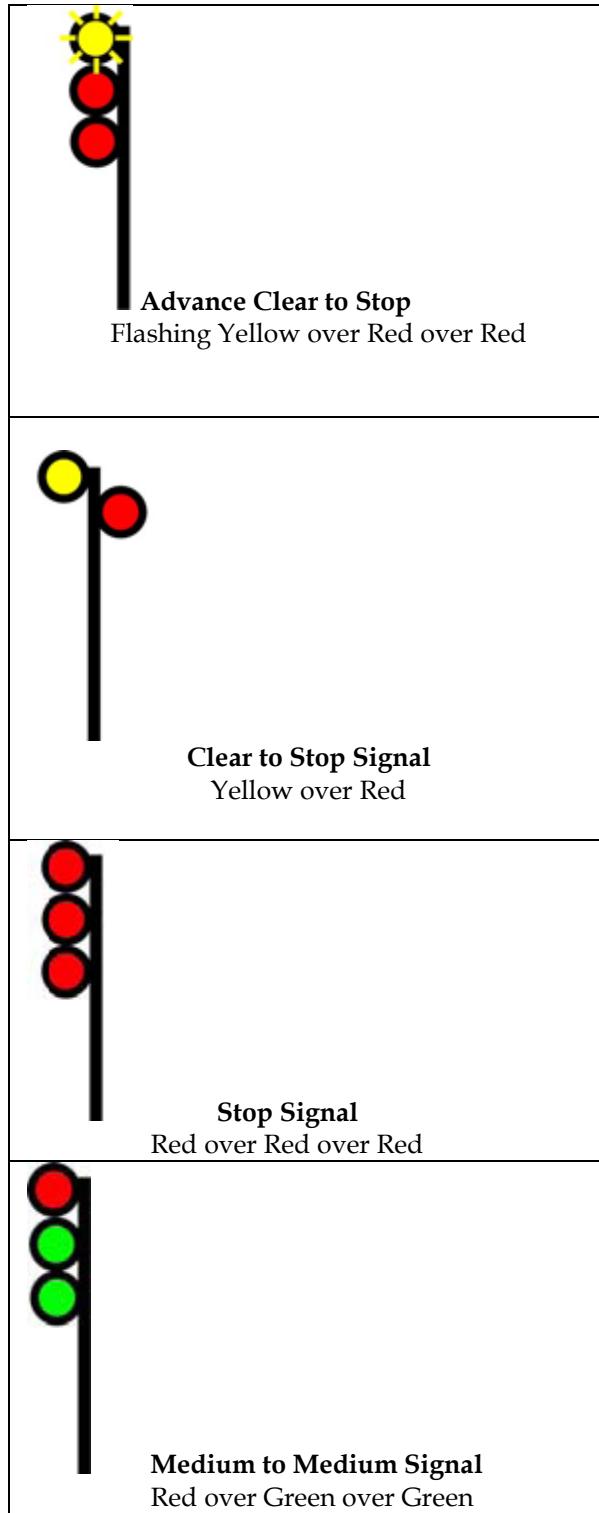
Figure 3. Signal Aspects

The lead locomotive of train 300 had been equipped with a LocoCAM.⁴ A review of the video footage from this camera confirmed the following sequence of signal indications (see Figure 3):

- An Advance Clear to Stop indication at signal 404N (i.e., the intermediate signal preceding the advance signal to KC Junction).
- A Clear to Stop indication at signal 386N (i.e., the advance⁵ signal to KC Junction).
- A Stop indication was displayed on signal 370N, (i.e., the controlled signal governing eastbound movements on the north track, at KC Junction).

The lead locomotive of train 671 was also equipped with a LocoCAM. A review of the video footage from this camera confirmed the following signal indication (see Figure 3):

- Medium to Medium Signal indication at signal 367N (i.e., the controlled signal governing westward movements through the controlled location⁶ at KC Junction).

A review of the railway signal logs confirmed that there was a proper progression of signals and that there were no discrepancies with the functioning of the signal system.
