**RAILWAY INVESTIGATION REPORT
R13D0077**

DERAILMENT

**CANADIAN NATIONAL
FREIGHT TRAIN M37231-05
MILE 144.4, ST-LAURENT SUBDIVISION
TASCHEREAU YARD, MONTRÉAL, QUEBEC
06 NOVEMBER 2013**

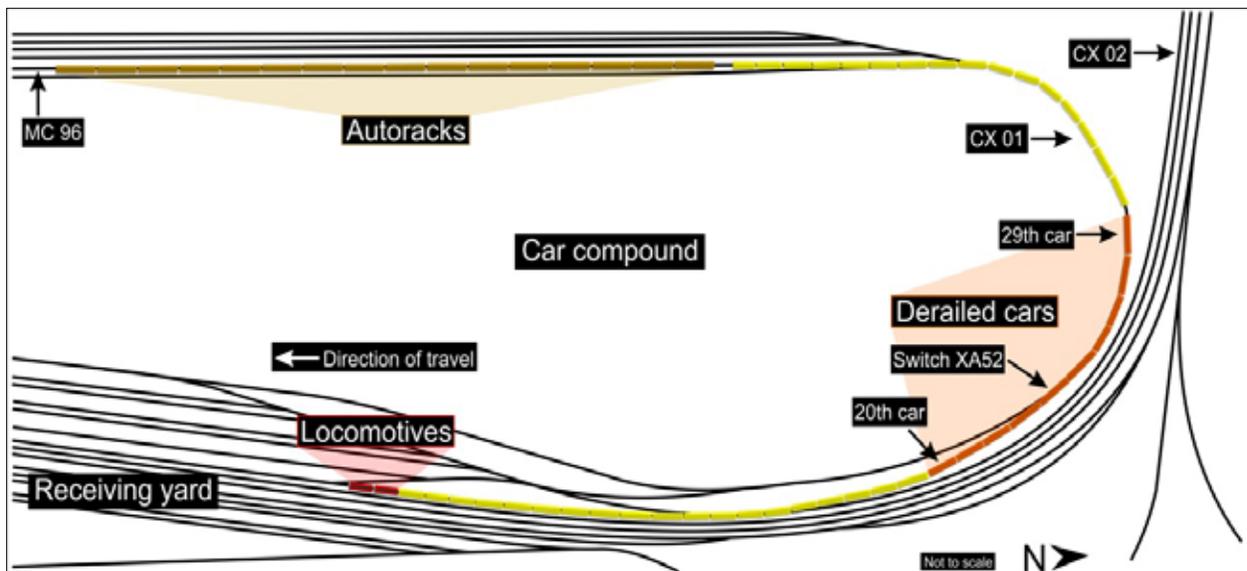
Figure 2. Site diagram

Upon reaching crossover switch XA52, the LE stopped the train, exited the cab and lined the crossover switch for track CX02. The LE then returned to the locomotive cab, moved the train forward onto track CX02 and stopped with the train occupying tracks CX02, CX01 and MC96 (Figure 2).

Track CX01 is U-shaped and includes a tight 15.75° curve (Figure 2). There are 5 other tracks (CX02 to CX06) that have similar configurations and are located adjacent and parallel to track CX01 for part of the curve. Track CX01 links the car compound tracks with the receiving yard tracks, and was used daily by train M37231 when setting off autorack cars. Other yard movements and road switcher movements also use track CX01, resulting in annual rail traffic of about 2 million gross tons on this track.

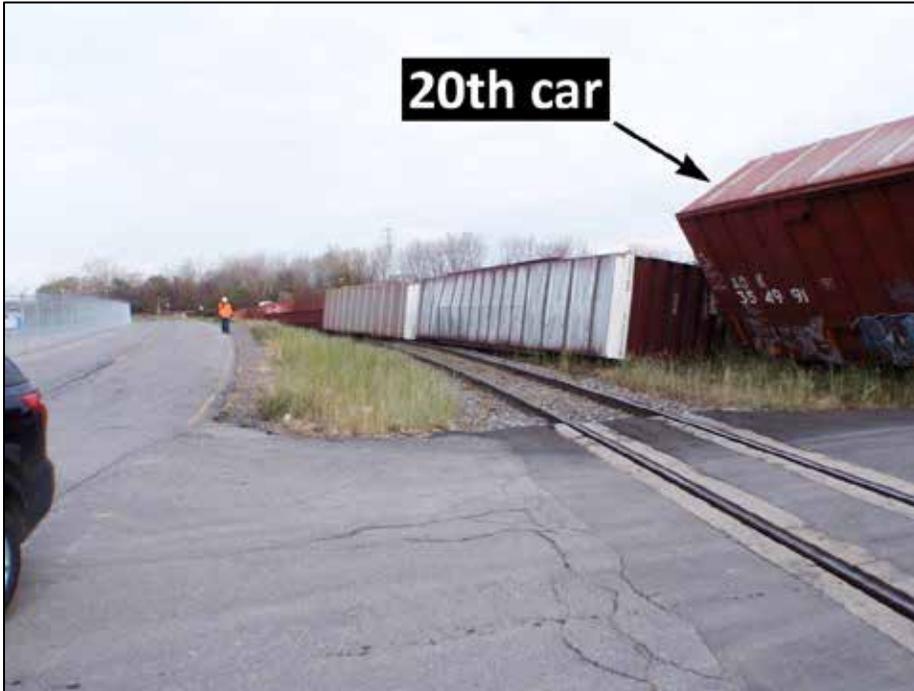
Photo 1. Derailment site (looking towards the 29th car)

- The 20th car from the locomotives (empty box car) had derailed, but remained coupled to the front of the train. This car was leaning at a 45° angle and was obstructing a crossing leading to the north exit of the yard (Photo 1).

- The following 9 empty cars (the 21st to the 29th cars) had derailed and were laying on their side. The 24th to the 29th cars were in the ditch adjacent to track CX01.

- The 29th car, an empty, 80-foot centrebeam bulkhead flat car equipped with EOCCDs, had separated from the rear portion of the train.
- The derailed cars were damaged and most of them had separated from their trucks. The knuckles and drawbars did not show any signs of distortion or rotation.
