# Lac-Mégantic runaway train and derailment investigation summary

This summary of the Transportation Safety Board of Canada's (TSB) Railway Investigation Report R13D0054 contains a description of the accident, along with an overview of the analysis and findings, the safety action taken to date, five key recommendations, and what more needs to be done to help ensure an accident like this does not happen again.

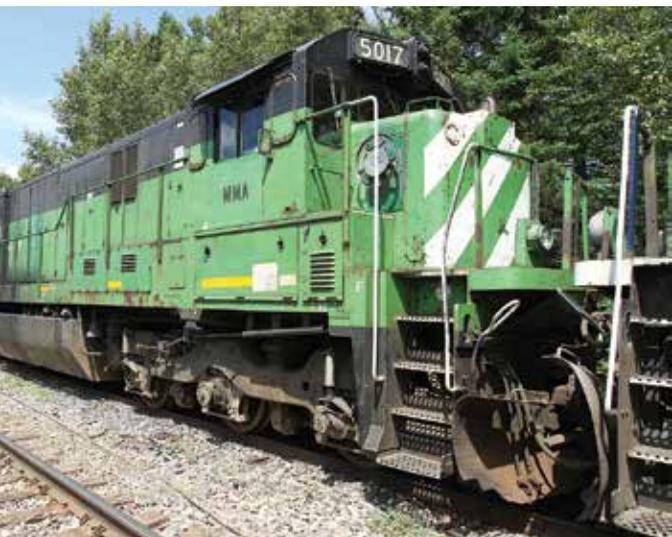
In October 2012, eight months before this accident, the lead locomotive was sent to MMA's repair shop following an engine failure. Given the significant time and cost of a standard repair, and the pressure to return the locomotive to service, the engine was repaired with an epoxy-like material that lacked the required strength and durability. This material failed in service, leading to engine surges and excessive black and white smoke. Eventually, oil began to accumulate in the body of the turbocharger, where it overheated and caught fire on the night of the accident.

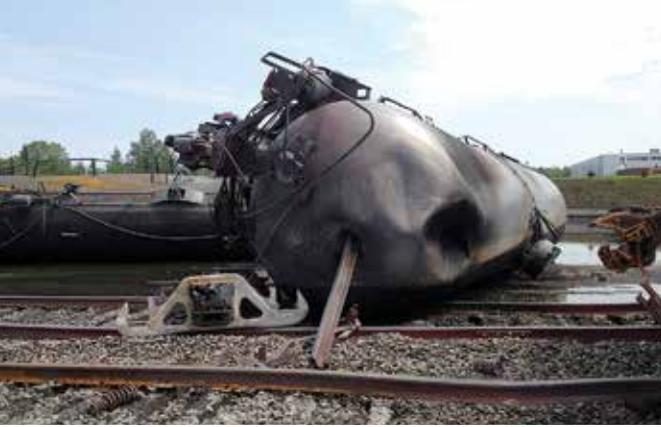
All 72 tanks cars were Class 111, manufactured between 1980 and 2012. Although they met requirements in effect at the time, they were built to an older standard, and they lacked enhancements such as a jacket, a full head shield, and thermal protection.

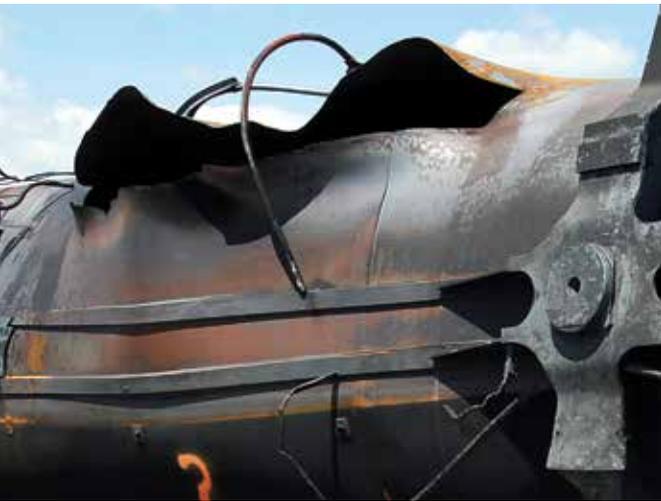
Almost every car that derailed was breached, some in multiple areas, including shells, heads, top and bottom fittings, and pressure relief devices. The exact location and extent of the damage varied depending on the orientation and speed of the cars during the derailment.

When the tank cars were breached, the petroleum crude oil was released, fuelling the fire. The damage to the tank cars could have been reduced by enhanced safety features. This is why the TSB called for tougher standards for tank cars carrying flammable liquids.
