RAILWAY INVESTIGATION REPORT

R16C0012

Non-main-track derailment

Canadian Pacific Railway

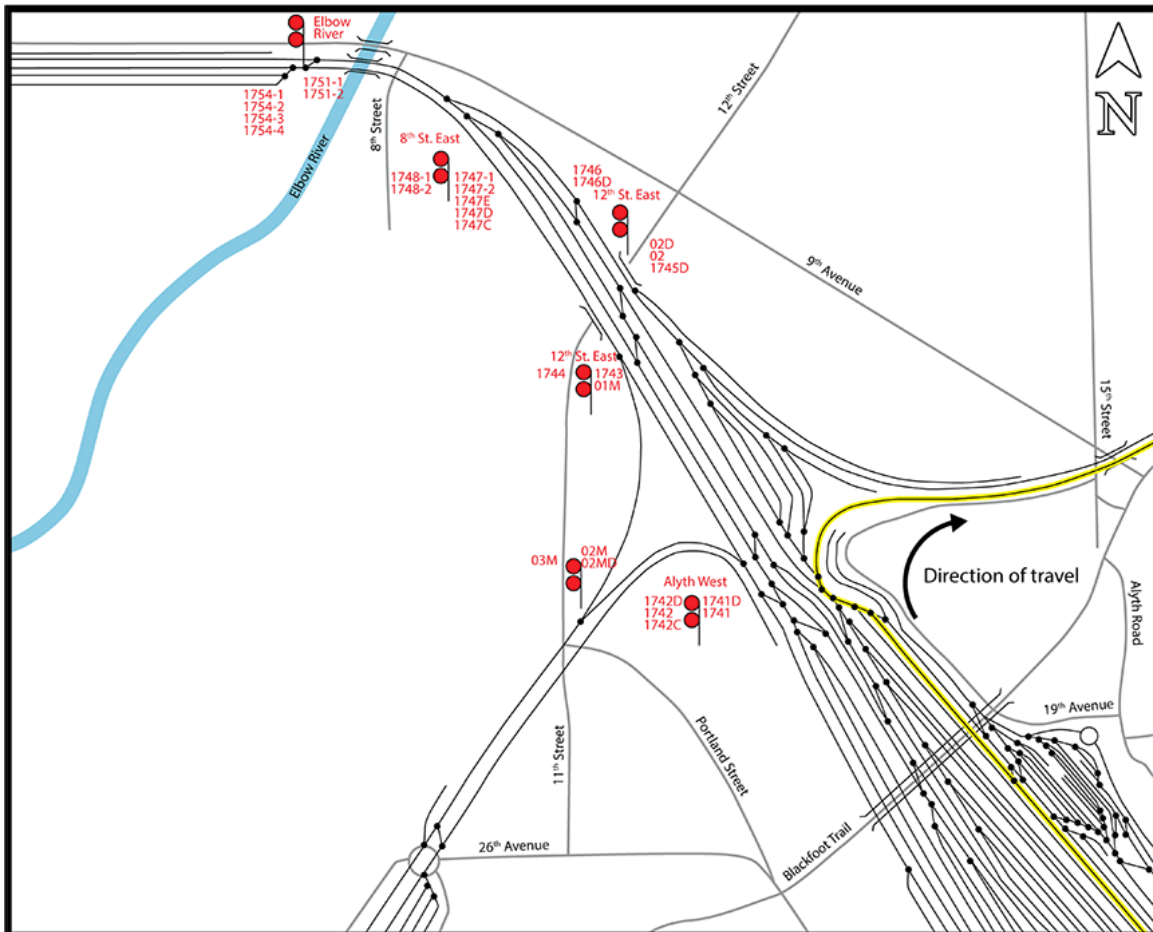
The train proceeded through track N14 and through the east leg of the north wye² (Figure 2) toward Bengal on the Red Deer Subdivision to facilitate the set-off.

Figure 2. Path (highlighted in yellow) of the train through track N14 and the east leg of the north wye (Source: Canadian Pacific Railway, with TSB annotations)

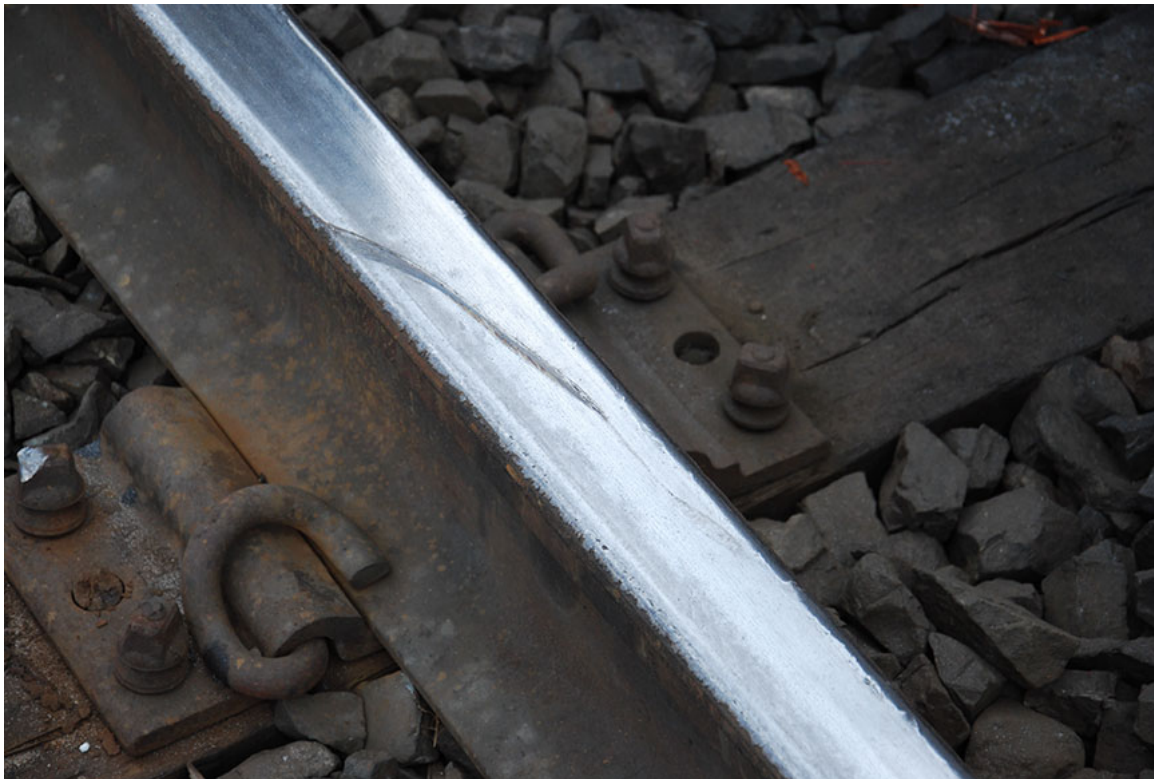
The derailment spanned approximately 1050 feet, and 9 of the 13 derailed cars were pulled over onto their sides. The track sustained minimal damage, consisting of wheel flange marks on the top of the south rail (Figure 3).

Figure 3. Flange mark left by the train on the rail (Mile 0.40, Red Deer Subdivision)

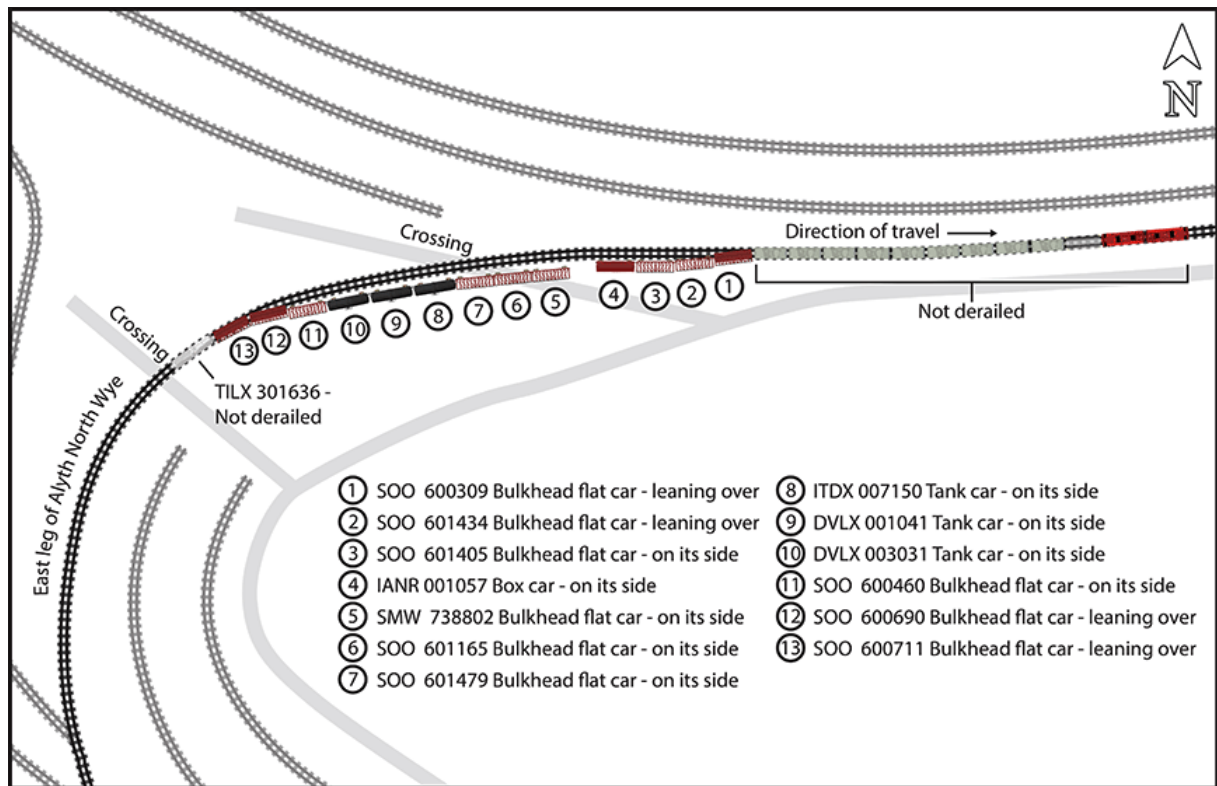
Figure 4. Derailment site diagram

Immediately preceding the 13 derailed cars were 10 cars (9 empties and 1 load) as well as the 2 locomotives (Figure 4). Of the 13 derailed cars, 9 were empty centre beam bulkhead flat

cars, 1 was a loaded box car containing canned green beans, and 3 were empty (residue) tank cars that had last contained molten sulfur. The first 2 derailed cars were upright and leaning over. The next 9 cars were on their sides, and the last 2 derailed cars were upright and leaning over.

The train had separated between the 4th and 5th derailed cars. The remainder of the train was not derailed. Following the derailment, a cut was made one car behind the last derailed car, and the tail end of the train was pulled back into Alyth Yard.
