RAIL TRANSPORTATION SAFETY INVESTIGATION REPORT R17V0220

MAIN-TRACK TRAIN COLLISION WITH TRACK EQUIPMENT

Canadian Pacific Railway
Freight train 868-078
Mile 68.4, Mountain Subdivision
Fraine, British Columbia
31 October 2017

Transportation Safety Board of Canada, Rail Transportation Safety Investigation Report R17V0220 (released 29 March 2019).

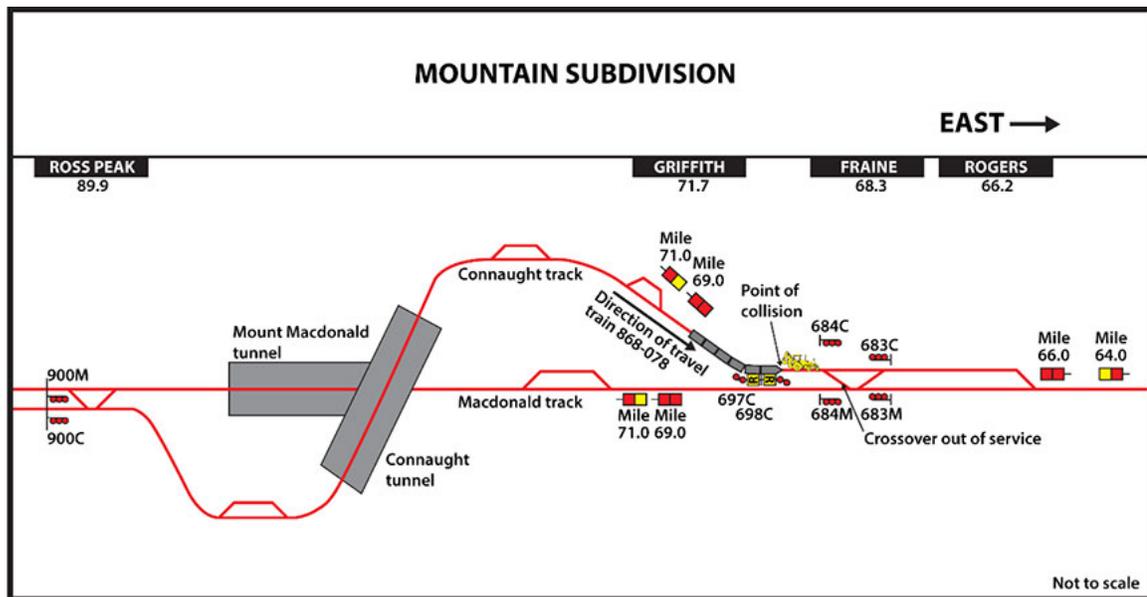
Figure 2. Occurrence site diagram

At 0545, as the train approached Mile 71 on the Connaught track, the train crew called the foreman to request permission to operate through the work limits, as required by Rule 42. The foreman contacted the track workers who were working directly under his supervision; the sub-foreman, who was protecting track workers under delegated protection authority from the foreman; and the supervisor. Upon being told that everyone was clear of the Connaught track, the foreman gave permission to the train crew to proceed on the Connaught track through the work limits with no restrictions.

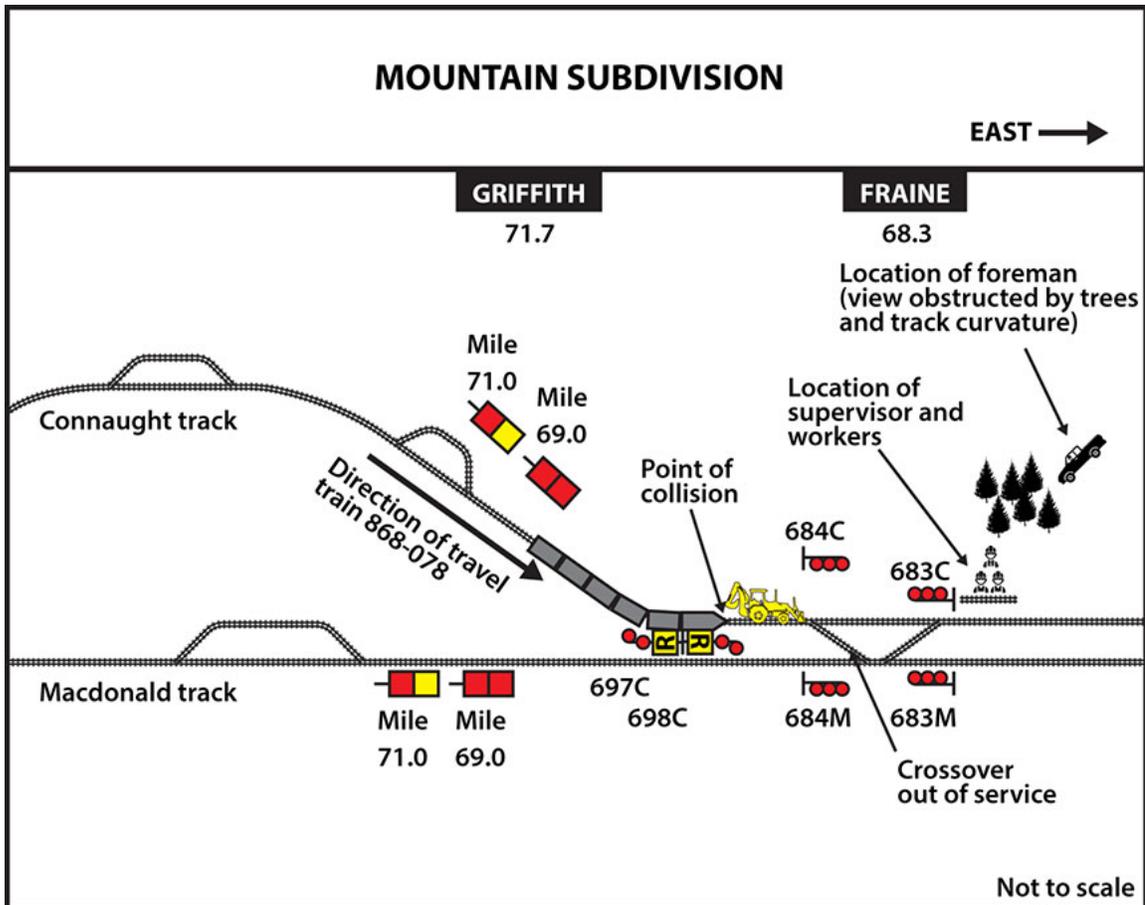
Figure 3. Location of workers at time of accident

The foreman was in his truck at the crossing northeast of the location where the supervisor and his crew were working on the switch panel. Although able to observe most of the employees who were working off the tracks, the foreman could not see the work activities on the main tracks west of signal 683C (where the backhoe was working) (Figure 3).

At about 0600, as the train was travelling at 25 mph and exiting a 1° right-hand curve near the work site, the train crew observed a backhoe on the track. The crew applied the train brakes in emergency, but the train could not be stopped before striking the backhoe. The backhoe operator was transported to hospital with serious injuries. The backhoe sustained extensive damage and the lead locomotive of the train sustained minor damage. There was no track damage.

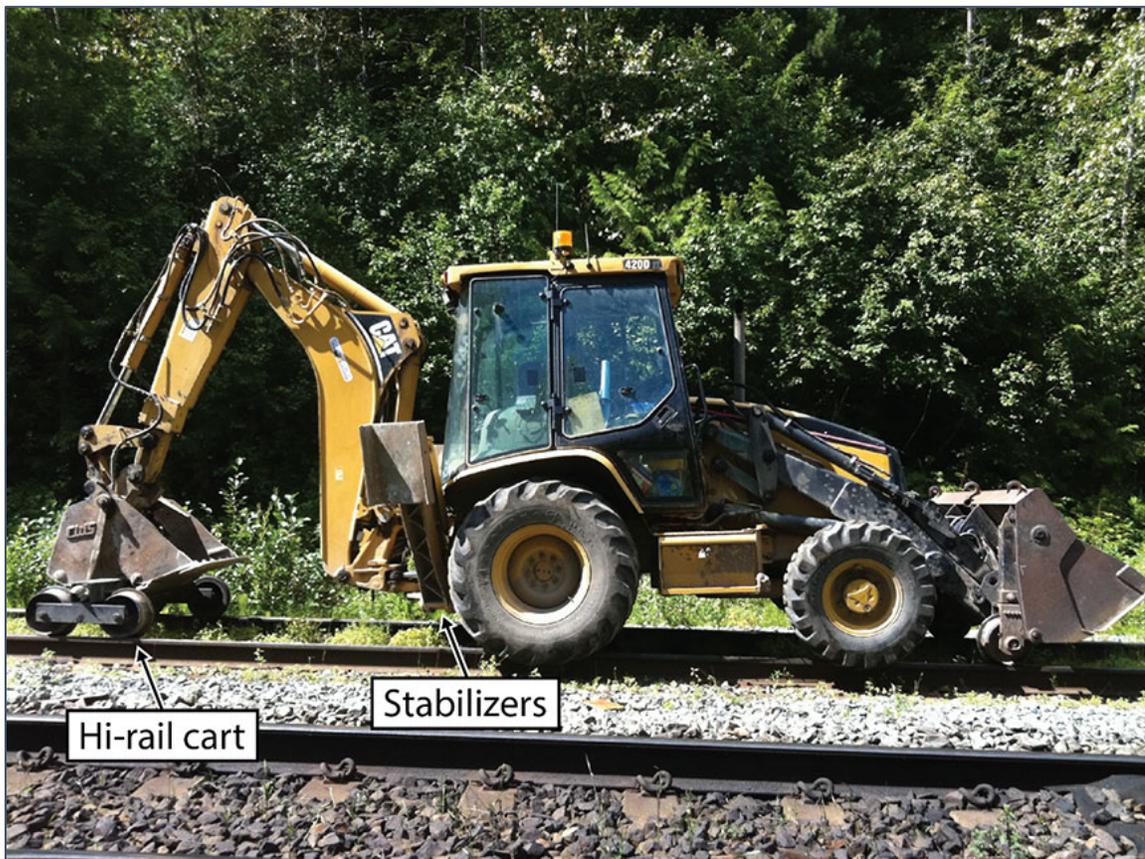
Figure 4. Similar backhoe with attached hi-rail-equipped cart

Working under the direction of the supervisor, the backhoe operator was performing clean-up duties along and between the tracks about 1000 feet west of the crossovers. The backhoe was attached to a hi-rail-equipped cart to facilitate movement of the machine on the track (Figure 4).
