AVIATION INVESTIGATION REPORT

A05Q0119

COLLISION WITH WATER

BELL 205 A-1 HELICOPTER C-GADA

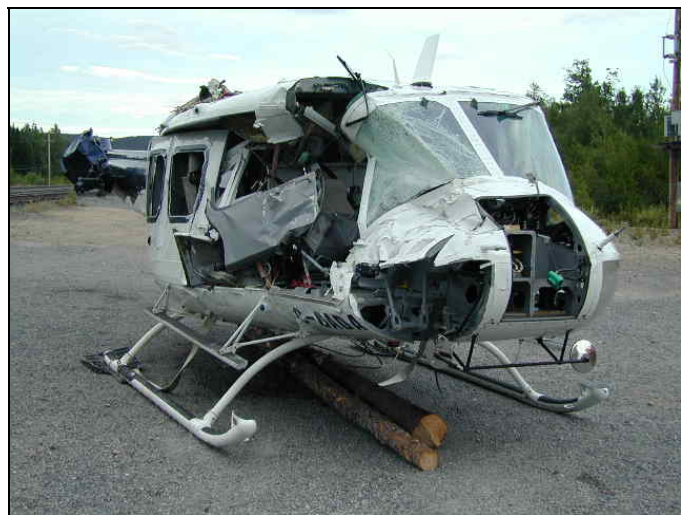
The helicopter came to rest inverted approximately 1000 feet from shore in about 25 feet of water and silt, which totally obscured the water during salvage operations. The initial attempt to retrieve the helicopter by the cargo hook resulted in the lift beam being torn off and lost. The water bucket, the tail rotor, and all parts that had been separated from the airframe could not be located due to the lack of visibility under water. Once the helicopter was recovered, examination of the airframe confirmed a nose-down impact on the right side (Photo 1).

Photo 1. Damage to Bell 205 A-1, C-GADA

The main rotor blades had been severely damaged from impact with the water. Signs of delaminating of the re-enforcing straps near the blade roots, usually associated with blade coning, were not present. Coning is the result of upward blade movement if rotor rpm decays following a loss of power and application of collective. The examination revealed that the impact loads had also broken the four main transmission pylon mounts. The transmission remained attached to the airframe only by the hydraulic lines and the flight controls. During the impact, the rotor head contacted the mast. The mast was disassembled and examined; no pre-accident condition, which could have been causal to the accident, was revealed. The main power shaft between the engine and the transmission was a KAflex type. Only the connectors to the engine and transmission were recovered, with some of the flexible segments still attached. All fractures associated with the KAflex were examined and found to have resulted from overload. The hollow portion of the shaft grooved a circular imprint of the shaft ends on both the connectors. This could only have occurred if the shaft assembly had remained in position until impact.

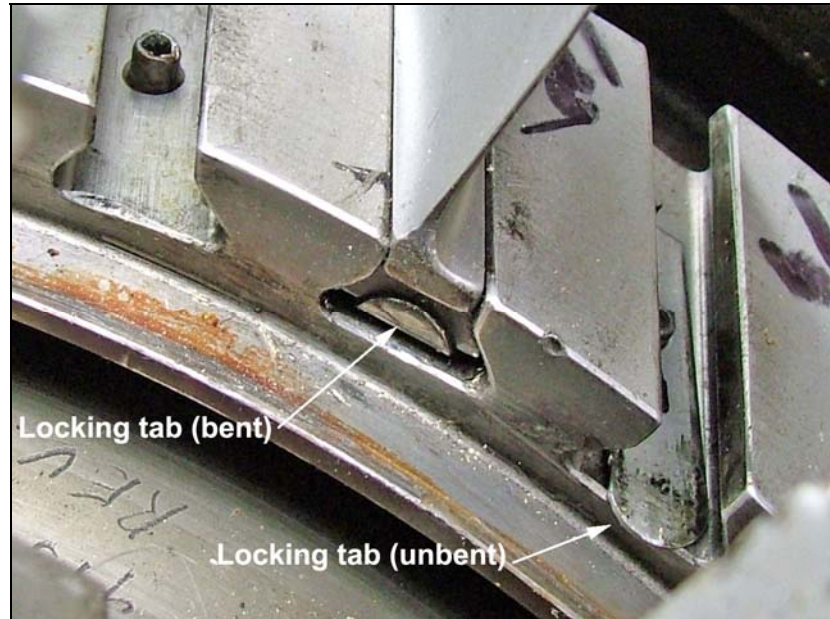
There are 31 blades (part number 1-100-361-06) on the first stage compressor disk. Each blade has a locking tab (part number 1-100-505-02). These are single use only items and should be replaced at each disassembly. The examination revealed that all the locking tabs, locking the blades to the first stage compressor disk, were found unbent (see Photo 2). All of the blades had moved back and there was rotational scoring on all aft blade platforms, with corresponding damage on the outer diameter of the vane support.

The disassembled engine was returned to the TSB Engineering Laboratory. The additional test results are outlined in report LP 046/2006 (Testing of Locking Tabs). The report shows that a calculated rearward acceleration in the vicinity of 2034 g would have been required to unbend the tabs. The relatively low impact sustained by the helicopter, the forward direction of the helicopter during the impact, and the observations made during the testing suggest that it is unlikely that the first stage compressor blades moved aft during the accident, unbending the tabs. It is likely that the tabs were not replaced and bent, as required, during the last maintenance conducted on the compressor (Photo 2).

Photo 2. Locking tabs

Air Asia Company Ltd. has taken safety action to ensure that the quality control within its maintenance facility is maintained by identifying and segregating military parts from commercial ones.

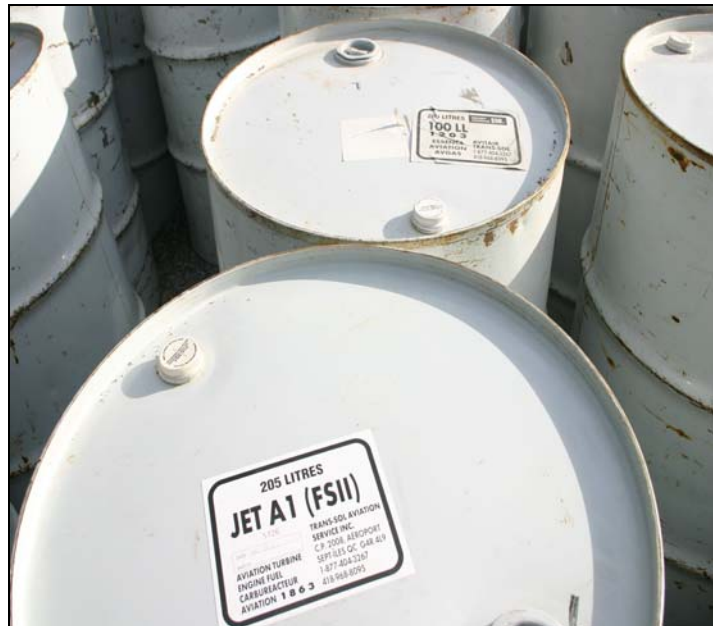
Photo 4. Fuel barrel identifying stickers

fuel) or a Class 3 product. No colour differentiation of the identifying stickers is necessary. The different products in the containers were not visible to the user, and do have a different colour and smell. AVGAS is blue and Jet fuel is yellow. Workers loading the product at the wholesaler and those delivering the product to the SOPFEU had mistakenly mixed some AVGAS barrels with the Jet A1 barrels. During the fuelling process, the helicopter pilots using the product mistakenly identified the AVGAS barrels as Jet A1 barrels.

Although the fuel product identifying stickers met provincial regulations, the similarity between the stickers may lead to misidentification of the fuel product. Operating with a small amount of AVGAS had no consequence on engine performance.

On 05 June 2006, the TSB issued Safety Information Letter A060026-1, Inadequate Identification of Fuel Barrels, to the Director General of Civil Aviation. The Safety Information Letter highlighted the criticality of proper identification of fuel barrels. The use of fuel barrels for remote helicopter operations is widespread throughout Canada.
