OPERATIONAL SERVICES BRANCH
ENGINEERING LABORATORY REPORT

LP181/2013

Locomotive Engine Fire Examination

Montreal, Maine & Atlantic Railway, Train MMA-002

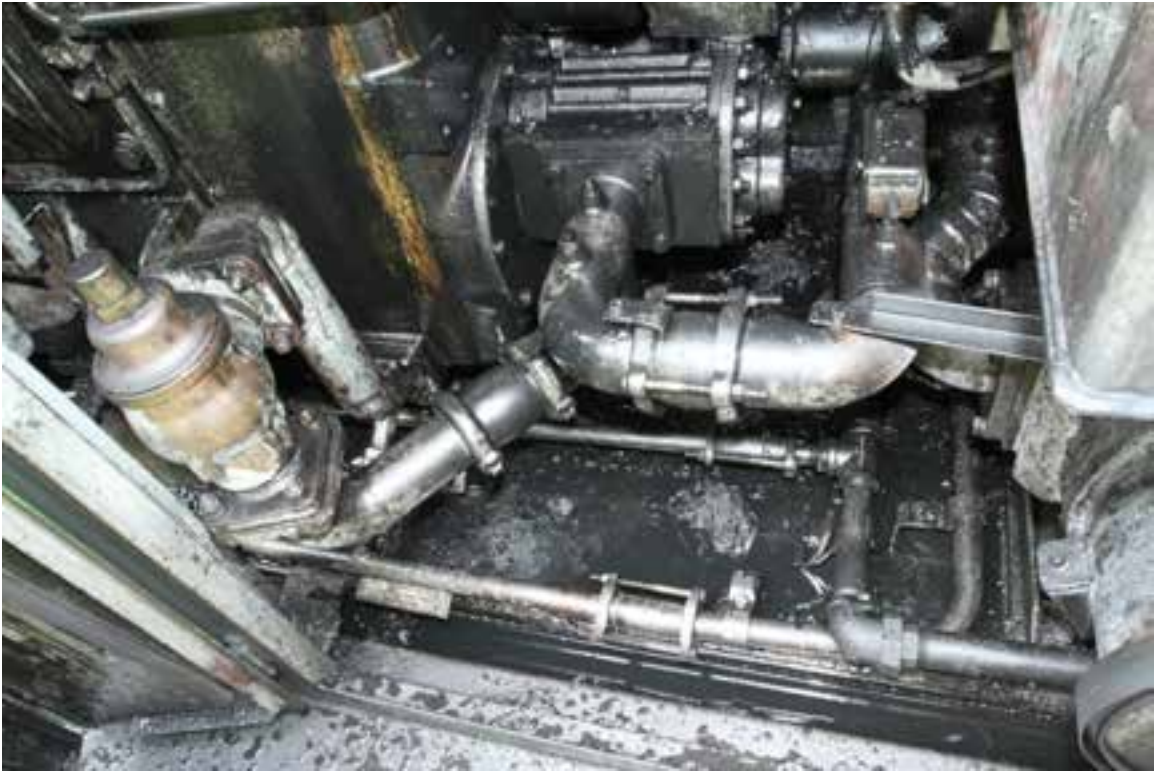
- 2.1.1 Initial field examination of the engine bay of MMA 5017 showed that engine oil had been dispersed inside the engine covers as well as outside, primarily near the turbocharger end of the engine. It could not be determined how much engine oil had been present in the engine bay prior to the fire, nor the extent to which this oil was disturbed in the act of extinguishing the fire. However, a significant amount of engine oil was observed all around the forward end of the engine (Figure 1).
- 2.1.2 Examination of the exhaust stack and surrounding roof panels showed that the fire had been concentrated in that area (Figure 2). Fresh rust was visible where paint

Figure 1: Representative view of engine oil dispersed inside MMA 5017 engine bay

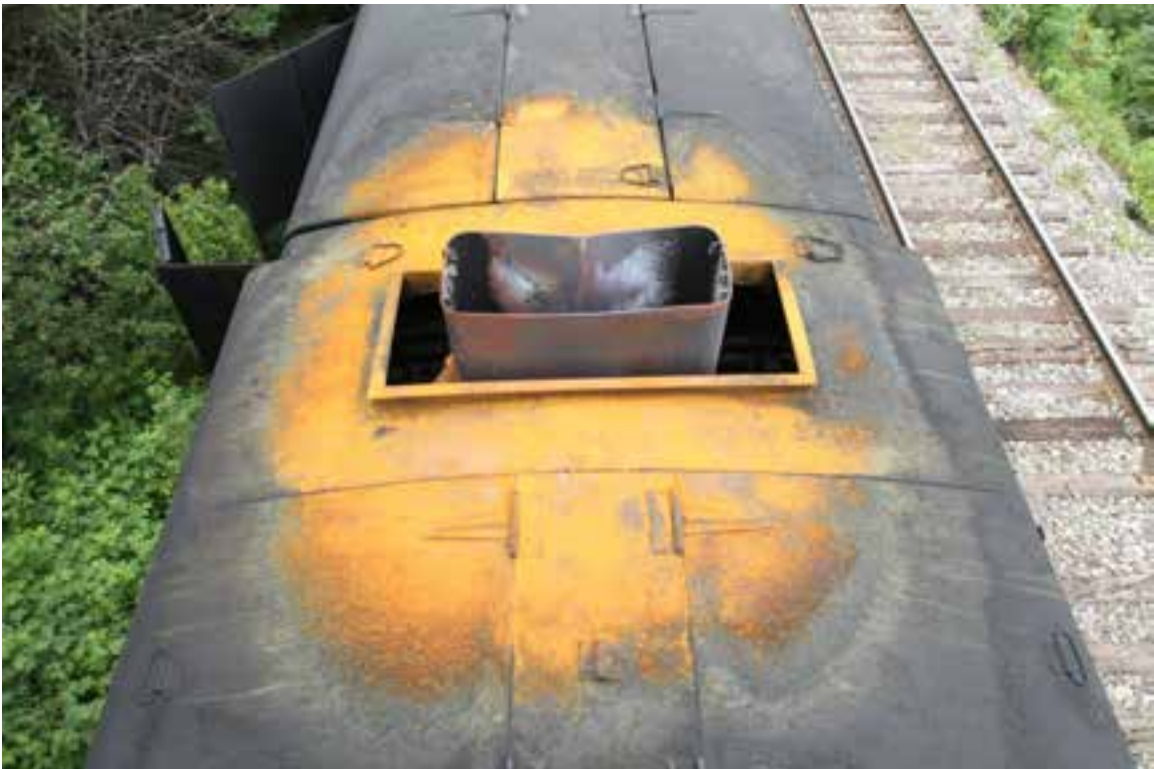
- had been burned off portions of the roof immediately adjacent to the exhaust stack, and the stack itself was cracked. Visual inspection inside the exhaust stack indicated that the body of the turbocharger was approximately half full of a mixture of oil and water (Figure 3).

Figure 2: Rust showing where fire was concentrated around the cracked exhaust stack

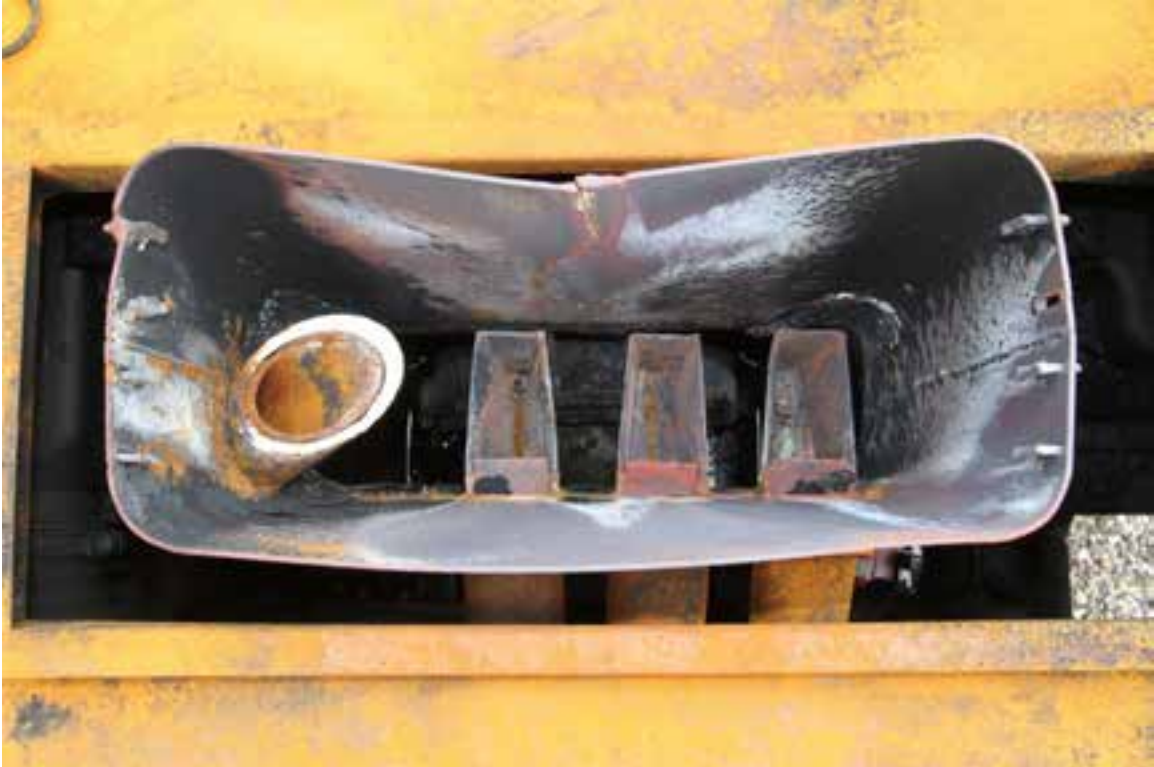
Figure 3: View inside the exhaust stack showing surface of oil/water mixture
Aspirator venturis are visible

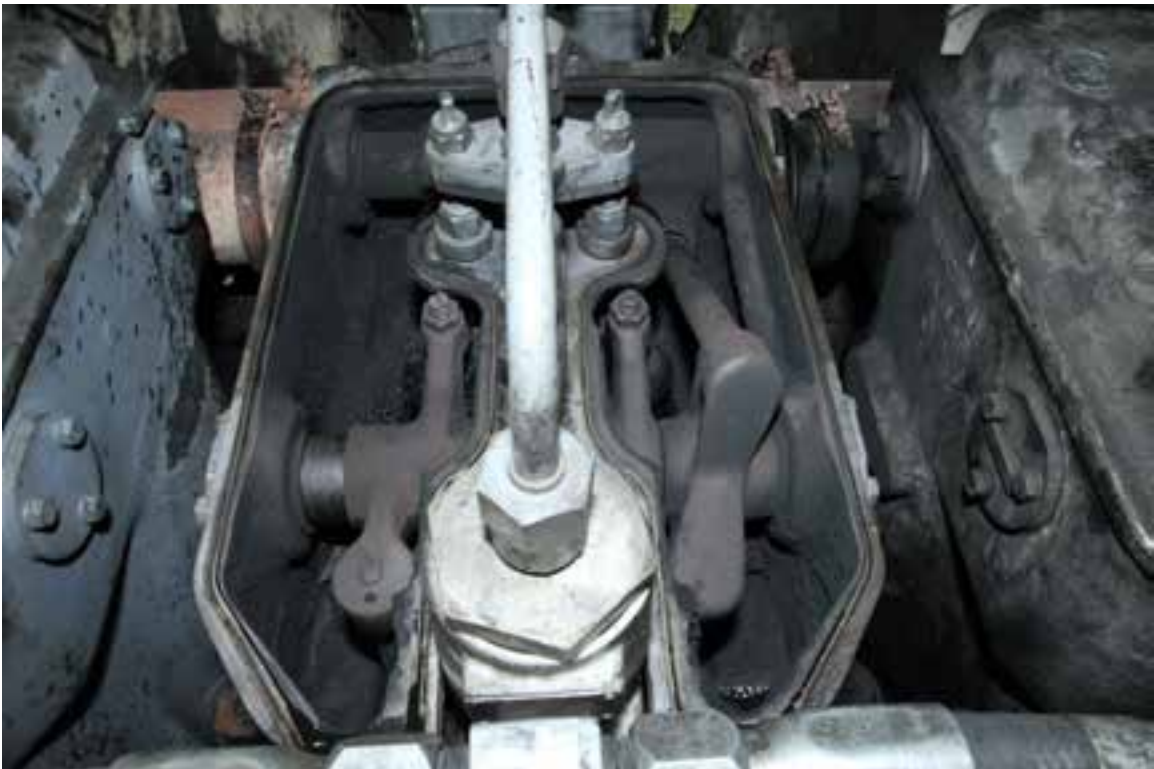
- 2.1.3 Removal of the valve covers revealed that the top of the number five power assembly on the right hand side (PA R5) was dry and coked, indicating that the valve train had been starved of oil for an extended period of time (Figure 4). The other power assemblies had a normal oily appearance (a representative example is shown in Figure 5 for comparison).

Figure 4: Power assembly R5 showing dry, coked valve train

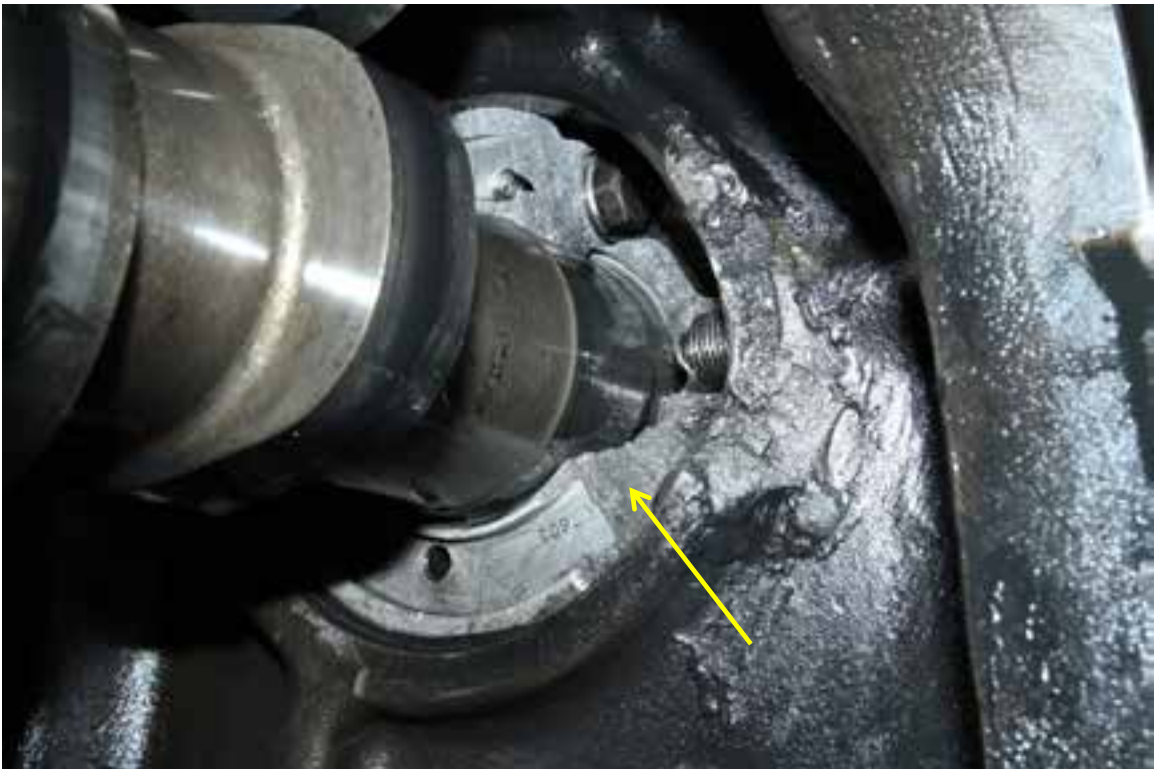
- 2.1.4 Removal of the crankcase inspection cover for PA R5 showed that the camshaft bearing between PA R4 and PA R5 was broken (Figure 6). A large section of the camshaft bearing had separated exposing the camshaft journal.

Figure 6: Broken camshaft bearing between PA R4 and R5 (arrowed)

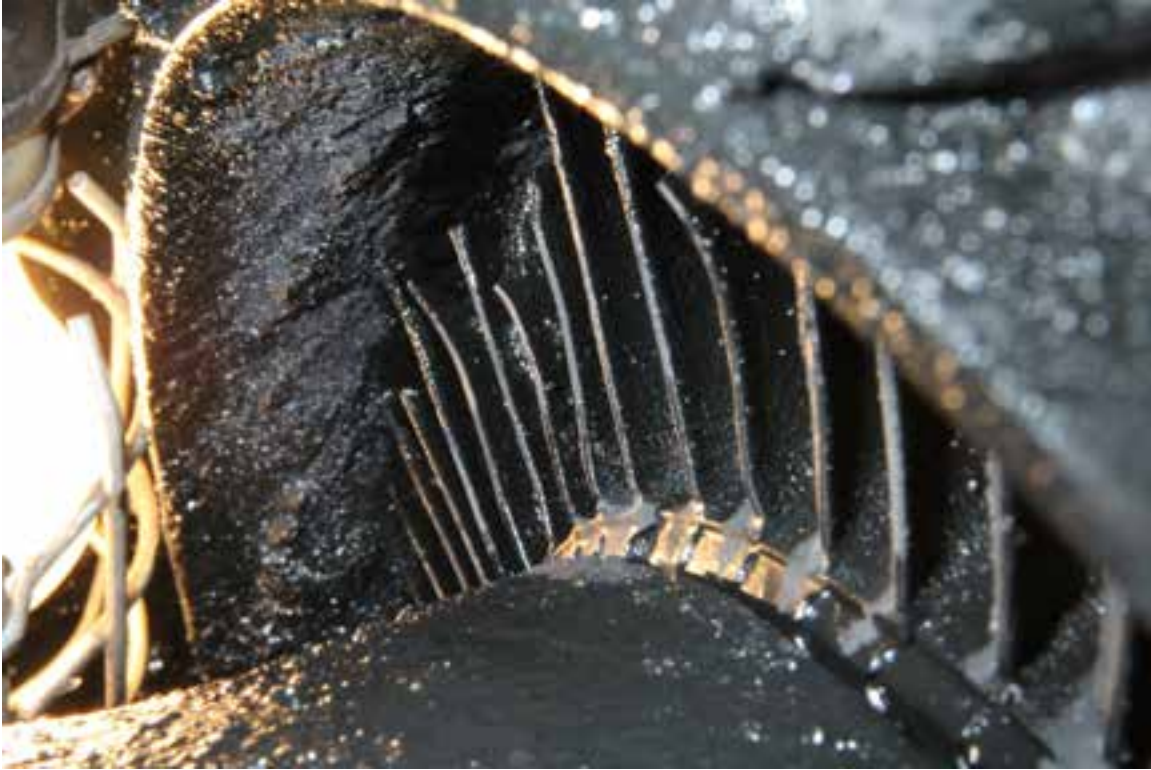
- 2.2.2 The turbocharger exhibited missing and broken blades but could be rotated by hand, indicating that the turbo shaft bearings were in good condition (Figure 7). Rags were passed through the lower portion of the turbocharger body to look for turbine blade fragments. None were recovered.

Figure 7: Bent and broken turbine blades in the turbocharger

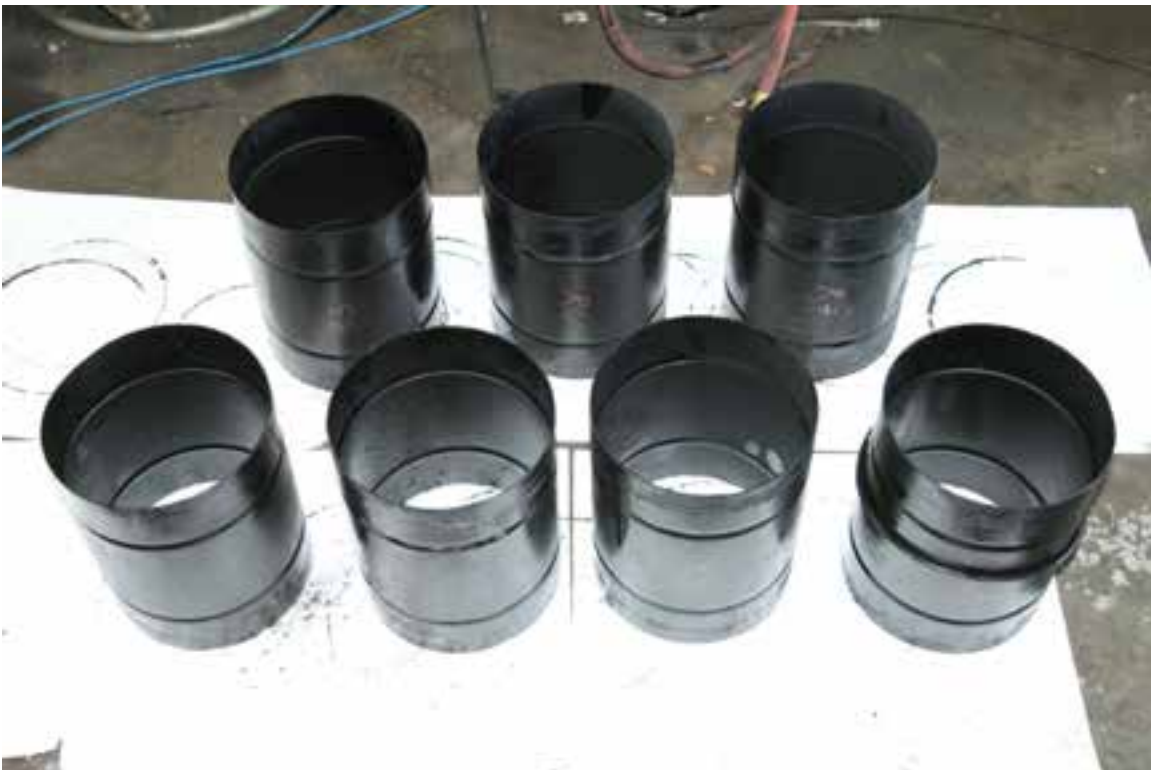
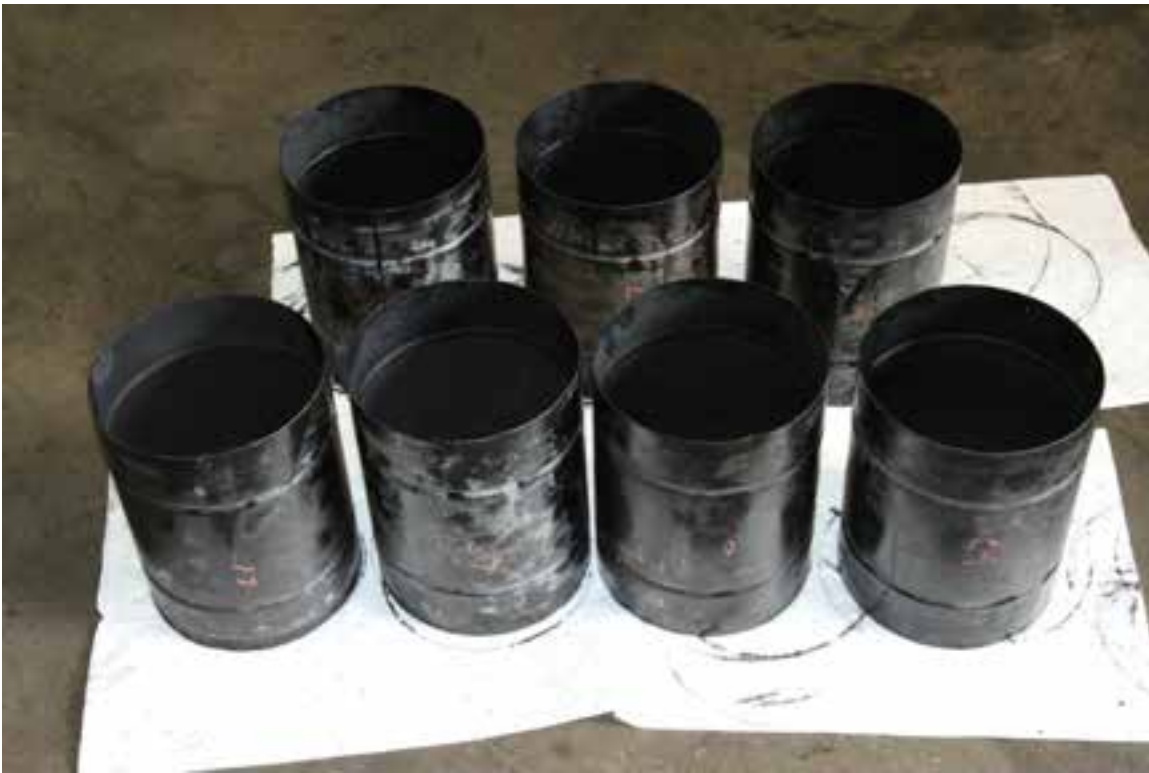
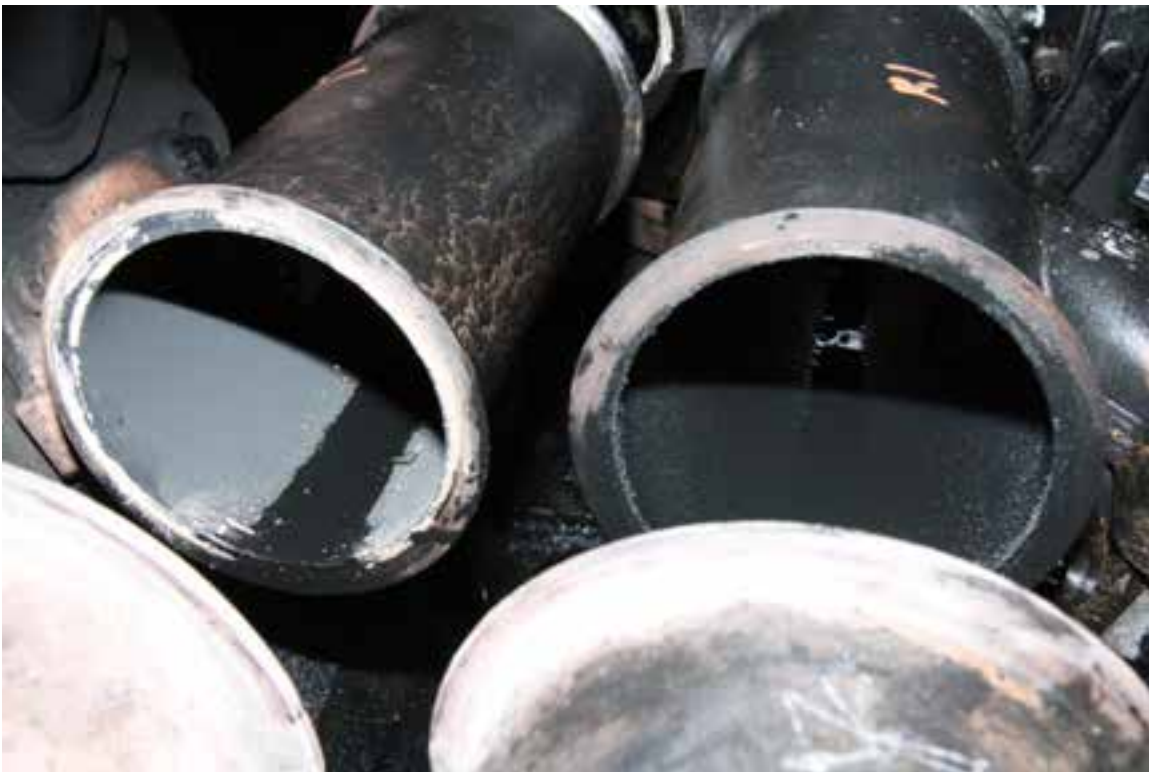
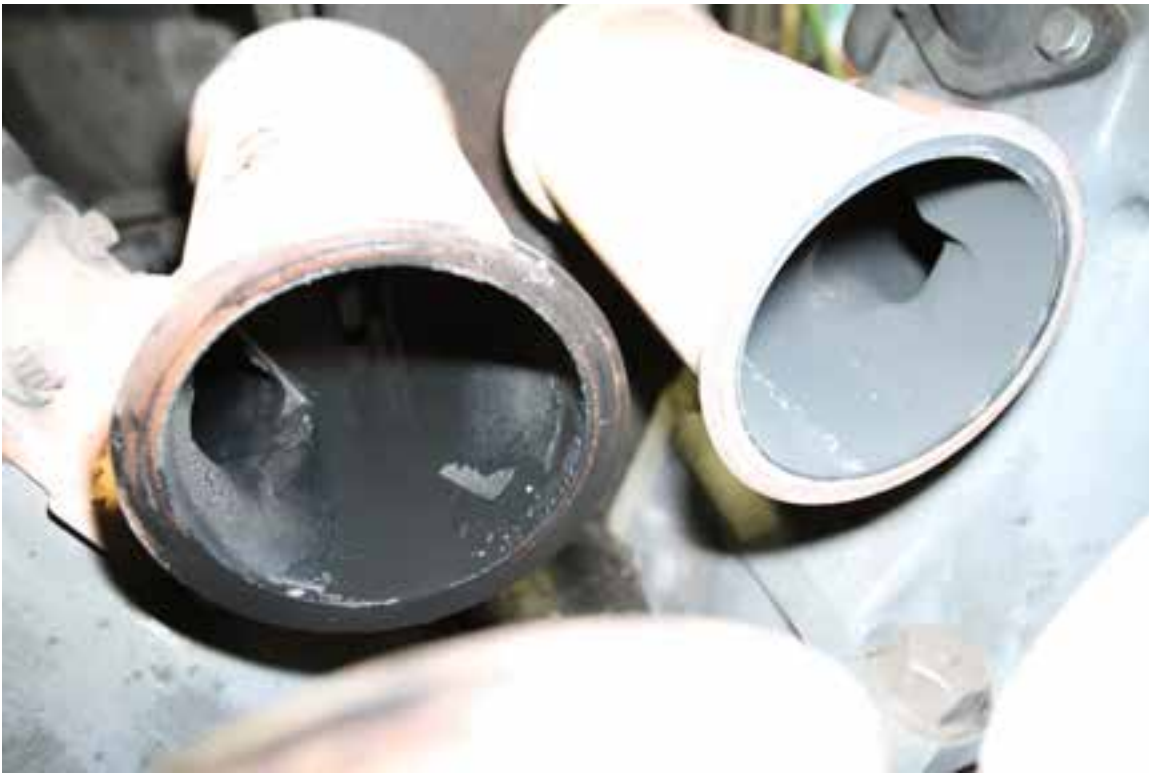
- 2.2.3 After removal of the engine bay doors, the joining tube sections of the intake and exhaust manifolds were labelled and removed. Examination of the intake manifold tube and body sections showed a gradual increase in the buildup of engine oil from the front to the rear cylinders, with a more pronounced deposit on right side cylinders (Figure 8) than on left side cylinders (Figure 9). The exhaust manifold tube and body sections showed an increase in oil buildup from the rear to the front cylinders, with a greater buildup on the right side cylinders (Figures 10 and 11). This is consistent with the direction of normal air flow through the engine. A separated valve head was observed in the transition section just upstream of the turbine (Figure 12).

- 3.4 A broken valve stem was trapped between the combustion chamber and the piston, and punctured the R5 piston crown. Normally, engine oil is pumped into the chamber beneath the piston crown for cooling. The puncture in the piston crown now permitted some of this oil to flow into the cylinder. The damaged intake and exhaust valves further allowed the oil to flow from cylinder R5 into both the intake and exhaust manifolds, and eventually, from the exhaust manifold into the body of the turbocharger. Evidence of this oil was observed in the intake and exhaust manifolds during the teardown (refer to Figures 8 through 11).

Figure 8: Right side intake manifold tube sections showing oil buildup

Figure 9: Left side intake manifold tube sections showing oil buildup

Figure 10: Exhaust manifold bodies for cylinders L1 and R1 showing oil buildup

Figure 11: Exhaust manifold bodies for cylinders R8 and L8 showing oil buildup

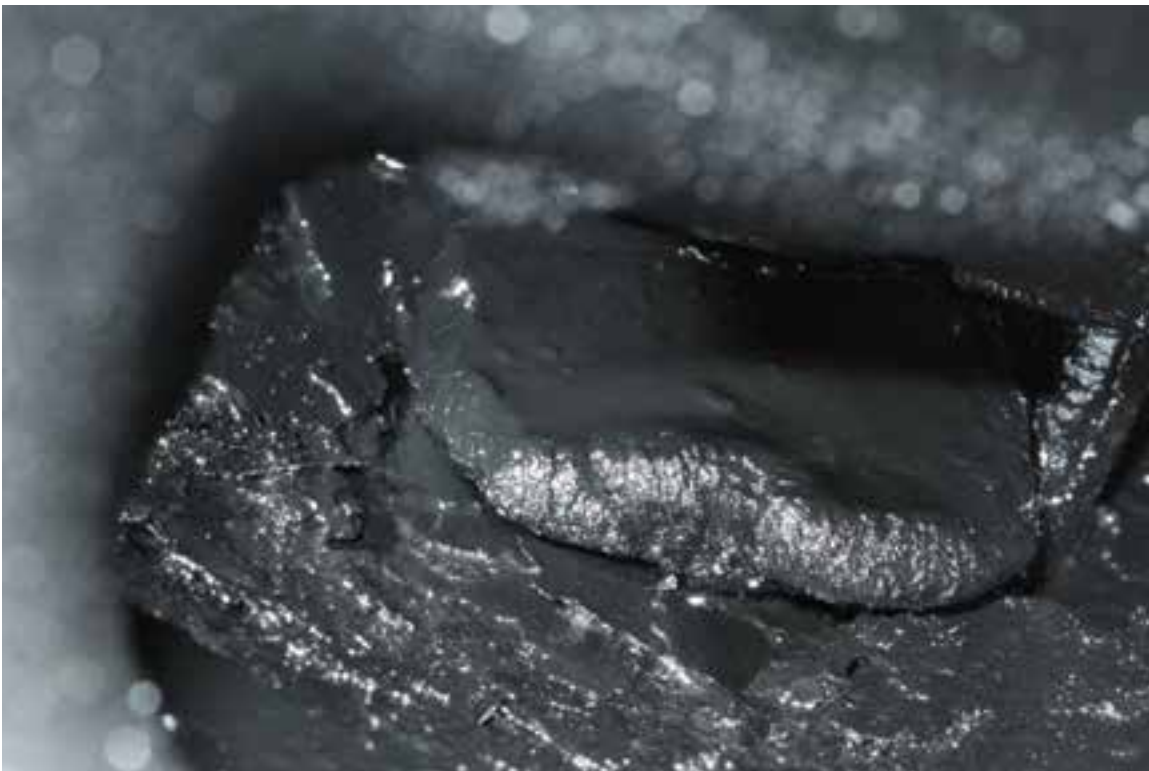
Figure 12: Valve head observed just upstream of the turbine

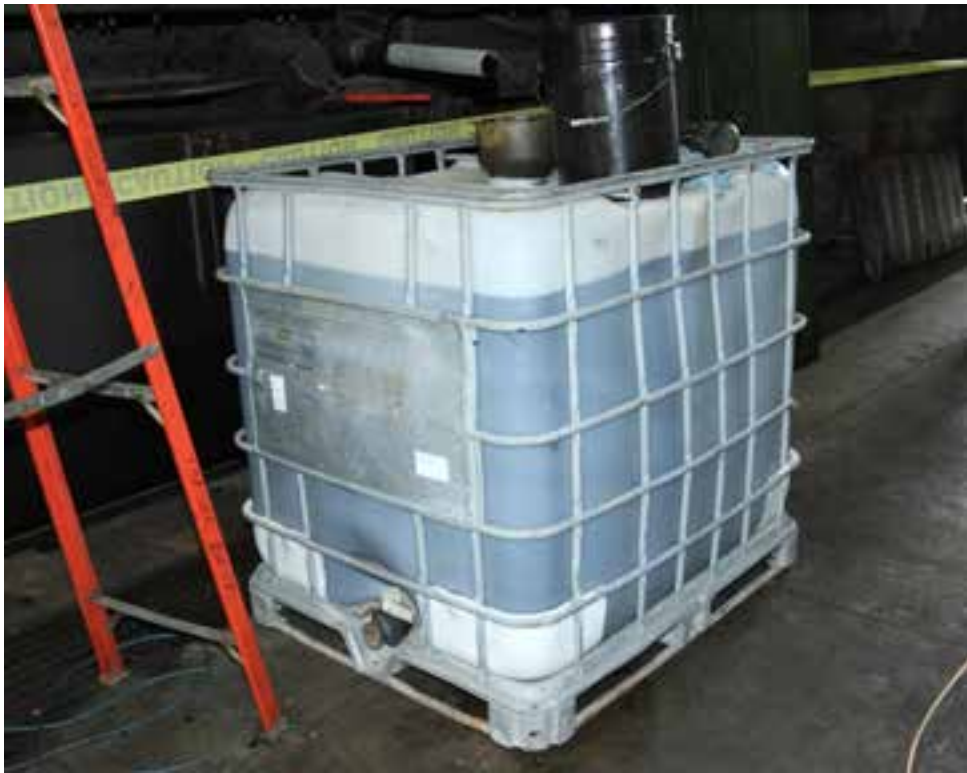
- 2.2.4 The engine oil was drained into a large plastic container to estimate the volume of oil remaining in the sump (Figure 13). Approximately 250 gallons of oil were recovered. The normal full sump volume was 380 gallons, indicating the level of engine oil was down approximately 130 gallons.

Figure 13: Engine oil drained from MMA 5017

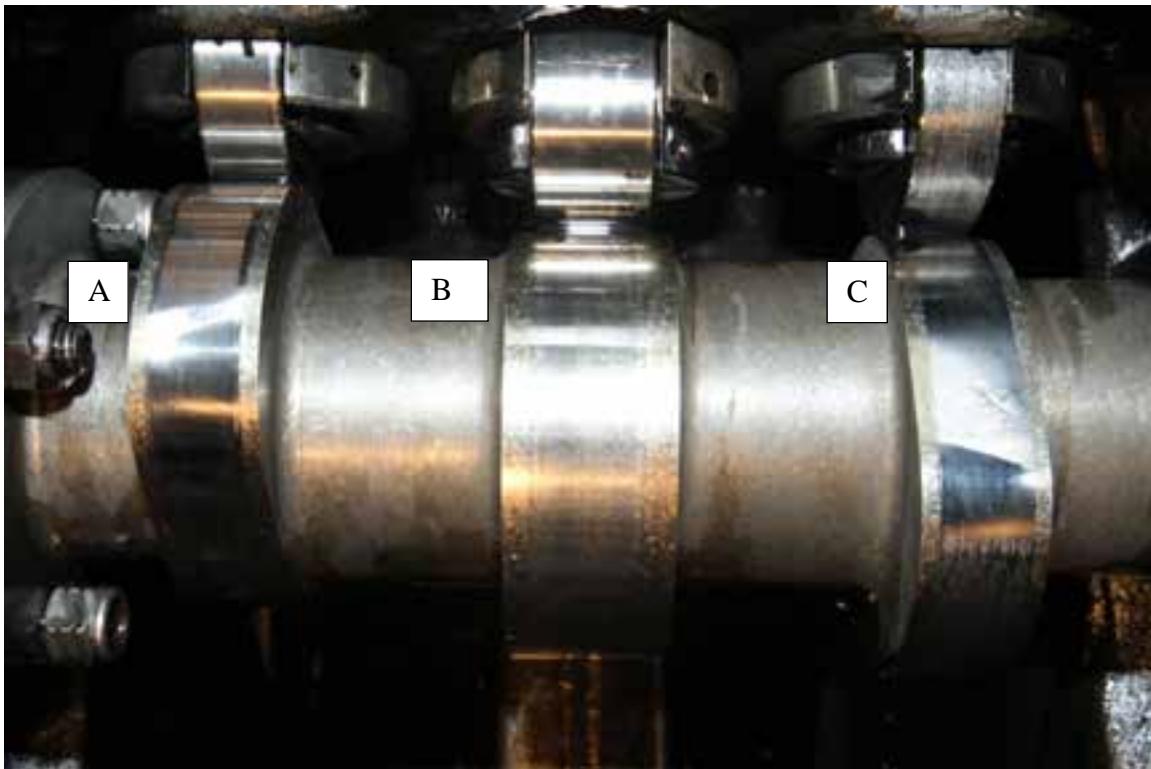
- 2.2.5 Examination of the camshaft section for PA R5 showed wear on the exhaust lobe and on the corresponding crosshead roller (Figure 14). The intake and fuel injector lobes and crosshead rollers had a normal appearance. Removal of the exhaust crossover pushrod from PA R5 showed that it was dry with fretting damage (Figures 15 and 16).

Figure 14: Condition of the intake, fuel injector and exhaust crossheads and cam lobes
The intake (A), fuel injector (B) and exhaust (C) lobes are indicated

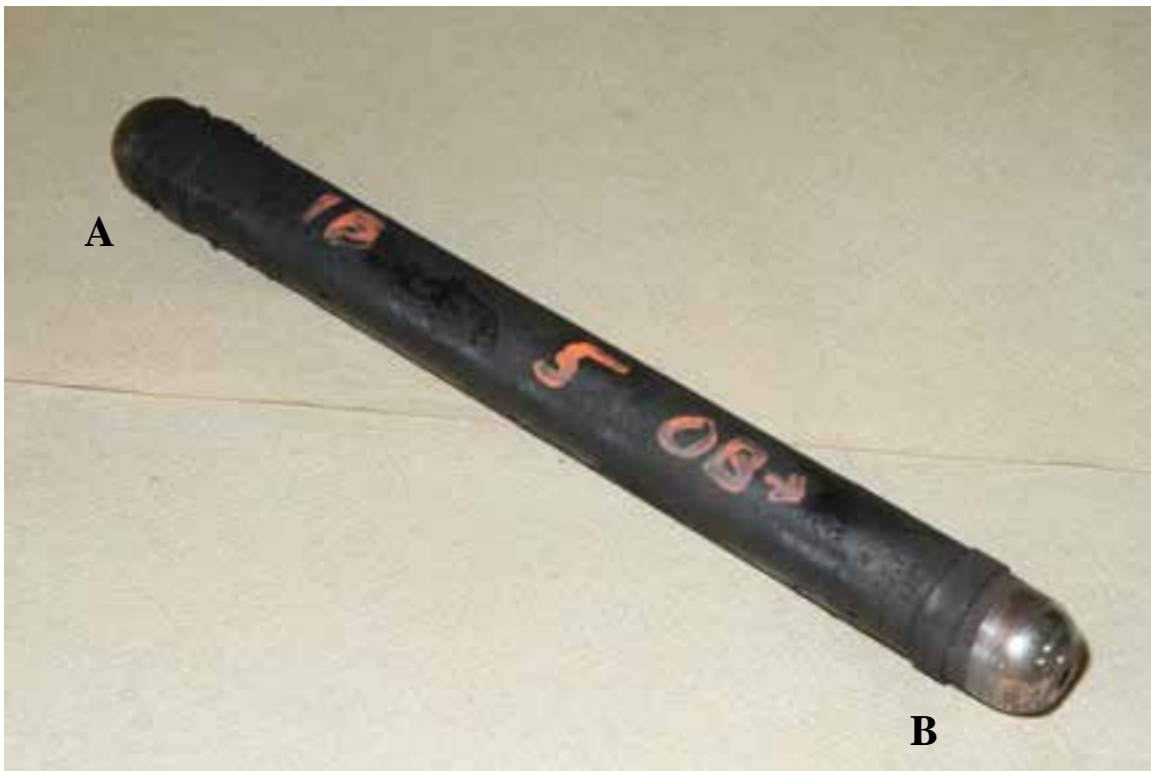
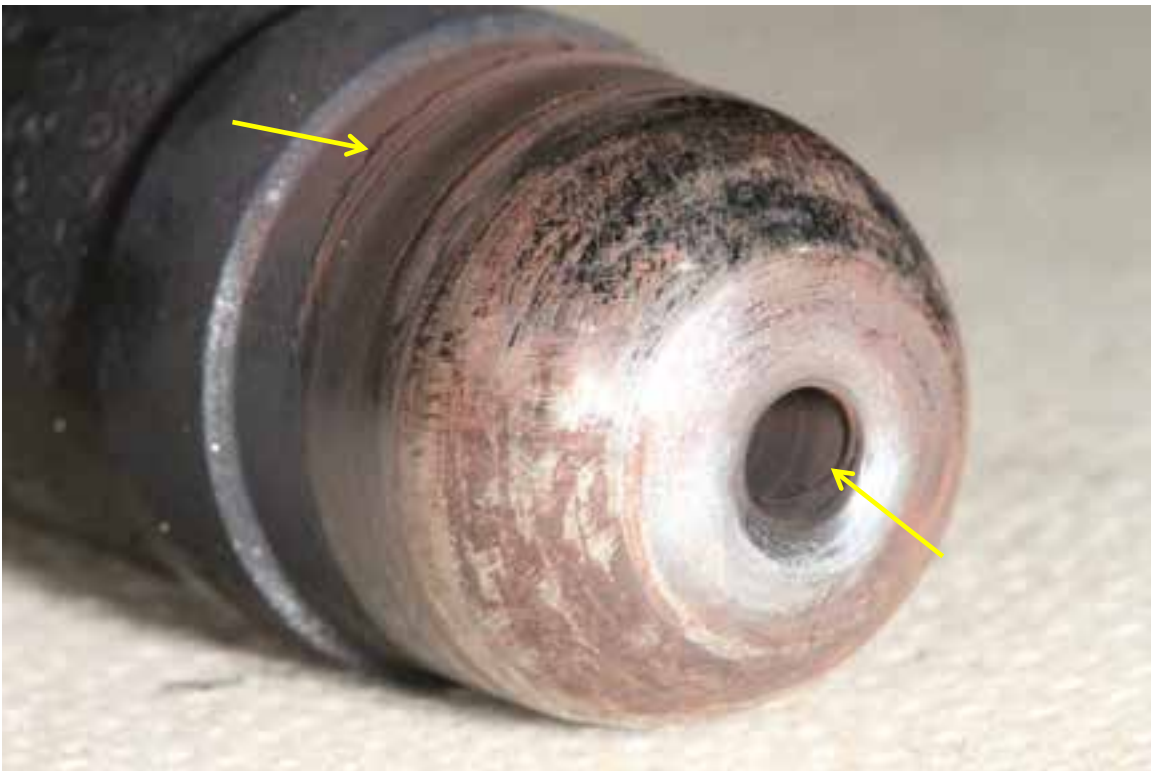
Figure 15: Exhaust crossover pushrod from PA 5
Inboard (A) and outboard (B) ends are labelled

Figure 16: Close-up of outboard end of the exhaust crossover pushrod from PA 5
Fretting damage is visible (arrowed)

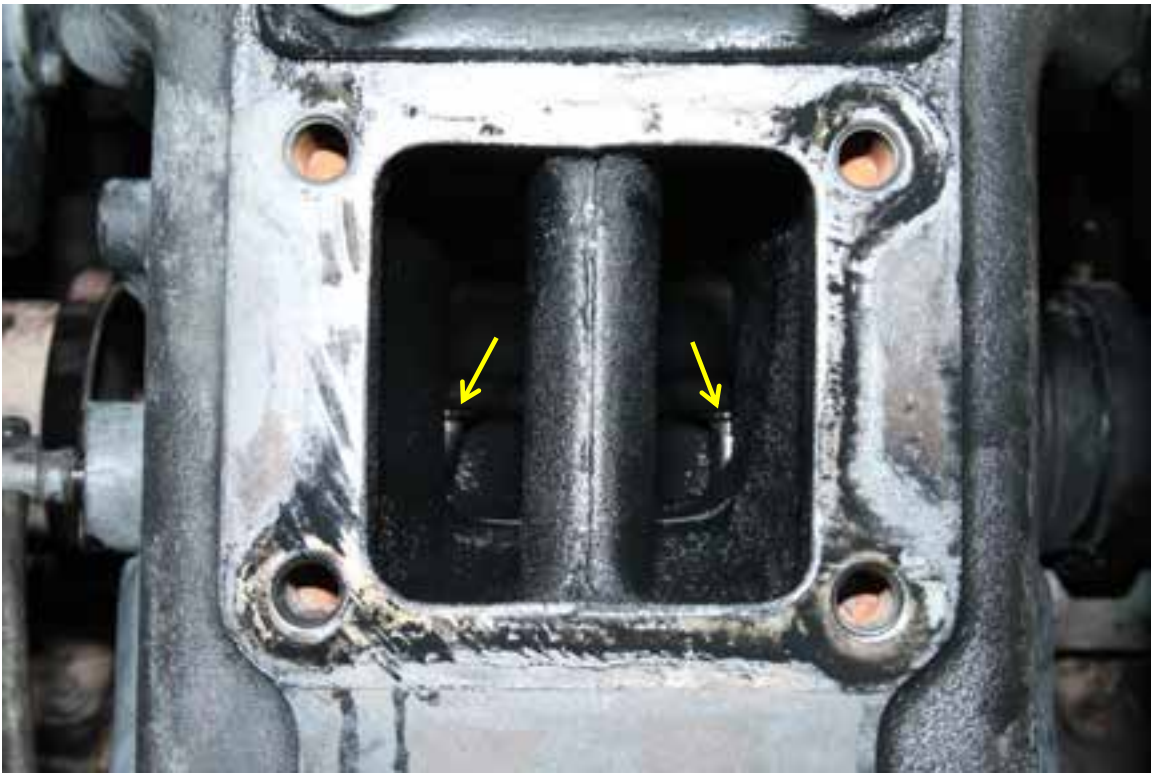
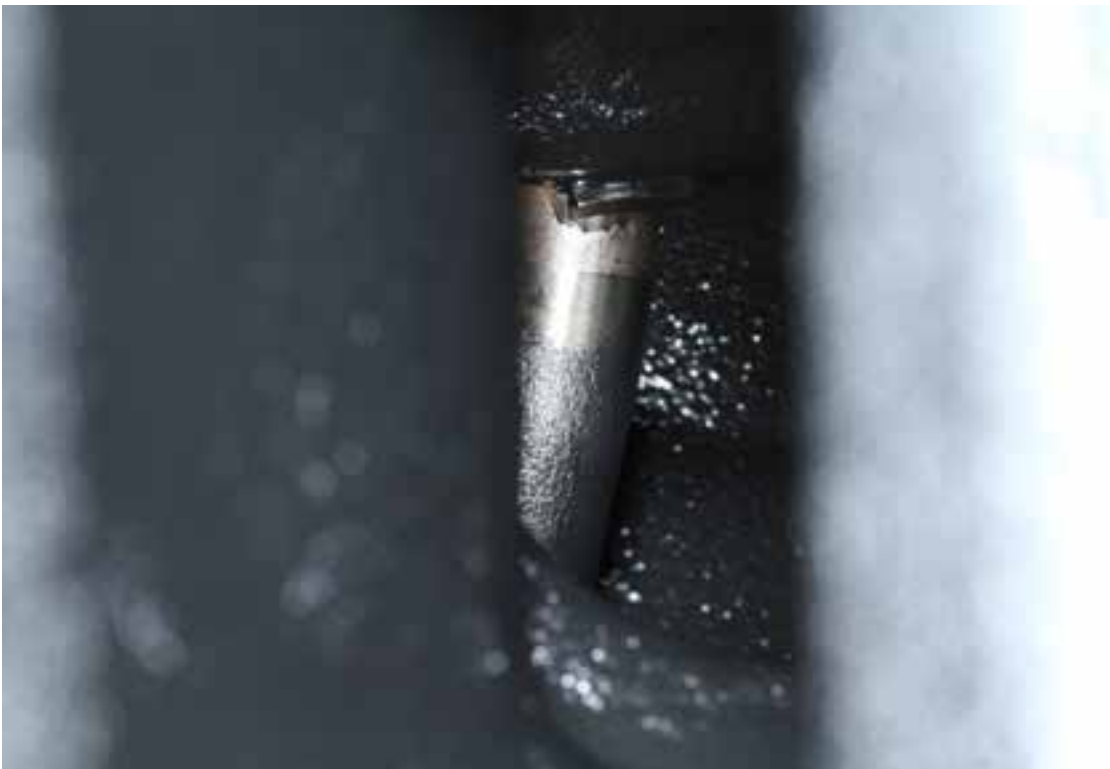
- 2.3.1 Removal of the intake manifold body from PA R5 showed that the intake valve stems were present but bent (Figures 17 and 18). Removal of PA R5 revealed extensive damage to the piston crown, consistent with repeated interaction with the valves (Figure 19). A valve stem sized hole had been punched through the center of the piston crown and the edges of the dished portion showed batter. The remainder of the piston was unremarkable. The intake pushrod had bent (Figure 20). The combustion chamber for PA R5 was damaged (Figure 21). Both exhaust valve heads were separated from their stems; one head was found jammed in the exhaust port (Figure 22). Both intake valves were impact damaged such that they no longer seated properly. Although the rockers moved easily, removal of the rocker shafts from the PA required the use of a hammer and brass drift, consistent with partial seizure. The shafts and bearings were dry on either end where they mated with the PA. The center portions of the shaft had a paste-like coating of oil residue (Figure 23).

Figure 17: Intake port for PA R5 showing bent valve stems (arrowed)

Figure 18: Close-up of PA R5 showing bent intake valve stem

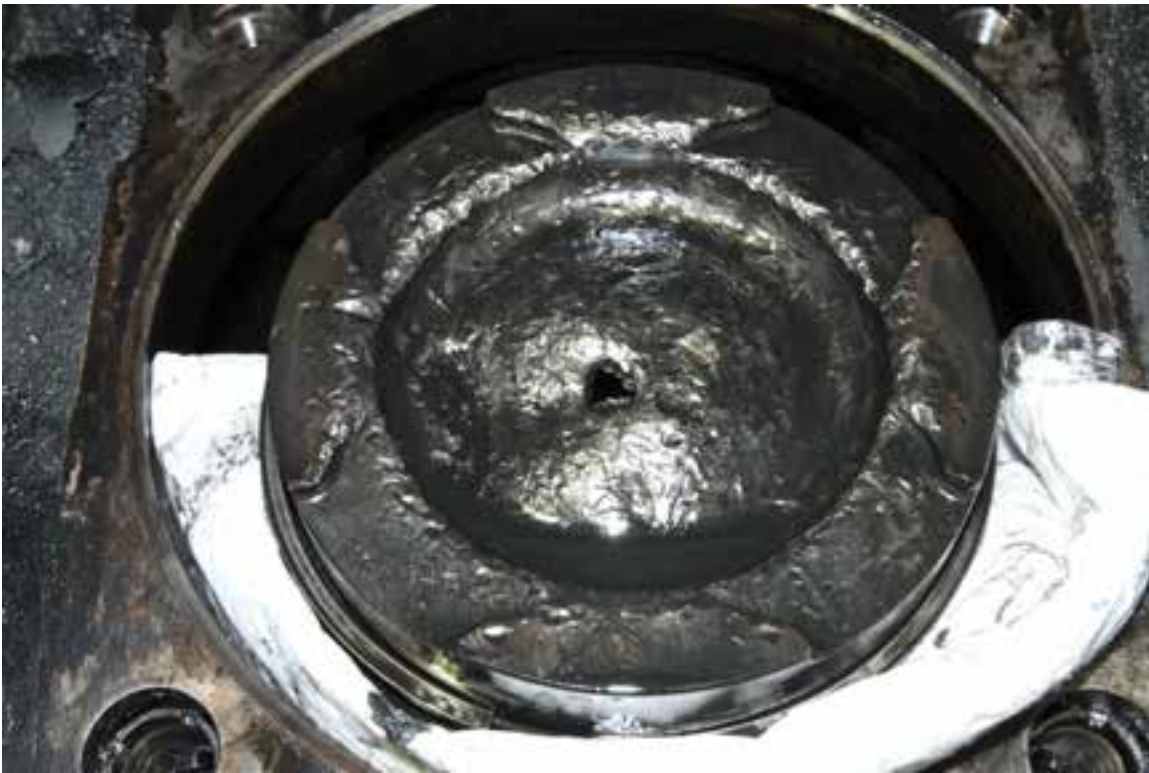
Figure 19: Piston crown of PA R5
Note the valve stem sized hole and oil puddle

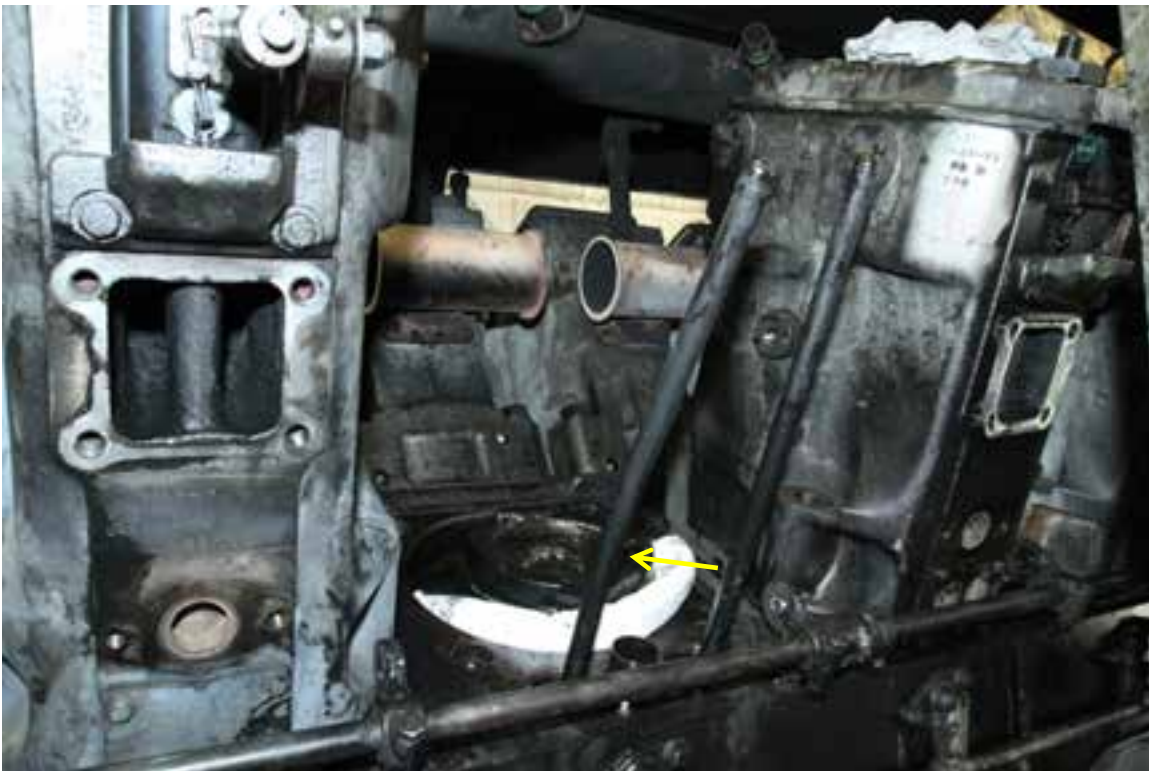
Figure 20: Bent PA R5 intake pushrod
(arrowed)

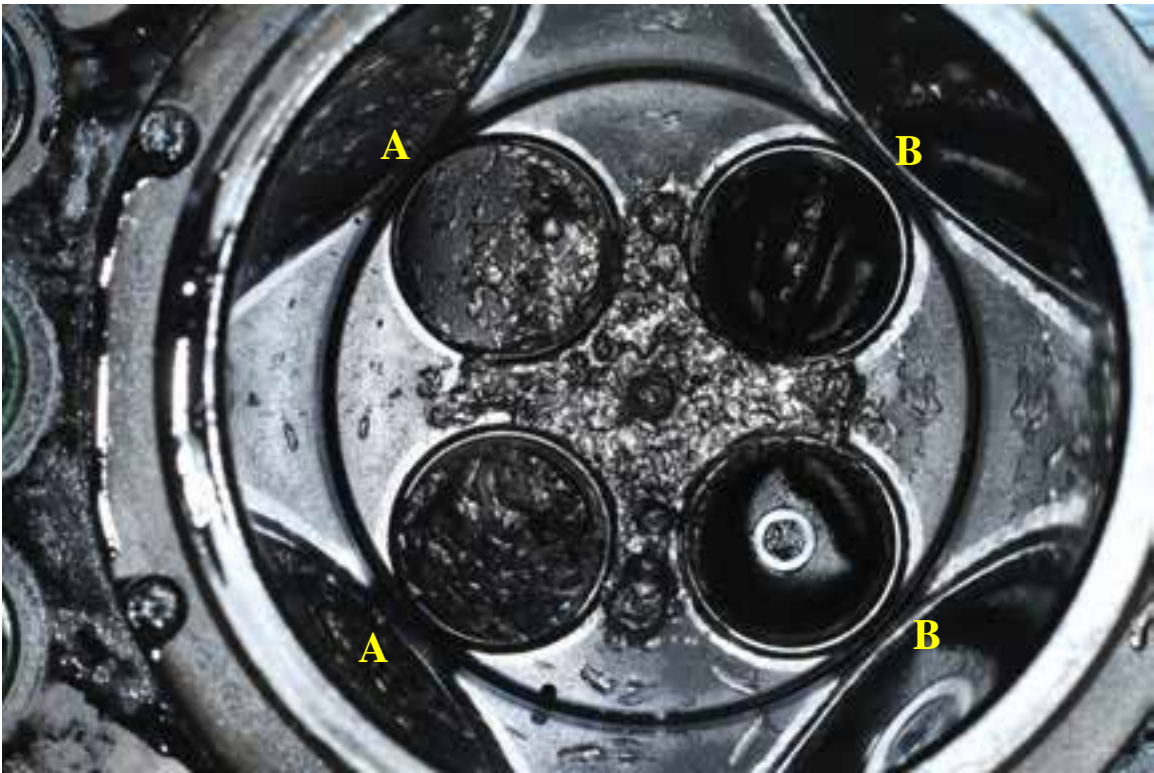
Figure 21: Damage to the combustion chamber of PA R5
The intake (A) and exhaust (B) valves are indicated

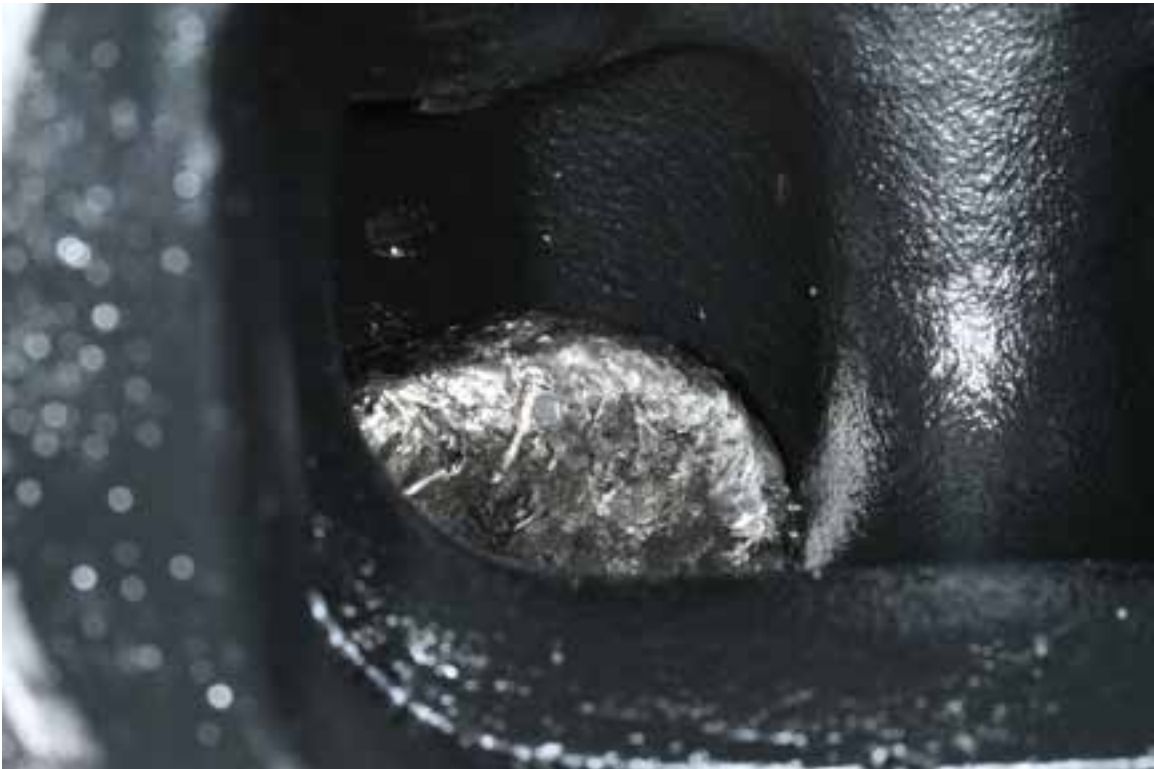
Figure 22: Exhaust valve head jammed in exhaust port

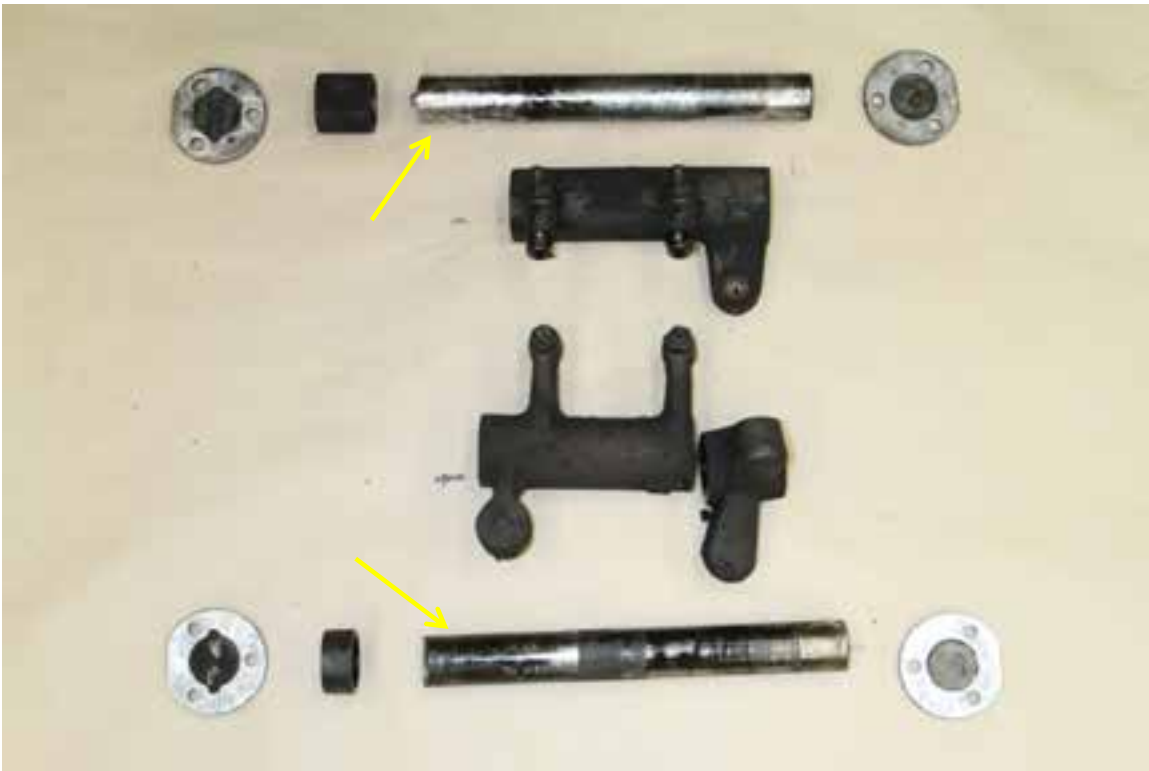
Figure 23: Rockers and shafts from PA R5
Note pasty oil residue on shafts (arrowed)

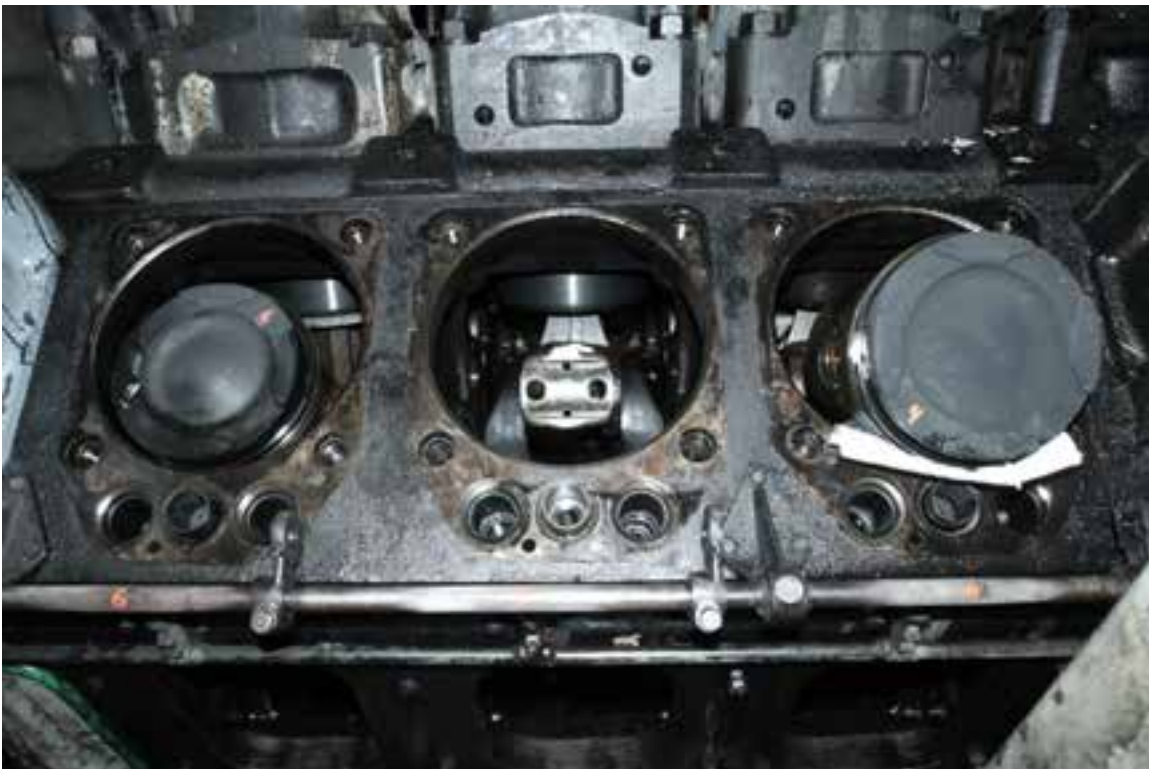
- 2.3.2 PA R4 and PA R6 were removed for examination. These assemblies were unremarkable apart from some differences in colour. The piston crown of R6 was oily and darker than the colour associated with normal operation. The piston crown of R4 was dry but still a little darker than normal (Figure 24). Removal of the rockers and rocker shafts showed that they were well lubricated and slid apart with ease (Figure 25).

Figure 24: Pistons R6 (left) and R4 (right) showing crown colour and condition
