OPERATIONAL SERVICES BRANCH
ENGINEERING LABORATORY REPORT

LP181/2013

Locomotive Engine Fire Examination

Montreal, Maine & Atlantic Railway, Train MMA-002

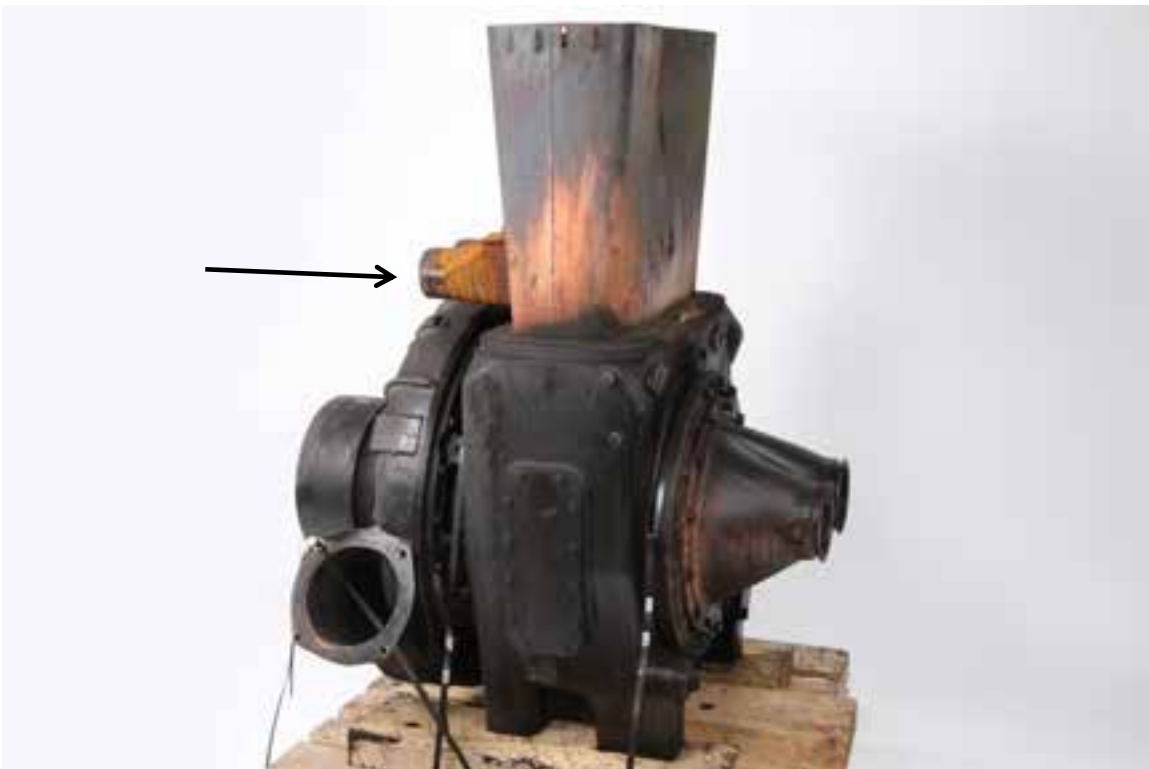
- 2.3.3 Re-assembly of the exhaust stack and turbocharger out of the locomotive showed the location of the fire with respect to the aspirator venturis in the exhaust stack (Figure 26). The paint and deposits on the body of the turbocharger had not been damaged by the fire whereas the area around the venturis and the lower portion of the exhaust stack were extensively fire damaged as shown by their rusty colour. Removal of the transition section from the turbocharger showed a buildup of oily deposits on the exhaust side (Figure 27). A fragment of valve stem was observed just upstream of the turbine (Figure 28).

Figure 26: Exhaust stack and turbocharger re-assembled
Note location of discoloration in relation to venturitis (arrowed)

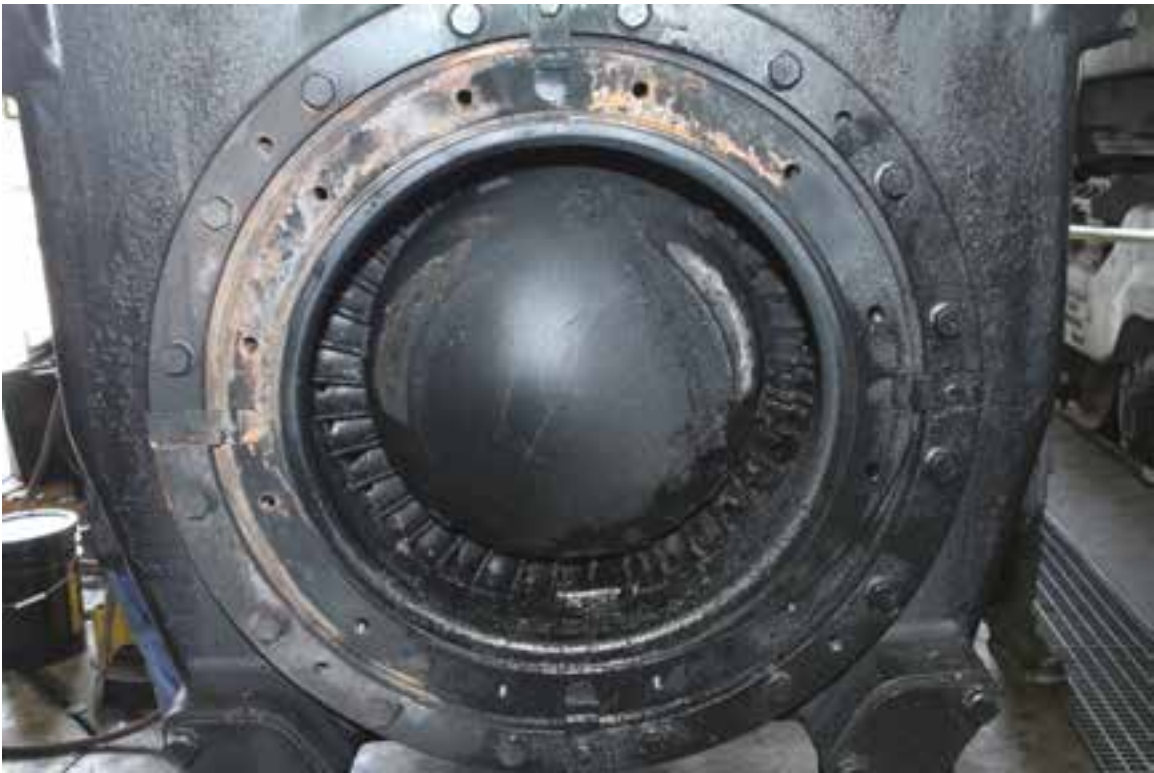
Figure 27: Turbocharger being removed from MMA 5017
Note buildup of coked oil

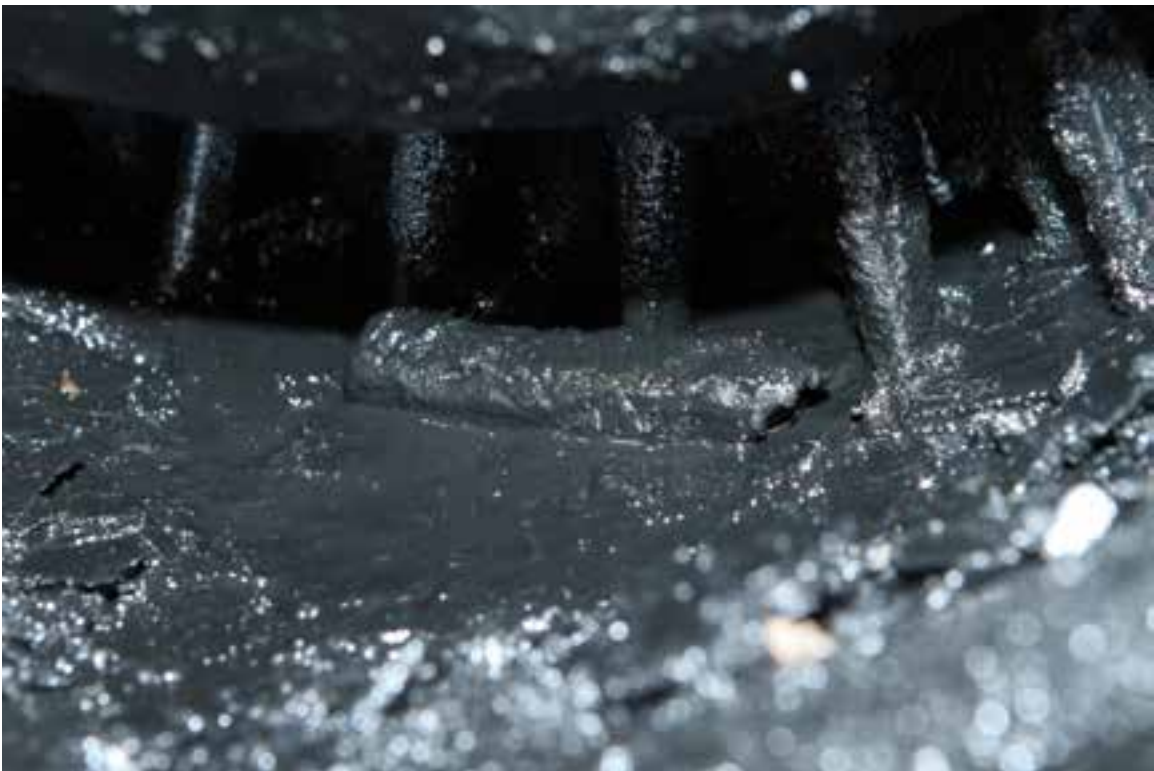
Figure 28: Portion of valve stem found just upstream of the turbine

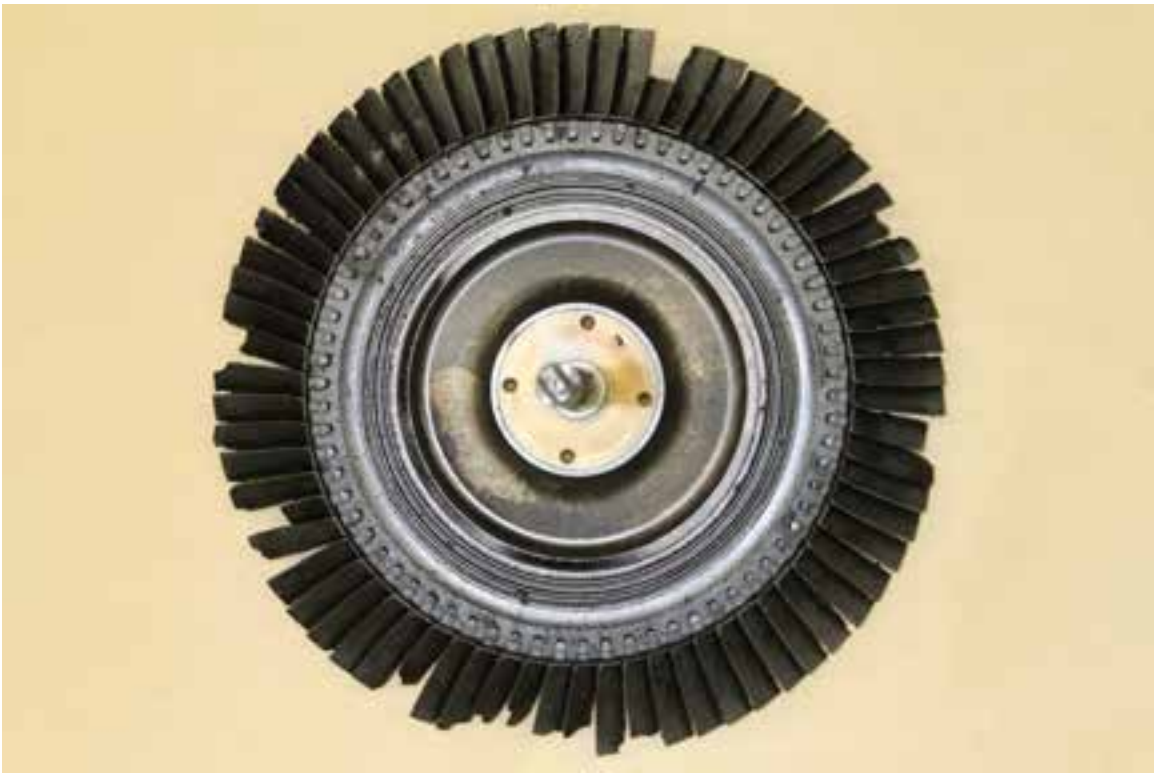
- 2.3.4 Disassembly of the turbocharger showed that approximately 12 of the 70 turbine blades had fractured (Figure 29). The turbine and compressor journal bearings and shaft showed wear damage, primarily on the compressor side (Figures 30 through 34). The wear areas on both the turbine and compressor bearings occurred in three locations radially around the bore of the bearings, between the three equally spaced oil delivery ports. A large quantity of dense oil sludge was found in the body of the turbocharger indicating that oil had been collecting in the turbocharger for some time. However, the oil seals for both the compressor and turbine bearings were in good condition and there was no sign of abnormal leakage (Figure 35).

Figure 29: Damaged turbine blades

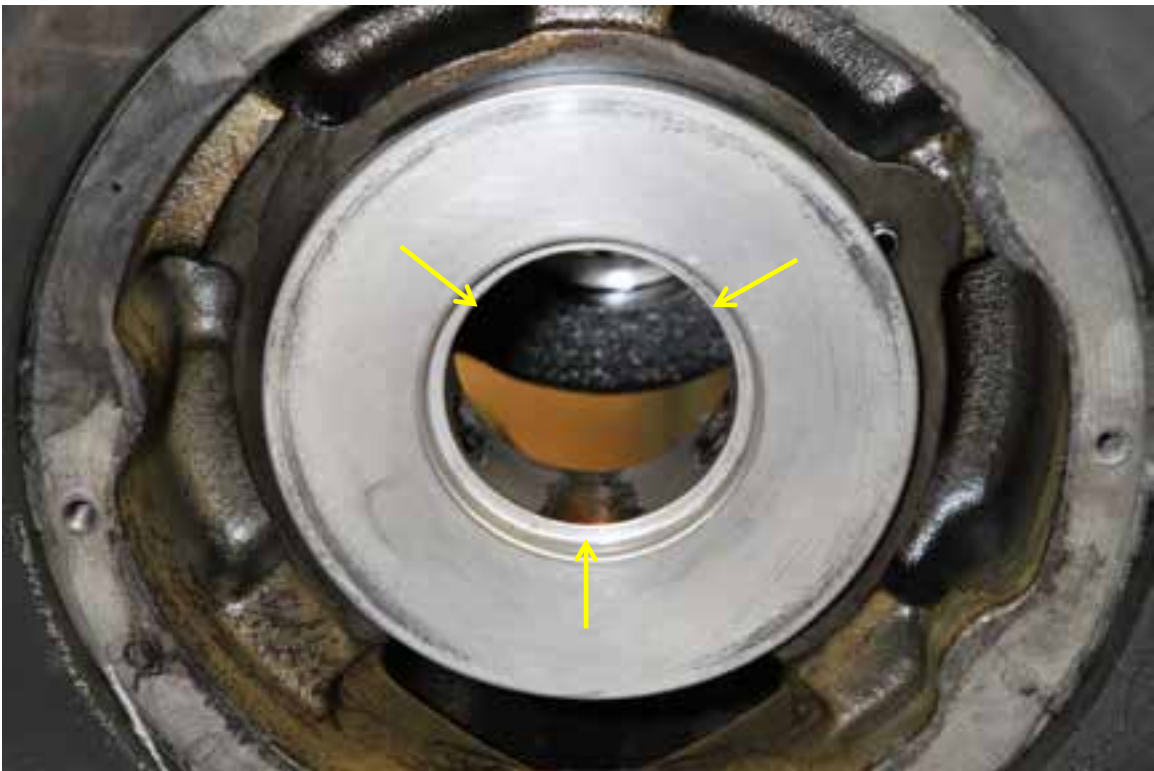
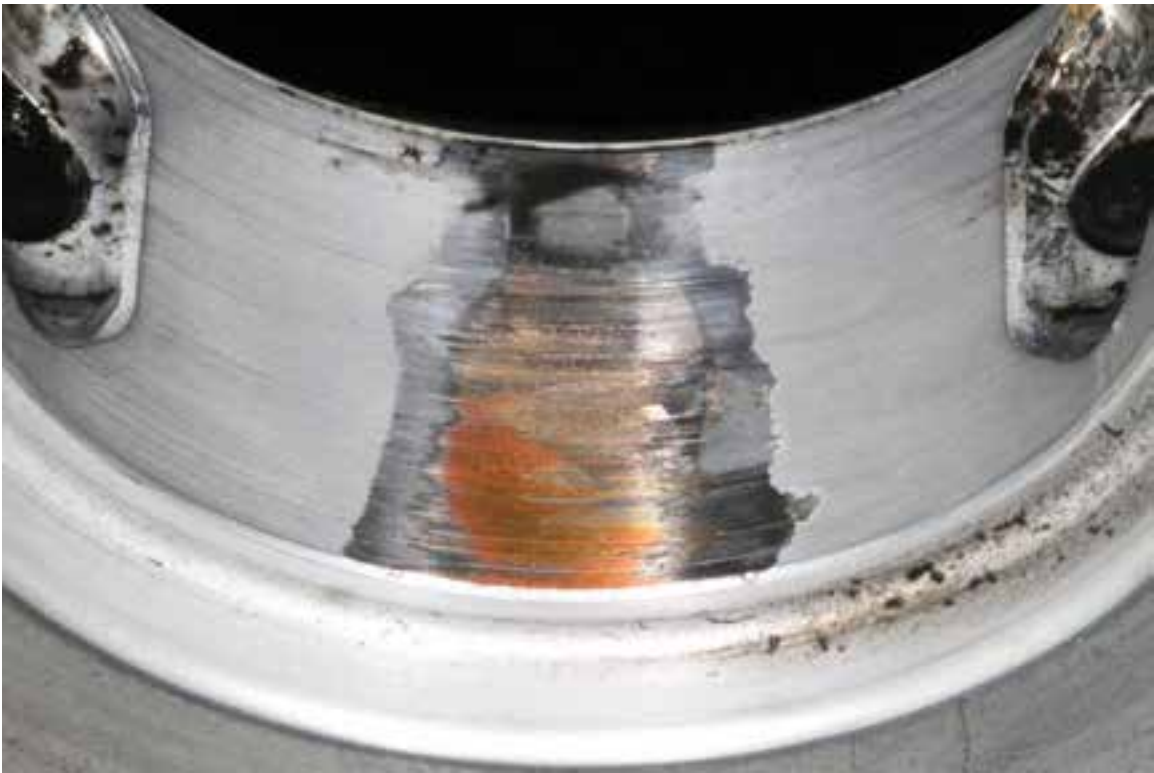
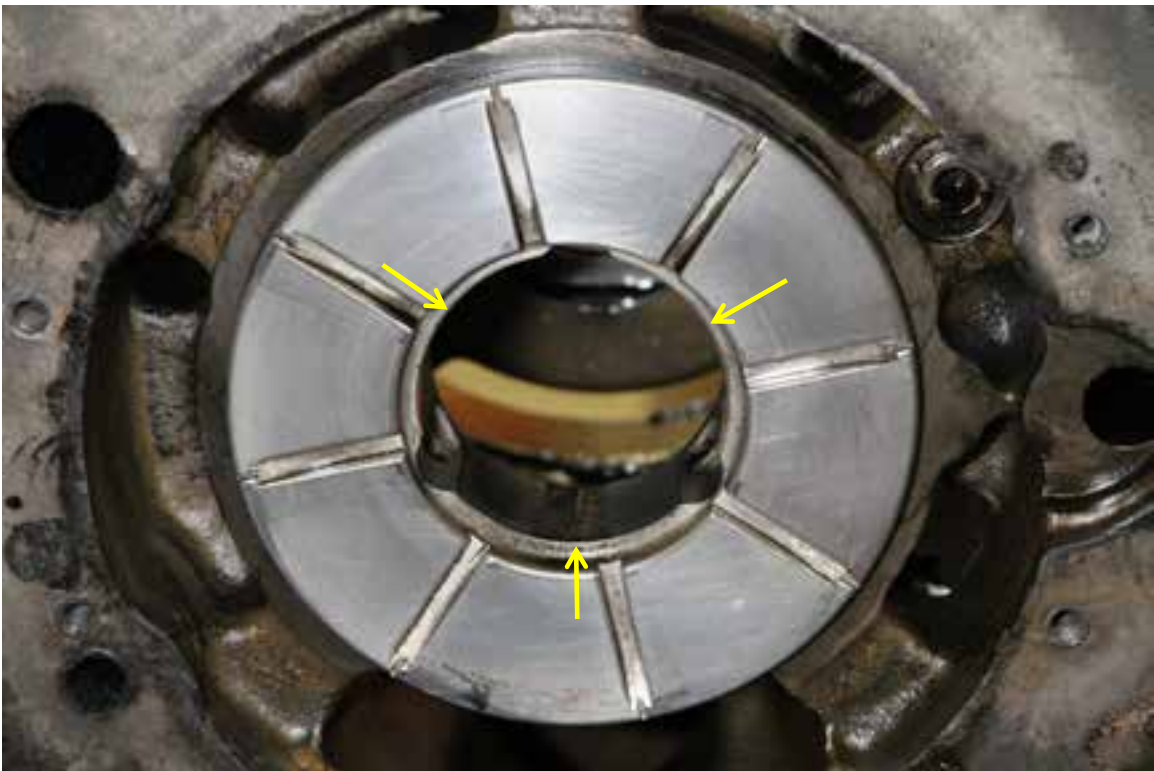
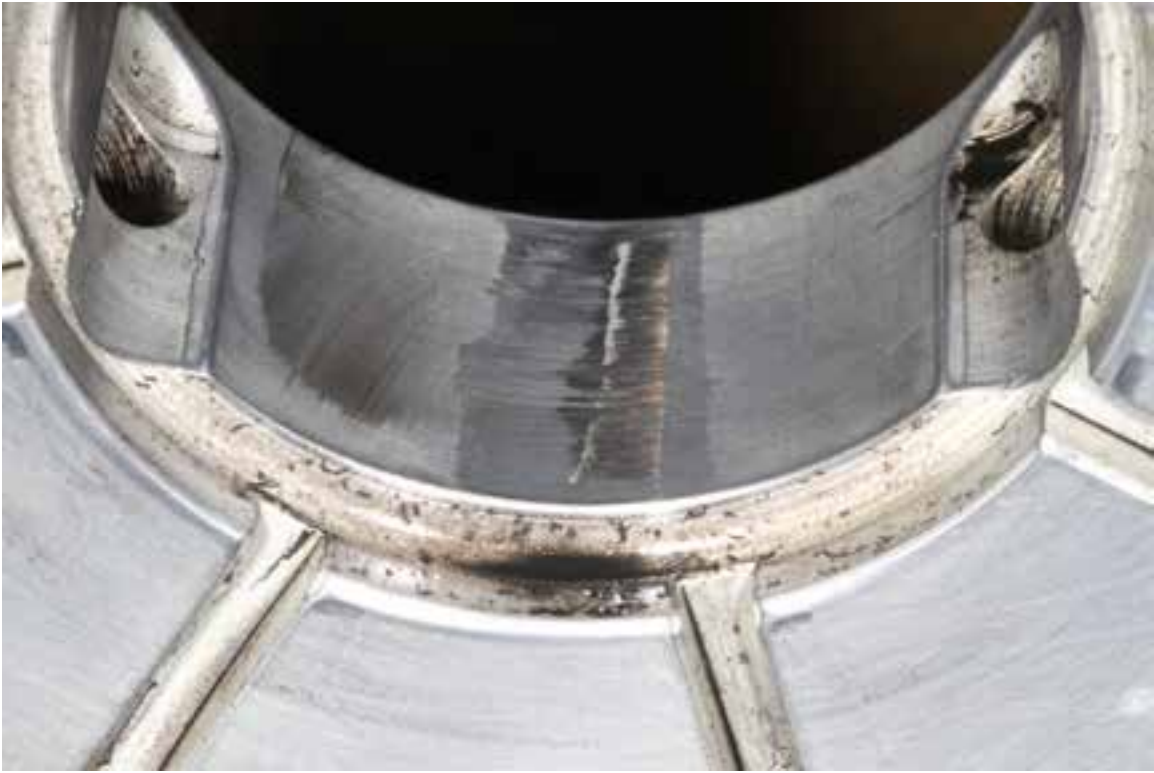
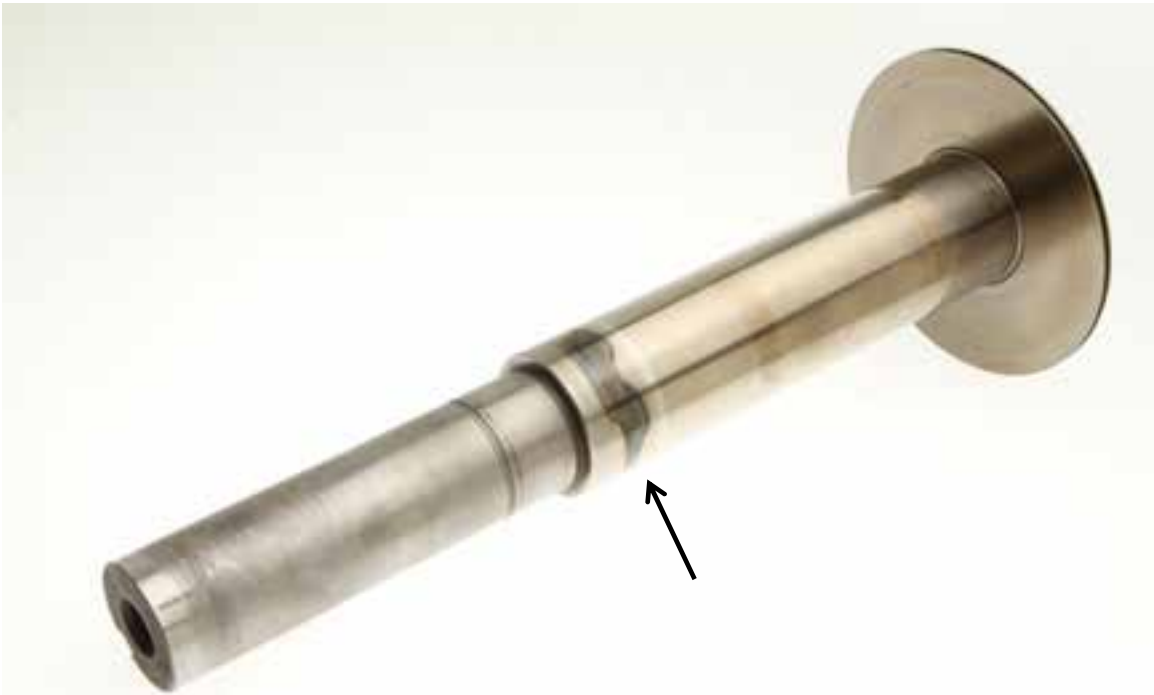
Figure 30: Compressor bearing showing damaged areas (arrowed)

Figure 31: Close-up of compressor bearing damage

Figure 32: Turbine bearing showing damaged areas (arrowed)

Figure 33: Close-up of turbine bearing damage

Figure 34: Turbocharger shaft showing heat damage at compressor bearing journal (arrowed)

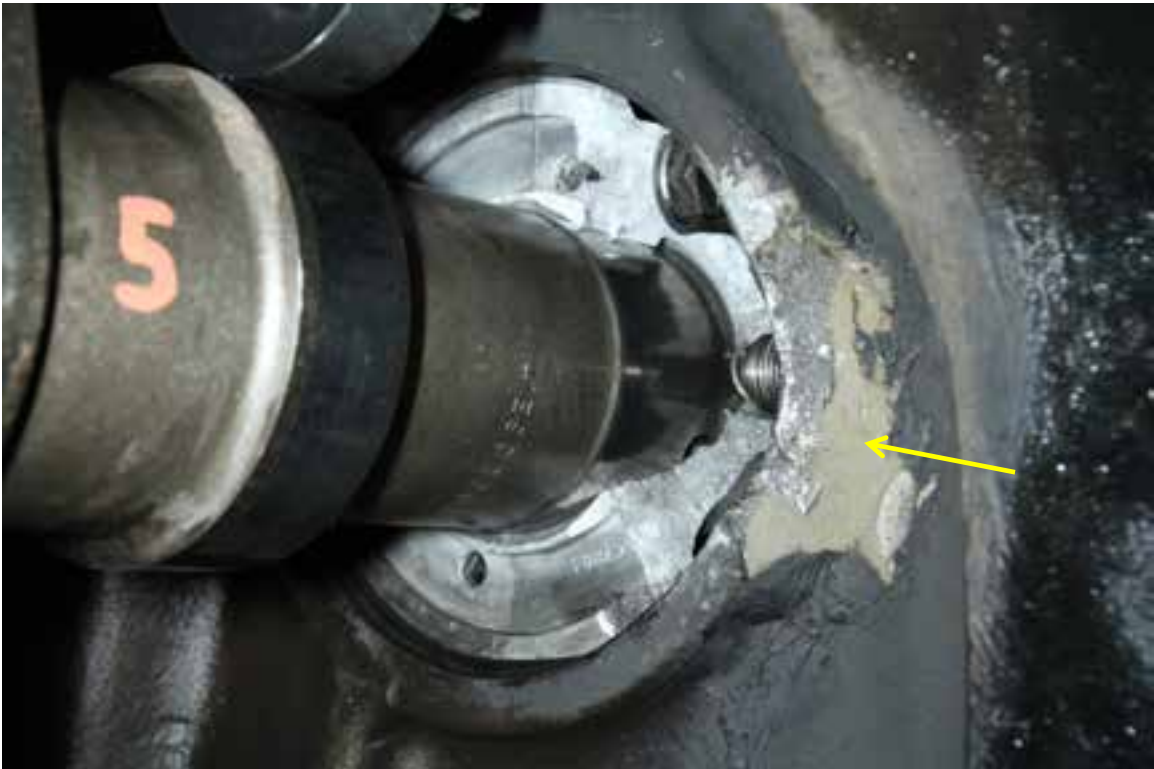
- 2.3.5 Cleaning of the area around the failed R4/R5 cam bearing revealed that the cam bearing bore had been previously repaired with a polymeric material (likely some type of epoxy) (Figure 36). A portion of the engine frame adjacent to the cam bearing bore had been broken away and replaced with this polymeric material. The repaired area had failed and some of the polymeric material was missing.

- adjacent polymeric material repair broke off. The repair material failure was adhesive in nature close to the bearing bore indicating the bond between the block and the repair material failed (refer to Figure 36). Further outboard of the cam bearing the repair material failed in a cohesive manner, indicating it was unable to withstand the applied stress. This could have been a result of the oil pressure at start up following the repair or later when the mounting bolt was over-tightened.

Figure 36: R4/R5 cam bearing bore showing previous repair (arrowed)

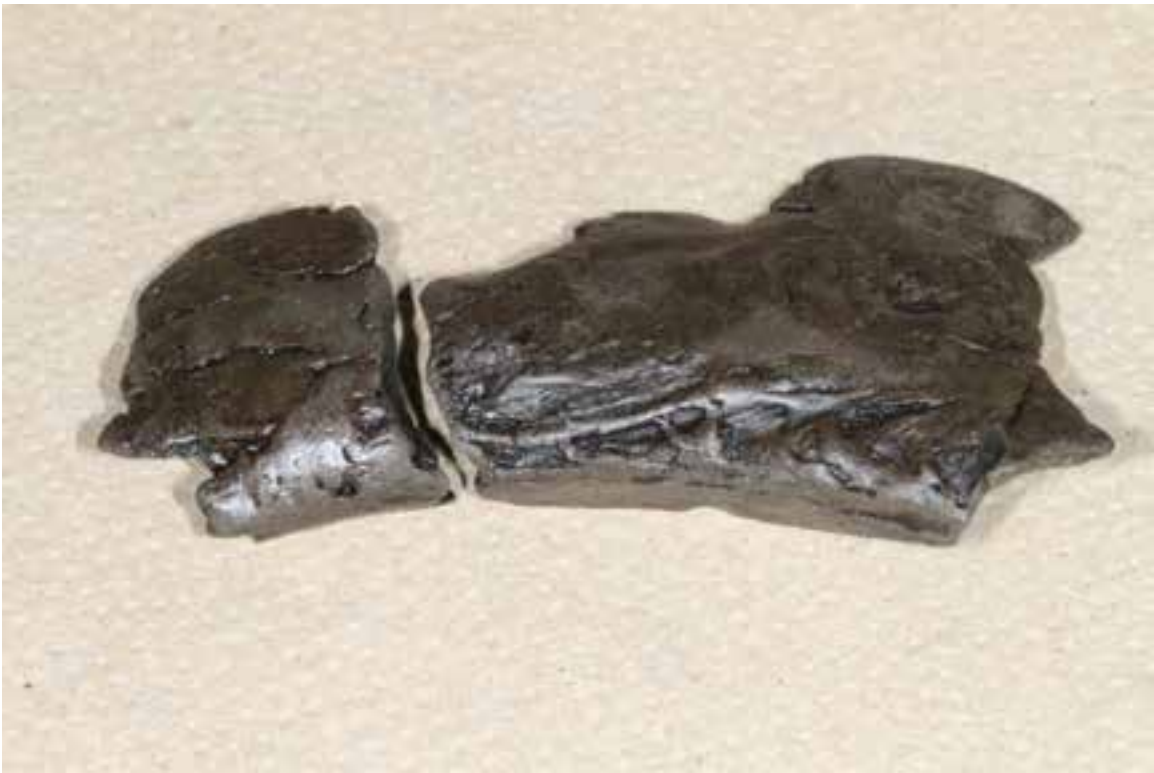
- 2.3.6 A sweep of the engine sump produced the missing pieces of repair material and the fractured portion of cam bearing (Figure 37). In addition, debris originating from several other engine components was recovered in the sump, consistent with an engine failure event pre-dating this occurrence (Figure 38).
- 2.3.7 The failed cam bearing was removed and an intact bearing was installed in the R4/R5 position to show the extent of unsupported bearing area and the deformation of the cam bearing bore (Figure 39). Figure 40 shows the recovered fragments of polymeric material fitted to the damaged area also indicating the extent of the repair.

Figure 37: Recovered section of cam bearing bore repair material

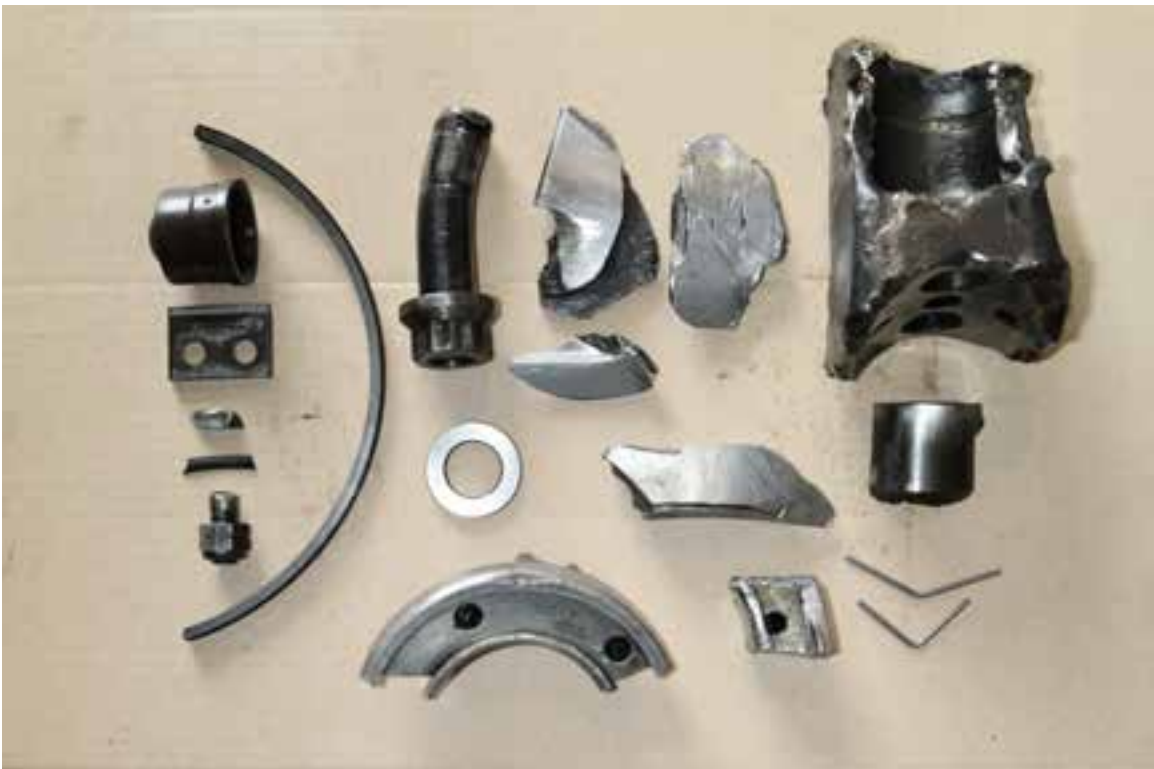
Figure 38: Debris recovered from MMA 5017 engine oil sump

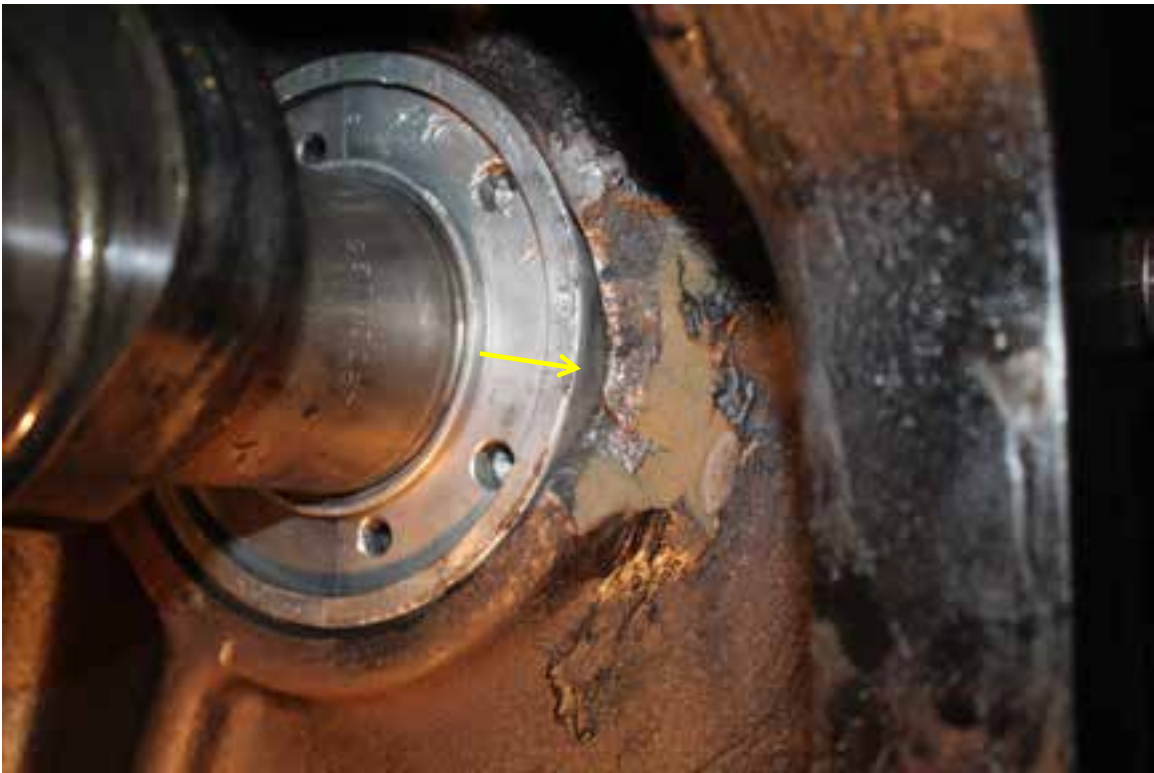
Figure 39: Substitute bearing in R4/R5 position showing unsupported bearing area (arrowed)

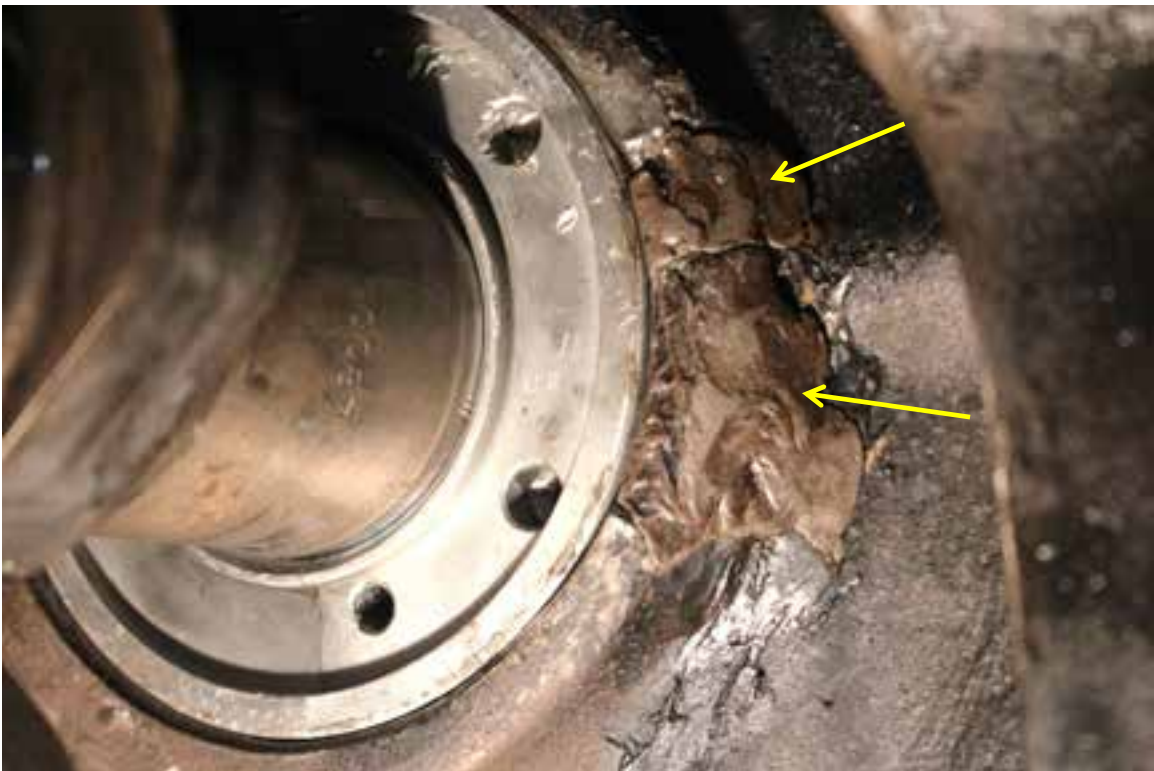
Figure 40: Recovered polymeric material pieces refitted showing extent of repair (arrowed)

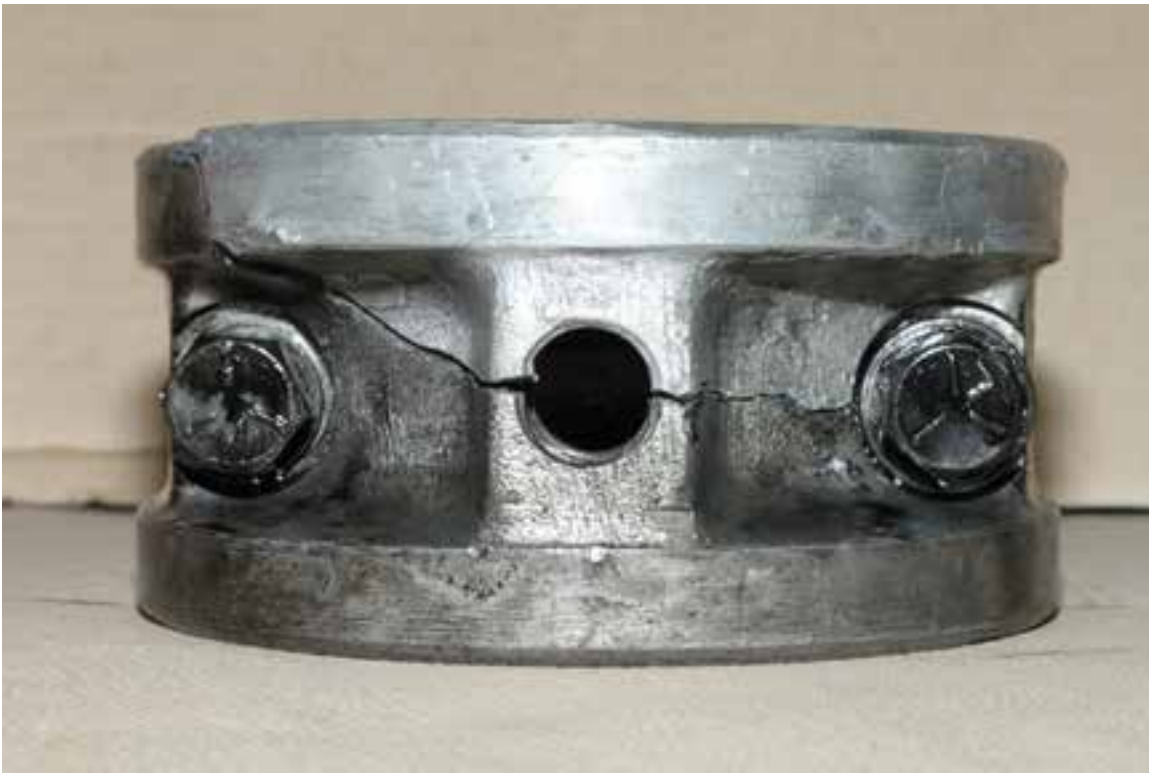
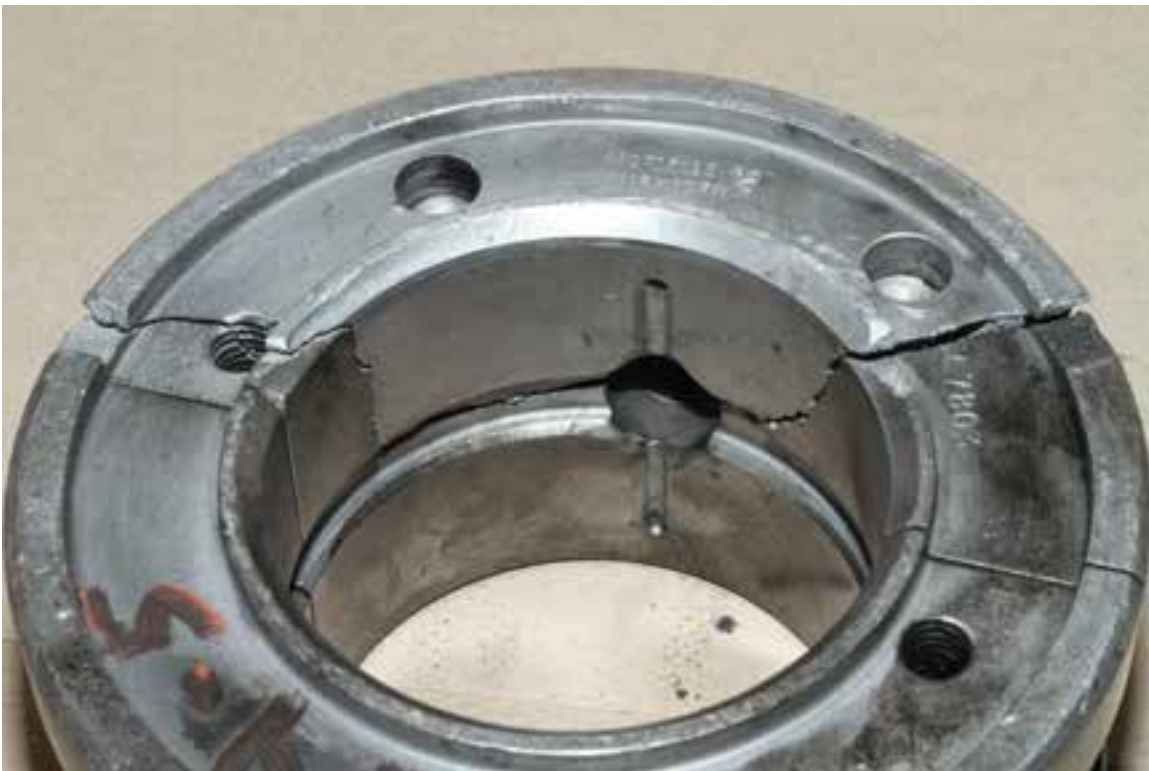
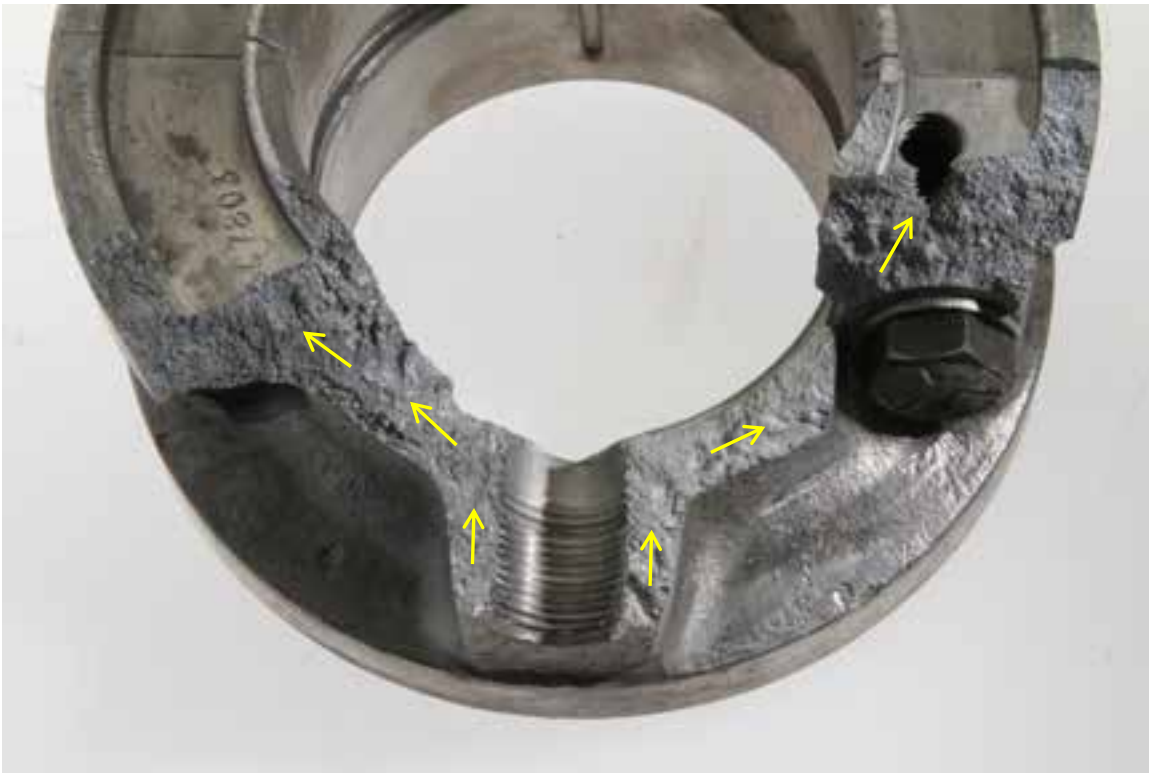
- 2.4.1 The failed cam bearing had fractured at the mounting bolt hole (Figures 41 and 42). The fracture surface had a rough appearance with ridges pointing back to the outboard end of the bolt hole. This indicates that this was an overstress fracture that had initiated at the mounting bolt hole (Figure 43). No sign of progressive fracture was observed. The R4/R5 cam bearing is manufactured of aluminum alloy with a helical thread steel insert to accept the mounting bolt. Localized thread damage in both the separated portion and the remaining portion of the bearing (Figures 44 through 47) indicate that the fracture originated at the top and bottom of the mounting hole when the material surrounding the steel thread insert was overloaded axially in the outboard direction. The final portion of the thread insert itself was also deformed in the axial direction (Figure 48). The outboard edge of the separated section of bearing had contacted the camshaft resulting in a localized smear (Figure 49). These observations suggest that the bolt was over-tightened, overloading the cam bearing material around the threaded insert and causing its overstress fracture at the bolt hole.

Figure 41: External view of subject cam bearing showing location of fracture

Figure 42: Internal view of subject cam bearing showing location of fracture

Figure 43: Cam bearing showing direction of fracture (arrowed)

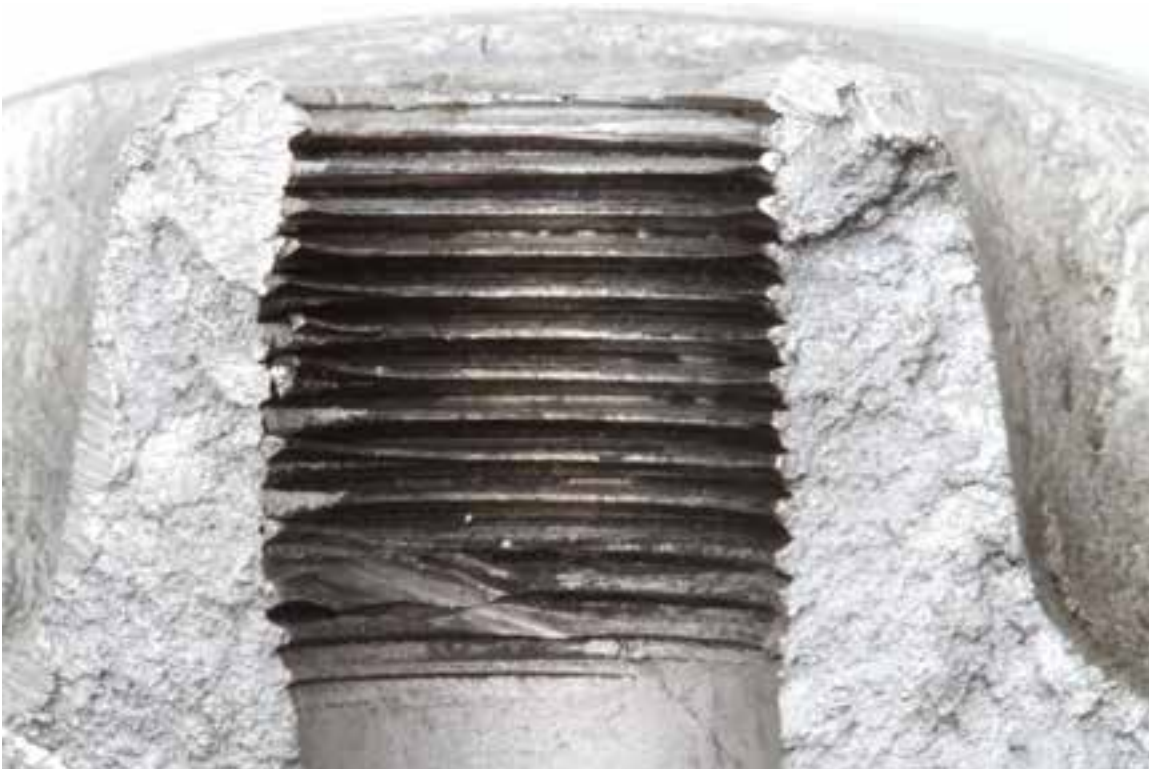
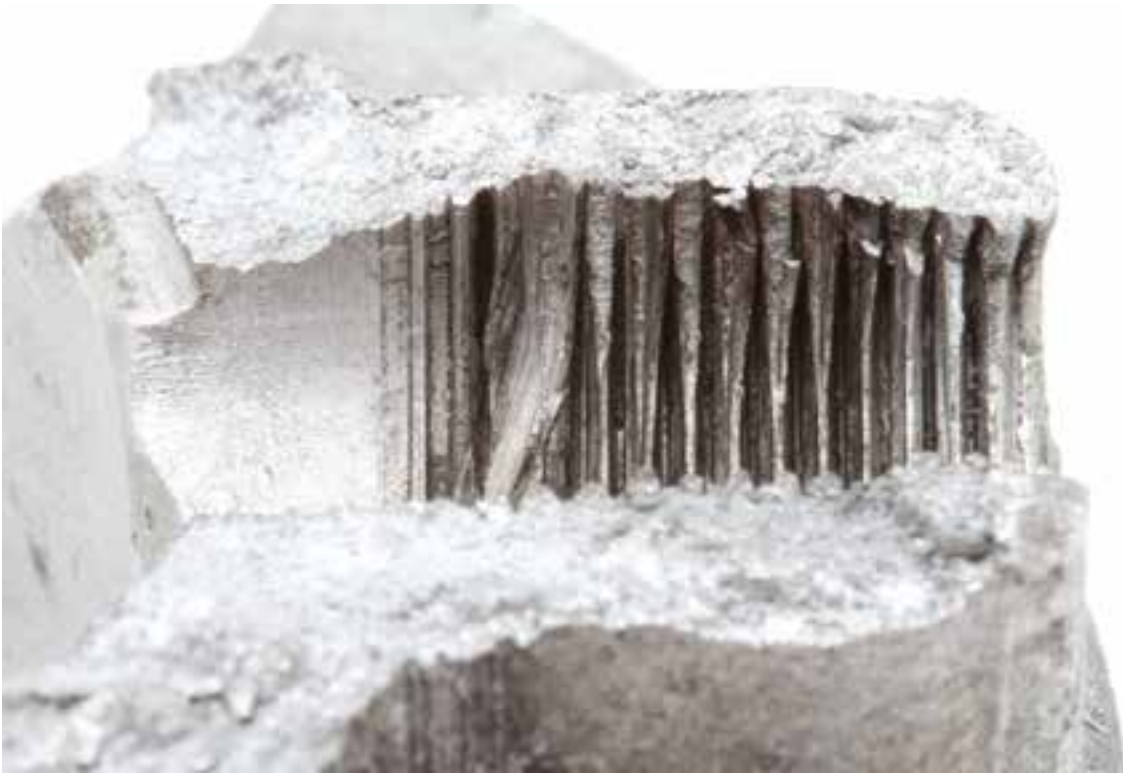
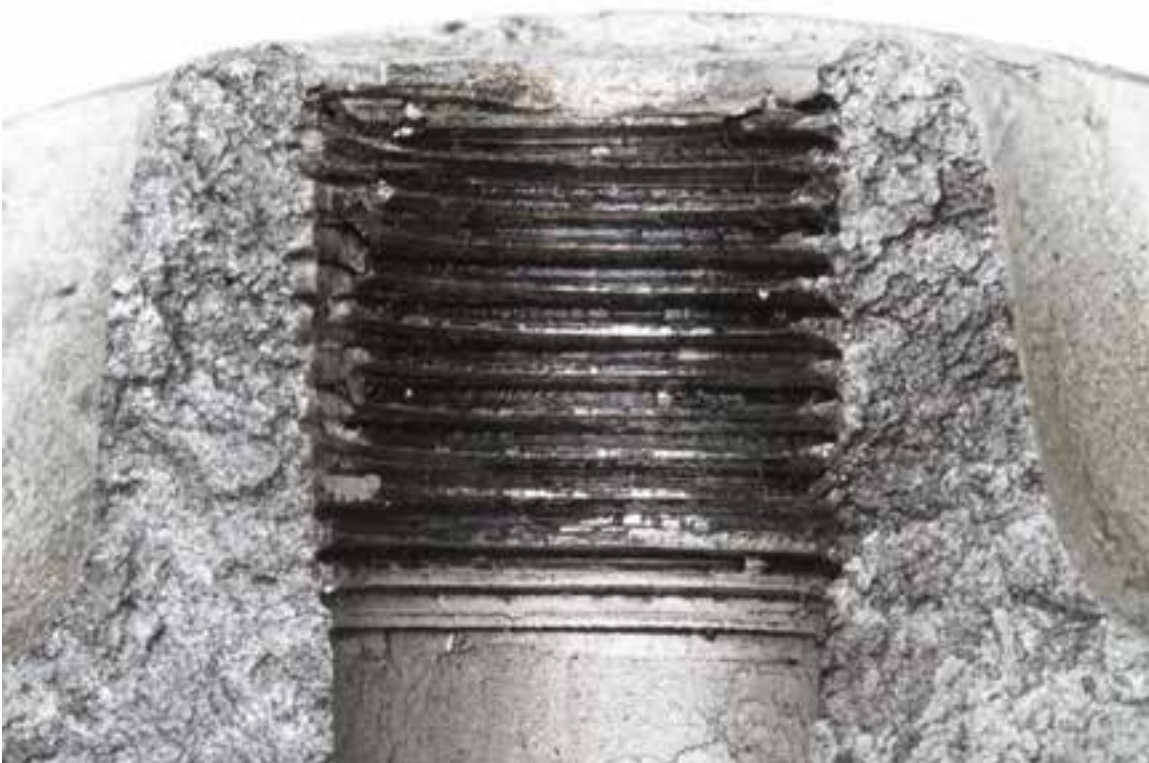
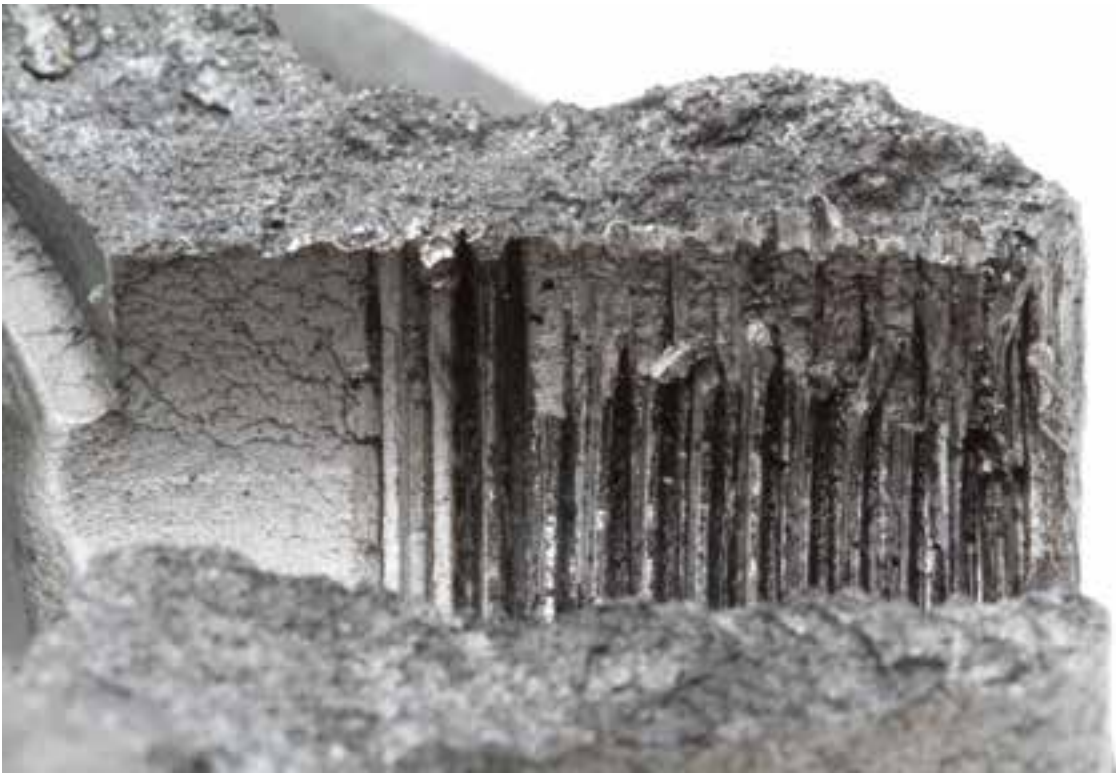
Figure 44: Mounting bolt thread damage in separated portion of cam bearing
Note the thread damage is localized at the fracture edges

Figure 45: Mounting bolt thread damage in separated portion of cam bearing
Note the thread damage is localized at the fracture edges

Figure 46: Mounting bolt thread damage in remaining portion of cam bearing
Note the thread damage is localized at the fracture edges

Figure 47: Mounting bolt thread damage in remaining portion of cam bearing
Note the thread damage is localized at the fracture edges.

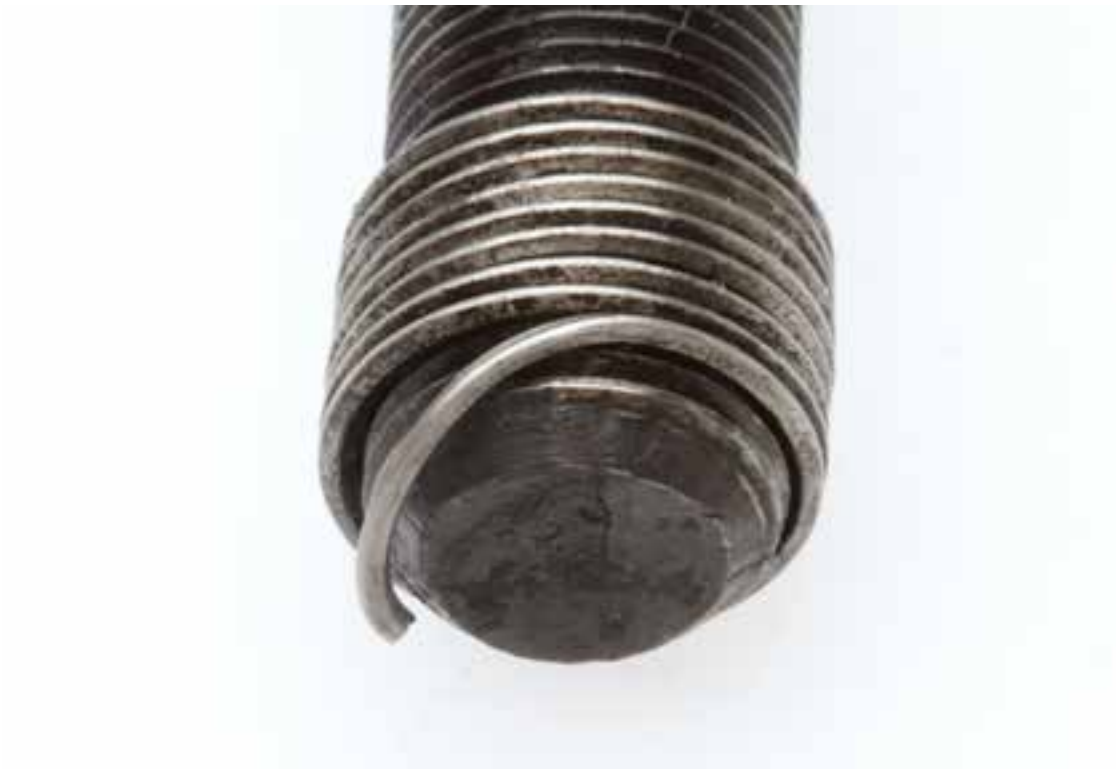
Figure 48: Axial deformation of the thread insert

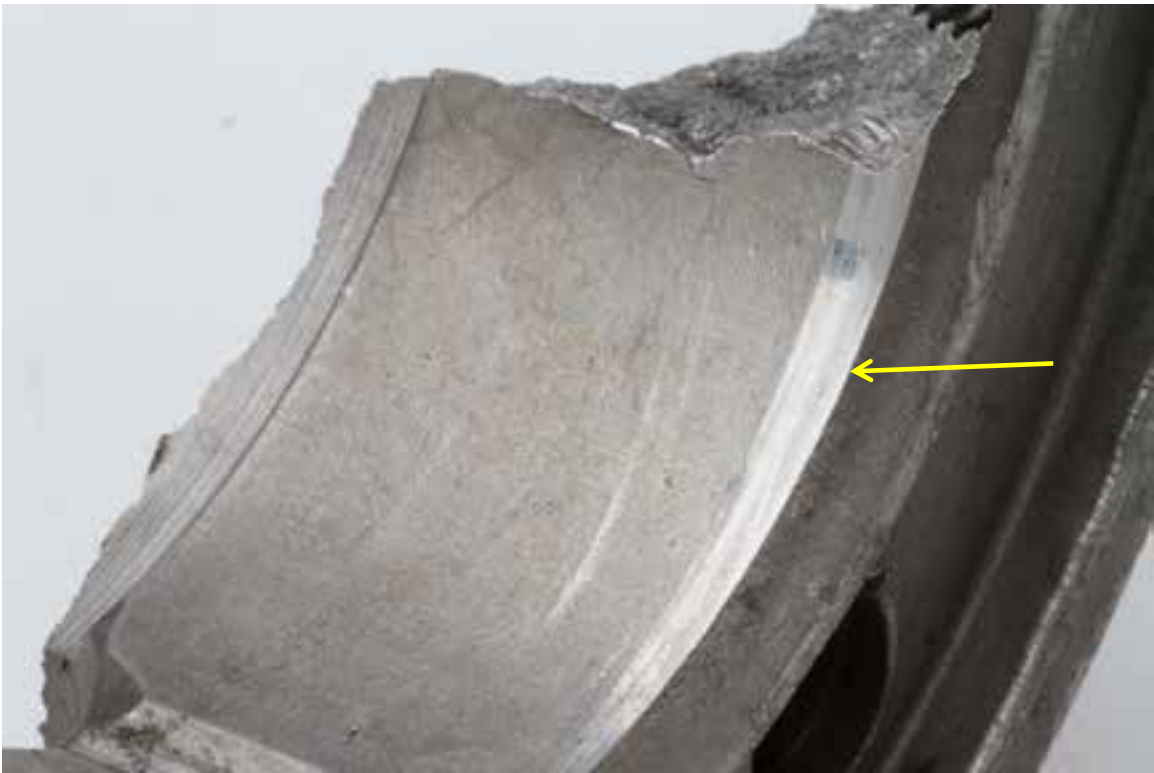
Figure 49: Smear on outboard edge of separated cam bearing portion (arrowed)
