OPERATIONAL SERVICES BRANCH
ENGINEERING LABORATORY REPORT

LP185/2013

Examination of Locomotive Air Brake

Montreal, Maine & Atlantic Railway, Train MMA-002

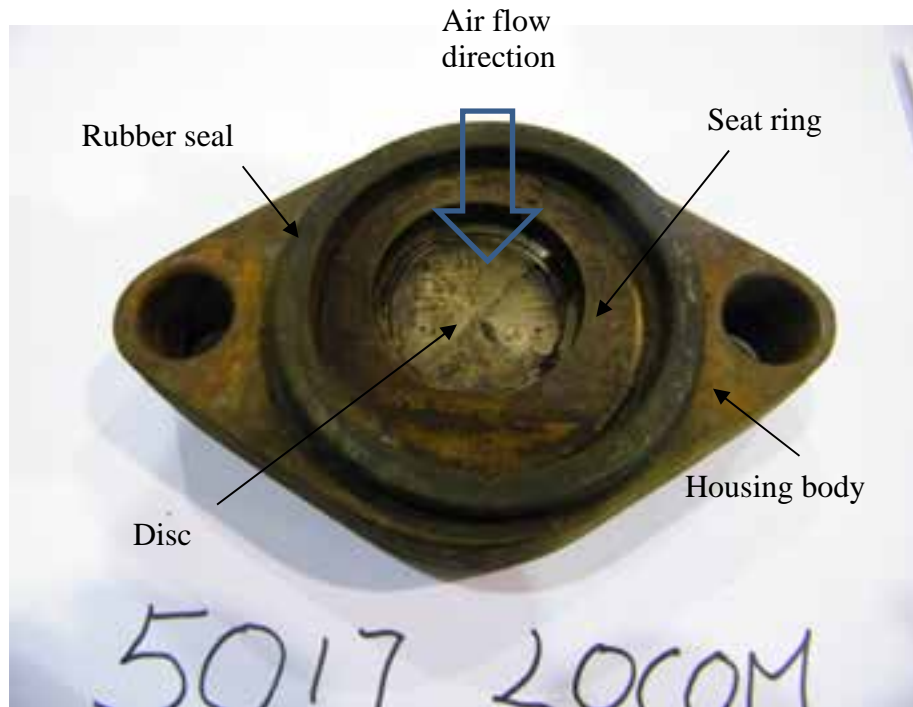
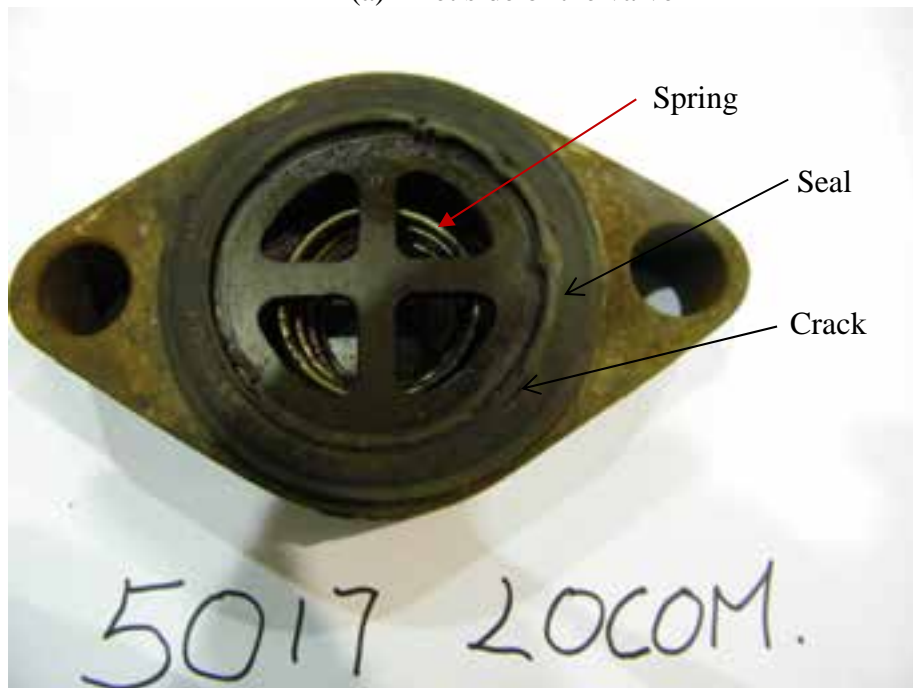
Figure 1: Photographs showing the main reservoir check valve from locomotive unit MMA-5017

2.1.1 Figure 1 shows the inlet and outlet sides of the valve. The valve is a typical disc type check valve, which consists of a valve housing body, a disc, a spring, a spring retainer and a seat ring, against which the disc is pushed upon by the spring to form the valve. Viewing from the inlet side of the valve (Figure 1a), dirt accumulation is observed on the surface, which appears to be a mixture of oil and fine particles. The rubber seal has lost its elasticity and surface smoothness and is completely coated with fine particle contaminants. Viewing from the outlet side (the side connected to the main reservoir), there is visible dirt on the spring retainer and the rubber seal is badly deformed with several cracks on its edge, indicating a loss of elasticity of the seal and proper sealing function.

3.1.1 The examination revealed the presence of dirt on the sealing areas on the disc and seat ring as well as the deformation and loss of elasticity of the rubber seal between the check valve and main reservoir, consistent with aging damage. While the dirt contamination on the disc and seat ring may result in air leakage to some extent, the deformation, loss of elasticity and cracking of the rubber seal due to aging was probably the main reason for the leaking of this check valve.

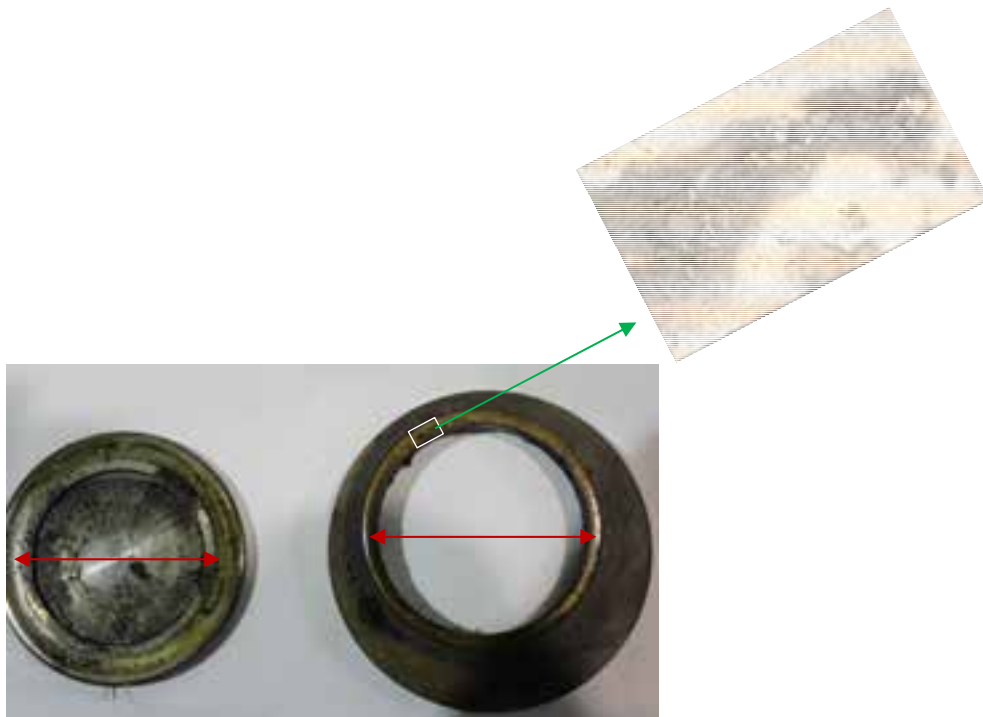
2.1.2 Figure 2 shows the dirt accumulation on the sealing area (which is indicated by the red arrows) of both disc and seat ring after they were taken out from the housing body. The zoomed in area in Figure 2 is an optical microscope image taken after the oil was evaporated by placing the seat ring on a laboratory hot plate for 5 minutes. The image confirms that the dirt on the sealing surface was an accumulation of fine particles, which probably contributed to air leaking of the valve.

- 4.1 The cause of the excessive air leakage of the main reservoir check valve from locomotive unit MMA-5017 was determined to be loss of elasticity and cracking of the rubber seal due to aging. Contamination of the disc and seat ring by an oil-dust mixture on the disc and seat ring may also have contributed to the air leakage. The advanced stage of aging of the rubber seal suggest this valve had not been inspected or serviced for some time.

Figure 2: Dirt accumulation on sealing areas of the disc and seat ring of the main reservoir check valve from locomotive unit MMA-5017

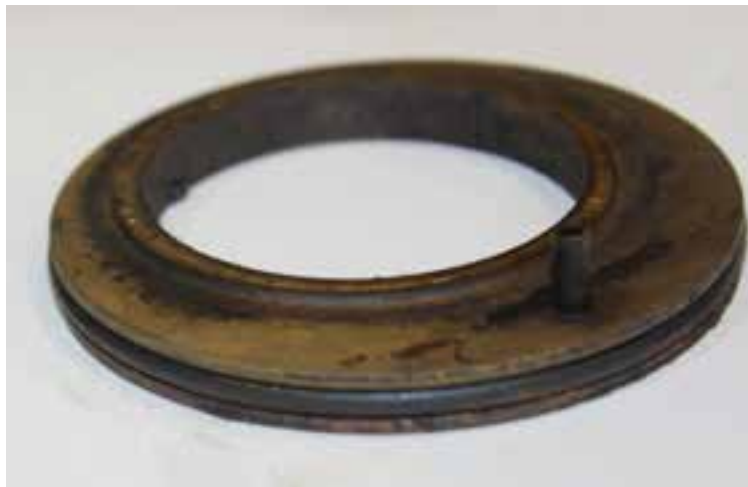
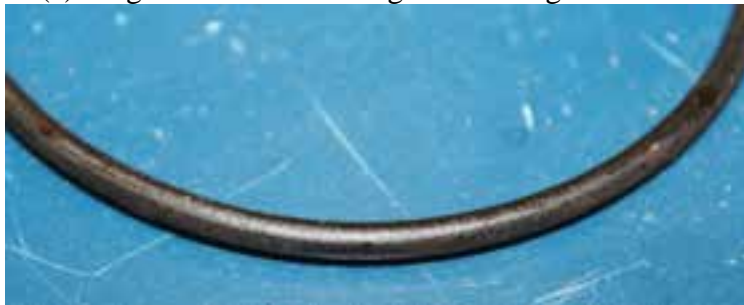
Figure 3: Angled view of seat ring with O-ring from the main reservoir check valve from locomotive unit MMA-5017

2.1.3 Figure 3 shows an angled view of the seat ring after it was removed from the housing body. There is an O-ring fitting into the groove on the side of the seat ring, which was designed to seal the passage between the seat ring and housing body of the check valve. The condition of this O-ring was unremarkable.

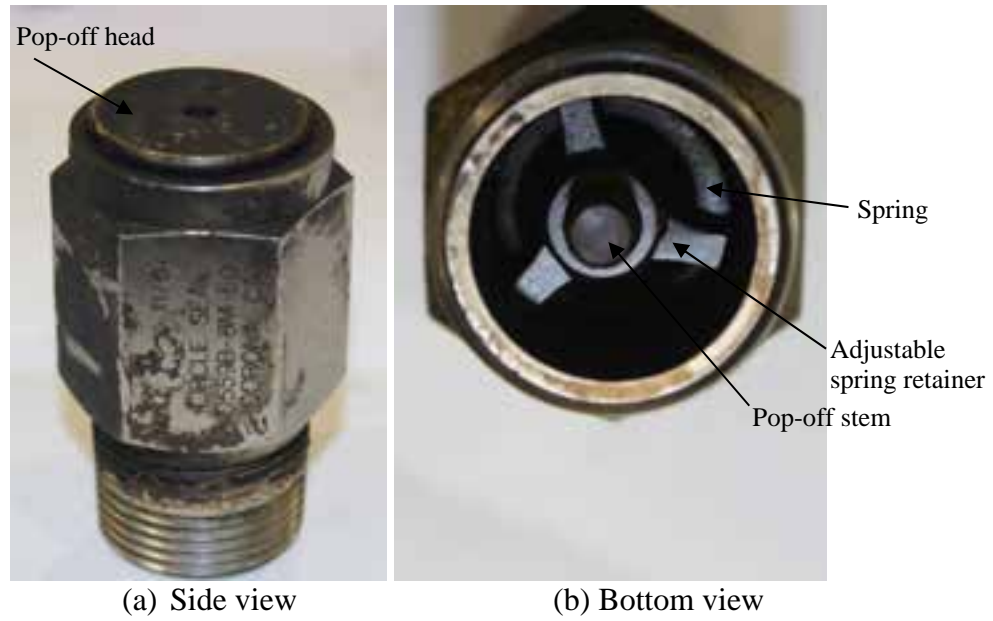
2.2.1 Figure 4 shows the compressor relief valve⁵ (part number D559B-8M-60) that had a default setting for pop-off (or relief) pressure of 60 psi.

2.2.3 The test started at an air supply pressure of 0 psi and the pressure was slowly increased. From the very beginning, just above 0 psi, the sound of air leaking could be heard. By placing a finger in front of the head of the relief valve, a small air leak was also felt. Such leakage was detected until the test pressure reached about 50 psi when the valve was heard to pop off and the air was aggressively blown out from the valve. There was no change in the pressure gauge reading with further increase in air supply pressure. Thus the pop-off pressure of the relief valve was determined to be 50 psi whereas its default setting is 60 psi, which suggests that the relief valve's spring may have sagged a bit over time.

3.2.1 The rubber seal on the head of the pop-off stem was found to be aged, as indicated by the presence of deep grooves on its surface. However, it was unlikely that this was the reason for excessive air blowing from the valve during in-situ testing. Laboratory testing indicated that the relief pressure of the valve was reduced to 50 psi whereas the default setting was 60 psi. This was likely the main reason for excessive air blowing. It is likely that the retaining spring had sagged a bit over the years, which led to the reduction in relief pressure.

- 4.2 The relief pressure of the compressor pressure relief valve from locomotive unit MMA-5017 was reduced to 50 psi whereas the default setting was 60 psi. It was likely that the retaining spring had sagged a bit over the years, resulting in an undesired opening of the relief valve under nominal pressure and giving rise to excessive air blowing from the head of the valve.

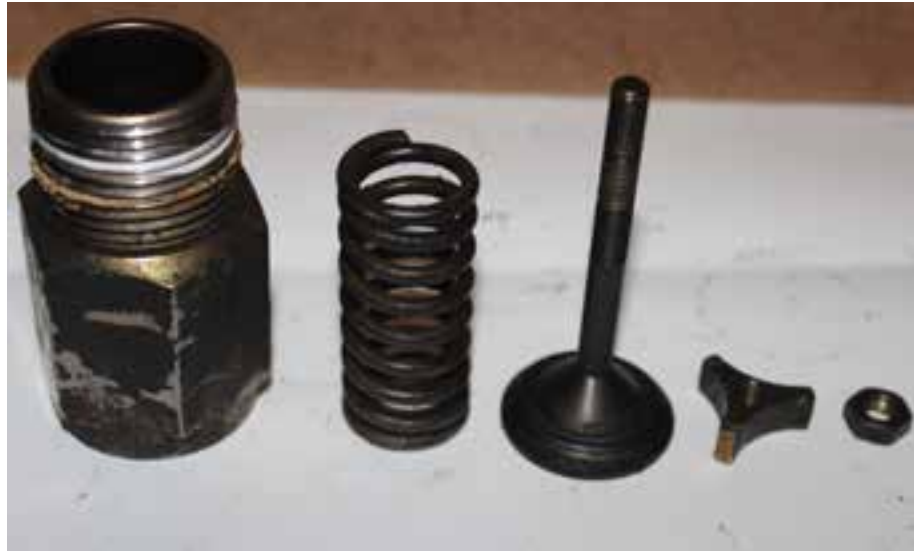
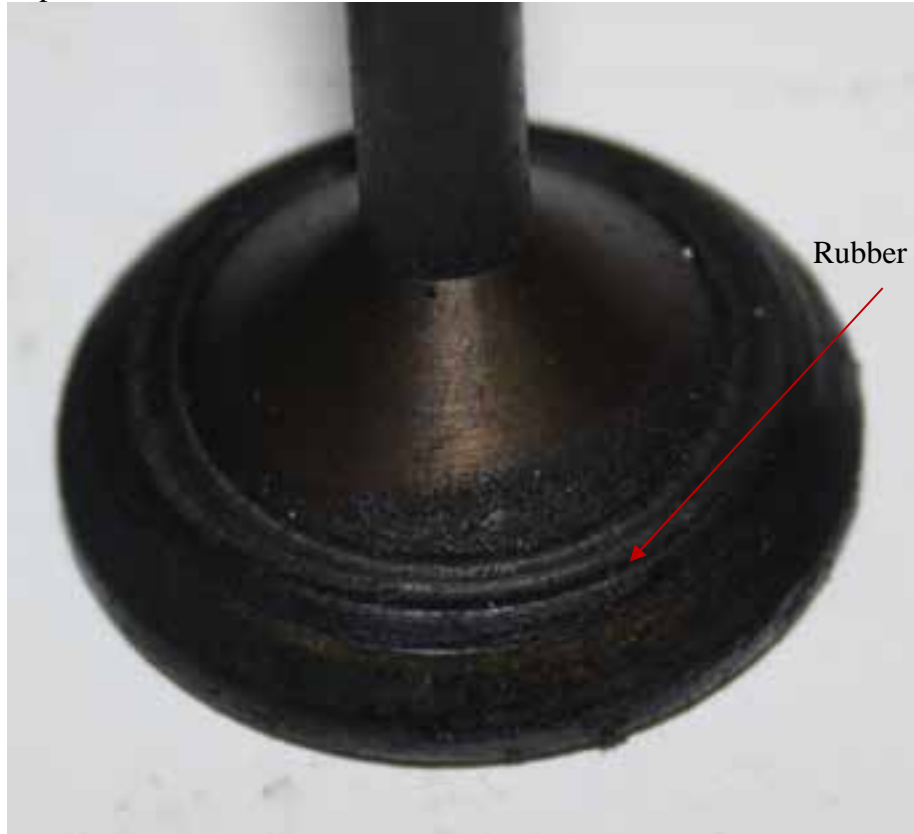
Figure 6: Disassembled compressor pressure relief valve from locomotive unit MMA-5017

2.2.4 Figure 6a shows the components of the disassembled relief valve. No component was broken or visibly deteriorated except for the rubber seal on the head of the pop-off stem. This rubber seal exhibited deep grooves on its surface (Figure 6b), a sign of loss of elasticity and proper sealing function due to aging. This may explain why there was a small amount of air leaking before the relief valve activated during the test.

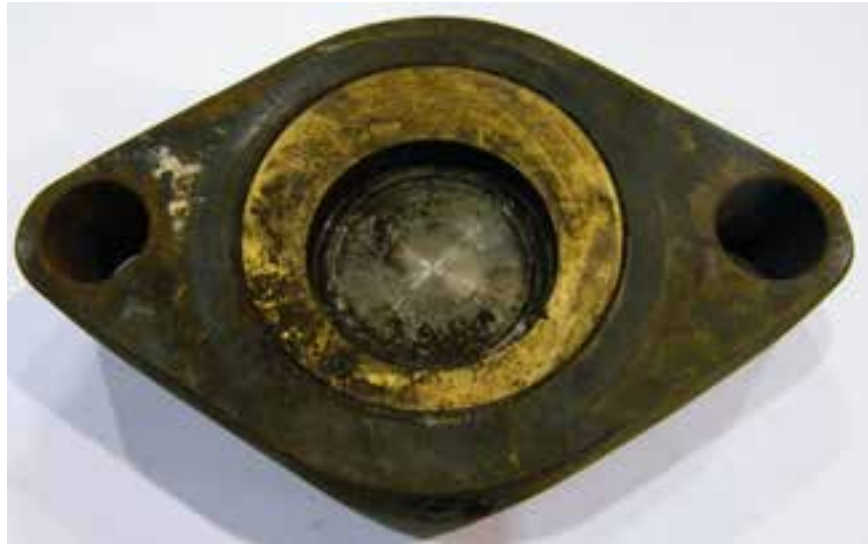
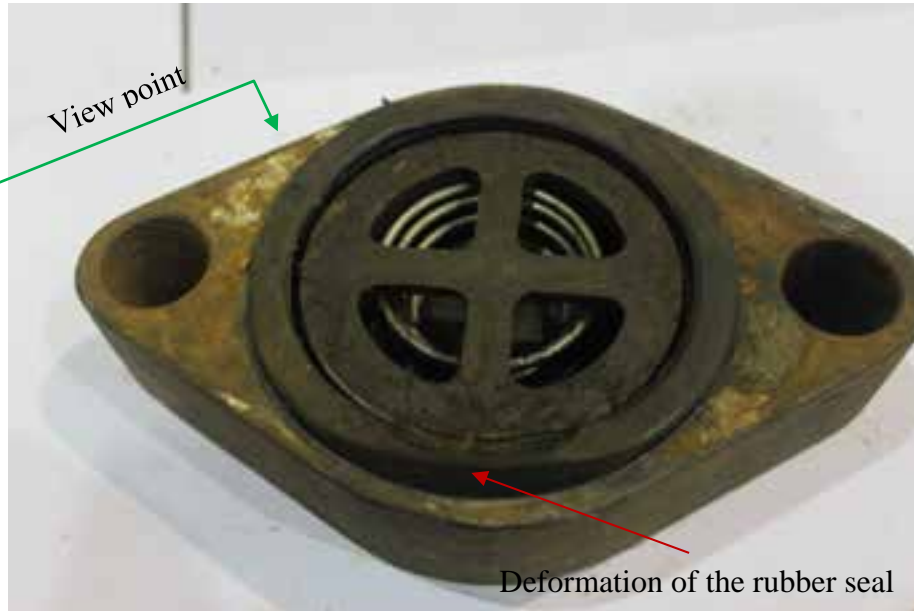
Figure 7: Photographs showing the main reservoir check valve from locomotive unit CEFX-3166

2.3.1 Figure 7 shows the inlet and outlet (side connected to the main reservoir) sides of the check valve. This valve was of the same type as the valve from locomotive unit MMA-5017 (see section 2.1). Viewing from the inlet side of the valve (Figure 7a), dirt accumulation was observed on the valve's internal surface. Viewing from the outlet side (Figure 7b), there was visible dirt accumulation on the spring and spring retainer. The rubber seal was badly deformed (see the red arrow on Figure 7b), indicating a loss of elasticity of the seal and its proper sealing function. When the rubber seal was taken out for further examination as shown in Figure 7c, the seal was found to be essentially broken with a large through crack along its circumferential direction.

3.3.1 The examination of the valve's components revealed that the rubber seal between the check valve and main reservoir was broken and that the O-ring between the seat ring and valve housing body was badly deformed because of the loss of elasticity due to the aging of the rubber. While contamination by an oil-dust mixture found on the disc and seat ring may have contributed to the air leaking to some extent, the broken rubber seal between the valve and main reservoir and the deformation of the O-ring were likely the two main reasons for excessive air leaking from the main reservoir of the air brake system.

- 4.3 Examination of the main reservoir check valve from locomotive unit CEFX-3166 found that the rubber seal was broken and the O-ring between the seat ring and valve's housing body was badly deformed, causing the excessive air leakage from the main reservoir. The advanced state of aging of the rubber seal and O-ring suggest this valve had not been inspected or serviced for some time.

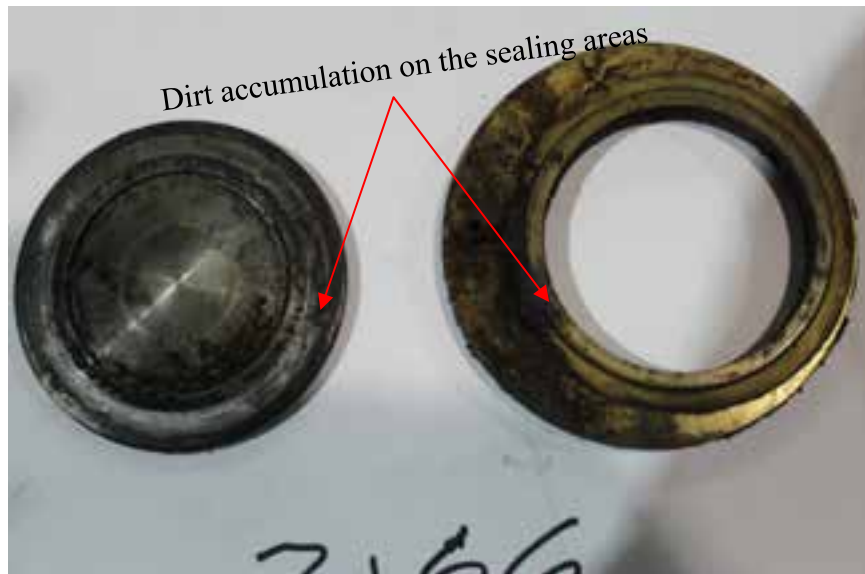
2.3.2 Examination of the sealing surfaces on the disc and seat ring of the check valve was conducted as described in section 2.1.2. Dirt accumulation was clearly visible as indicated by the arrows in Figure 8.

Figure 8: Significant dirt accumulation on sealing areas of both disc and seat ring of the main reservoir check valve from locomotive unit CEFX-3166

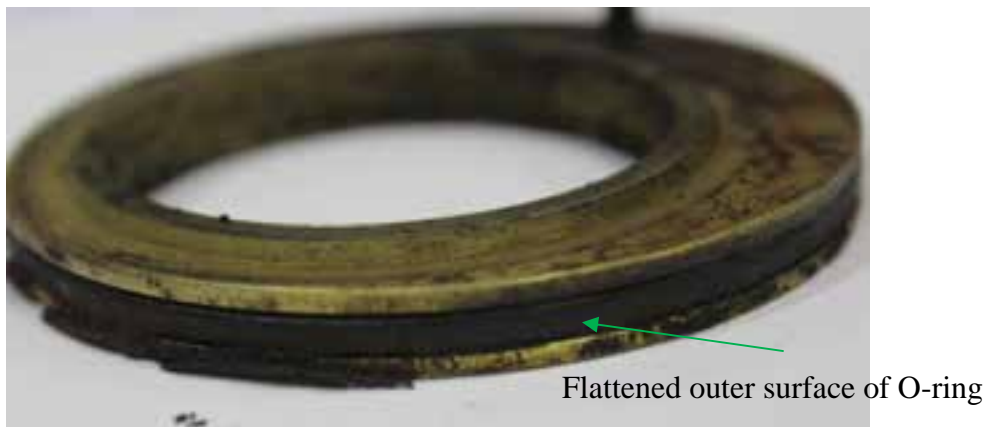
2.3.3 Figure 9 shows the O-ring installed on the seat ring, which is designed to seal the gap between the seat ring and housing body. The outer surface of the O-ring was flattened and it was flush with the side surface of the seat ring. This indicates that the O-ring had lost its elasticity, was permanently deformed and thus had lost its proper sealing function. The significant presence of dirt accumulation on the side wall of the seat ring is also an indication that excessive air (with dust contamination in it) had passed through the gap between the seat ring and the housing body of this check valve.

Figure 9: Side view of the seat ring showing the excessive wear on the O-ring of the main reservoir check valve from locomotive unit CEFX-3166

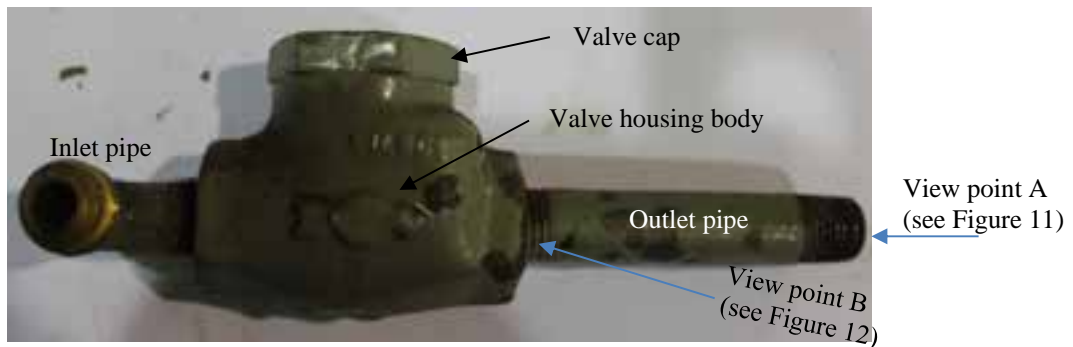
2.4.1 Figure 10 shows a photo of the dead engine pressure regulating valve. When examining the exit end of the outlet pipe connected to the body of the valve (marked as view point A in Figure 10), it was noted that the end of the pipe was rusted (Figure 11). Significant rust accumulation was present inside the pipe, partially blocking the outlet pipe.

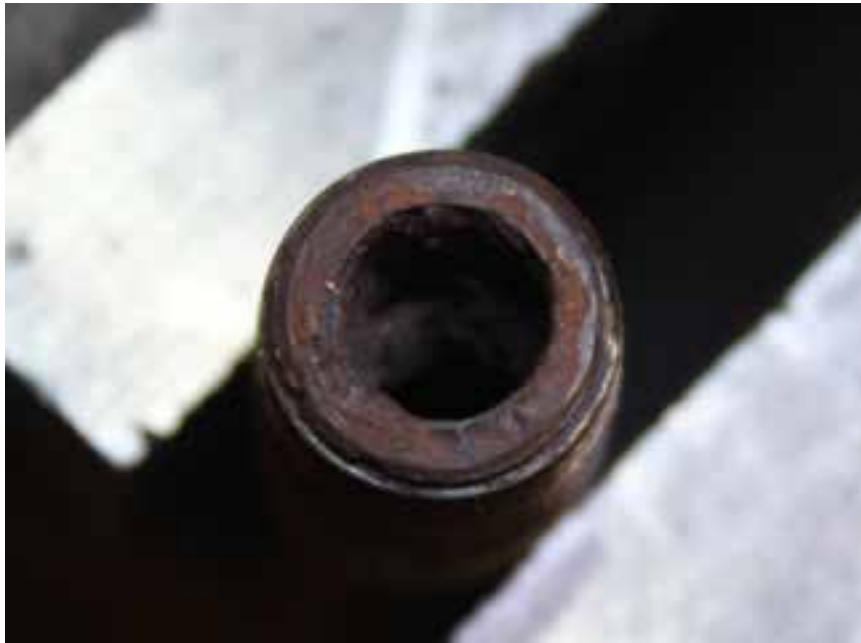
Figure 11: Photo showing the rusty end of the outlet pipe of the dead engine pressure regulating valve from locomotive unit CEFX-3166

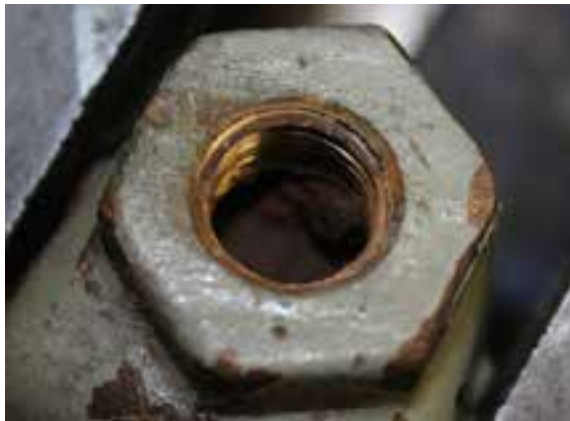
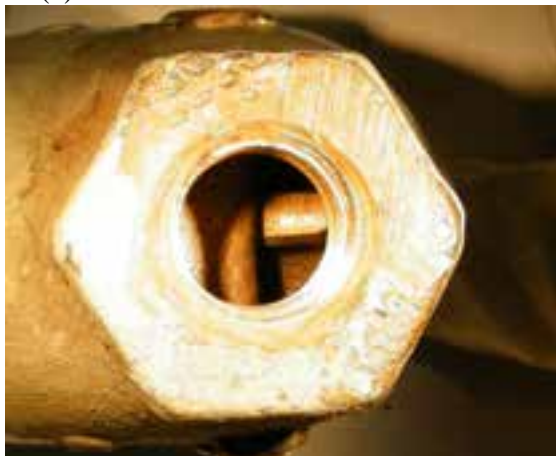
Figure 12: Photos showing rust accumulation inside the dead engine pressure regulating valve from locomotive unit CEFX-3166

2.4.2 Figure 12a is a photo taken from the exit hole on the valve body (marked as view point B in Figure 10) after the outlet pipe was removed. Rust accumulation inside the valve was clearly visible. When the valve was viewed from the entrance hole after removing the inlet pipe, no rust was visible inside the valve. It was noted that the valve is made of copper. Consequently, the accumulation of rust particles on the exit side of this one-way airflow valve indicates that a reverse airflow (air leak) had occurred over a long period of time.

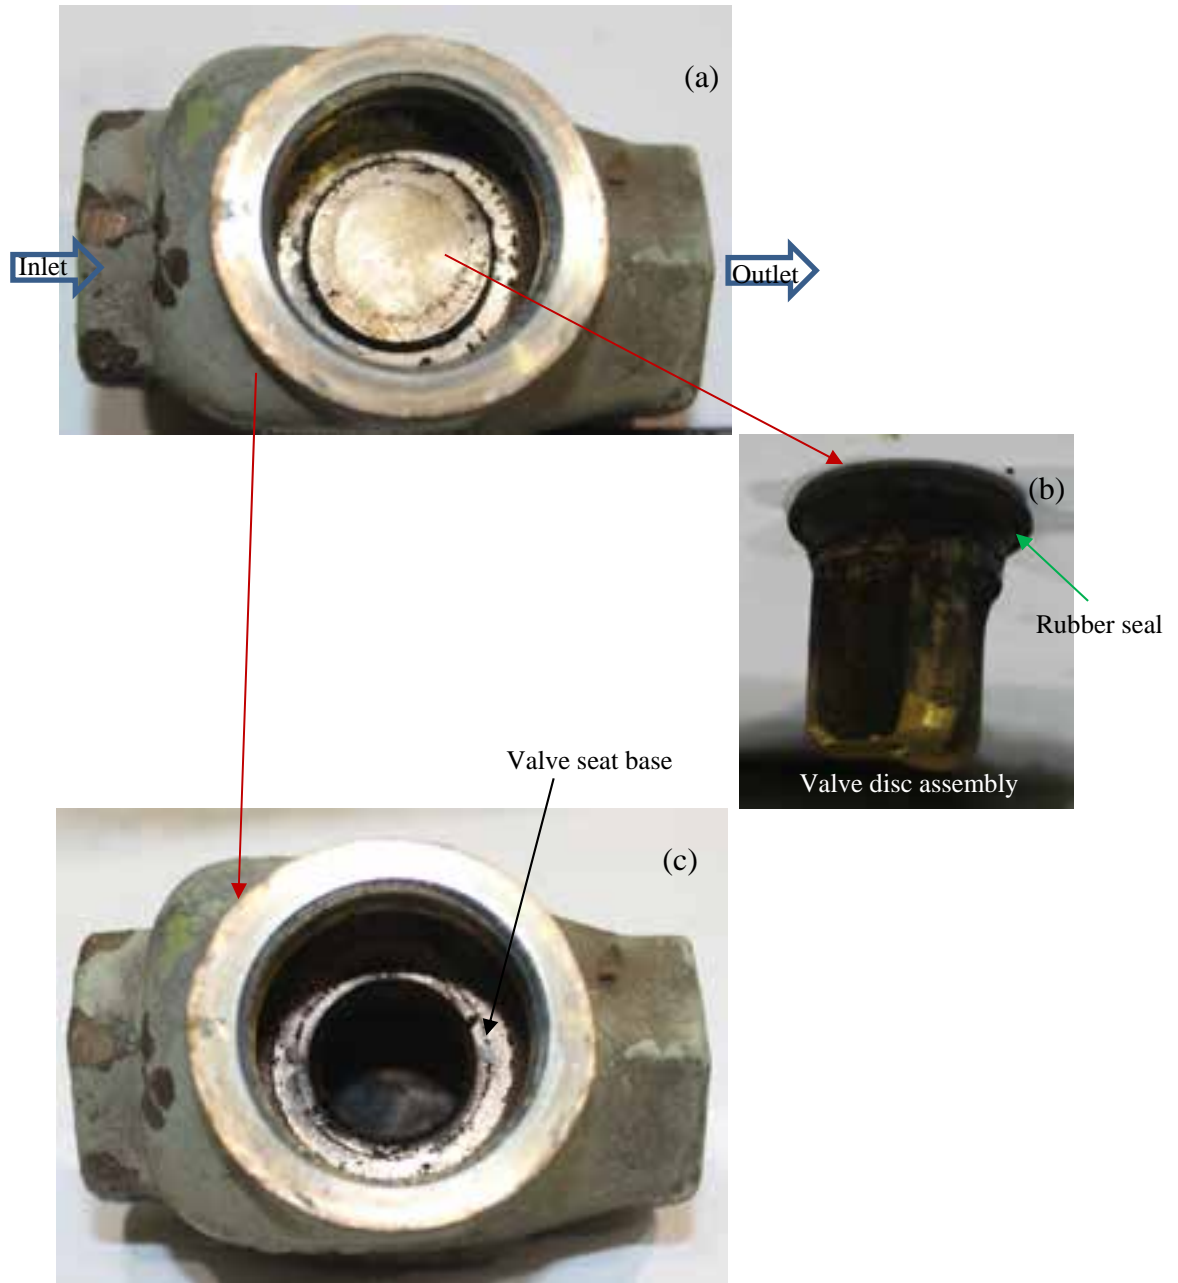
- 2.4.5 The disc assembly was removed, exposing the circular area on the base seat that is covered by the disc assembly (Figure 13c). This circular area had no visible defect except for a mixture of oil and dust particles on the surface. The disc assembly also exhibited a mixture of oil and dust particles on the rubber seal and moving guide (Figure 13b). The rubber seal contained a visible groove, an indication of aging, loss of elasticity and loss of proper sealing function. It was concluded that the sticky oil-dust mixture was likely the reason why the disc assembly did not move freely to close the valve.

3.4.1 The examination revealed a deformation of the rubber seal between the disc assembly and the base seat as well as the accumulation of particles on it, which probably affected the seal. The dust particles had a dark-red color suggesting that they originated from the outlet pipe, which was made of steel and was rusted. The badly aged rubber seal and rusted outlet pipe suggest that this valve had been in service for a long time, probably well beyond its designed lifespan.

- 4.4 The air leak from the dead engine pressure regulating valve from locomotive unit CEFX-3166 was primarily due to the aging rubber seal between the valve's disc and base seat. Rust particles on the rubber seal probably further aggravated the air leak.

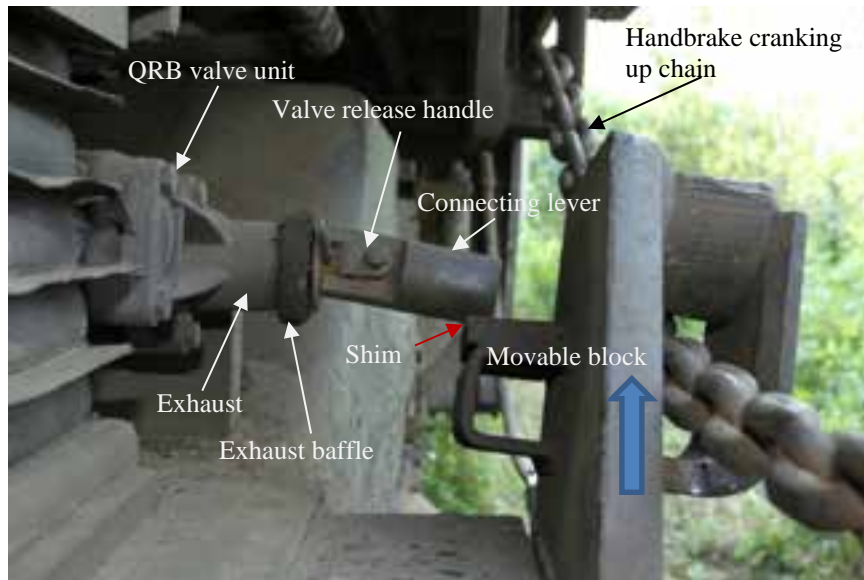
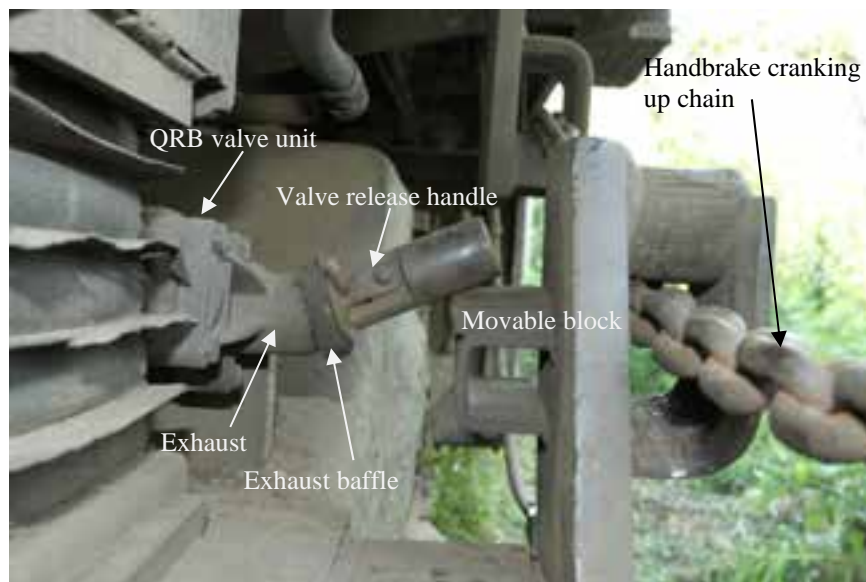
Figure 14: Photos showing in-situ condition of QR valve from locomotive unit MMA-5026

- 2.5 QRB Valve from Locomotive Unit MMA-5026
- 2.5.1 Figure 14 shows the QRB valve and its release handle's position before and after winding up the handbrake chain. When applying the handbrake, the tensioning of the handbrake chain brings up the movable block, which in turn moves the lever connected to the handle of the QRB valve upwards, to trigger a quick release of the air in the brake cylinder.

- 2.5.3 During the on-site examination, it was noted that a piece of shim had been placed on the horizontal plate of the movable block (indicated by the red arrow in Figure 14a). Repeated testing of the valve's functionality revealed that the valve did not work, i.e., winding up the handbrake chain to its limit did not result in the release of air from the brake cylinder. However, it was possible to activate the valve by pushing the connecting lever further up by hand.

- 3.5.6 The development of wear and damage to the lifter and inside surface of the retaining disc is considered to be a long term process. The use of a shim on the horizontal plate of the movable block (Figure 14a) possibly reflects the fact that at some stage of the subject QRB valve's service history, the wear and damage to these two components had caused the malfunction of the valve. By using a shim to increase the leverage angle, the valve was made to work again. However, this was an improvised remedy rather than a repair made according to a maintenance and service standard. It is considered that at the time of this occurrence, the wear and damage to the lifter and retaining disc had further progressed, resulting in the malfunction of the valve.

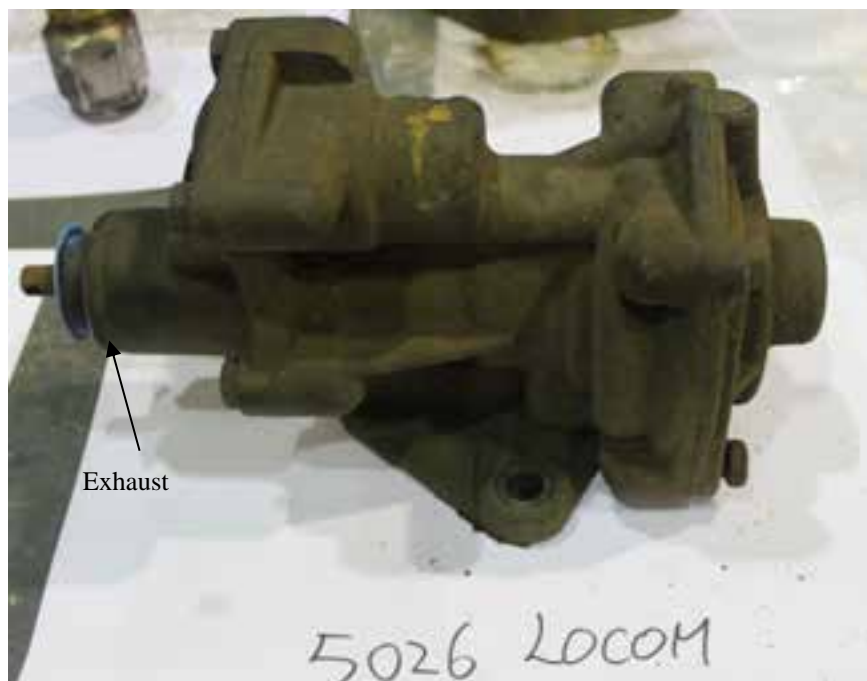
- 2.5.4 Figure 16 shows the QRB valve after it was removed from the locomotive. A blue plastic cap had been placed in front of the exhaust, pierced through by a rod sticking out from the body of the valve. A review of the parts diagram for the QRB valve (Appendix A) indicated that this rod is a component of the end plate (part #22), which sticks out of the body of the valve (part #23), goes through a hole on the baffle (part #26) and is then connected to the handle (part #27). The blue plastic cap was not indicated on the parts diagram, confirming it was not an original component of the subject valve. The function of this blue plastic cap was not clear.

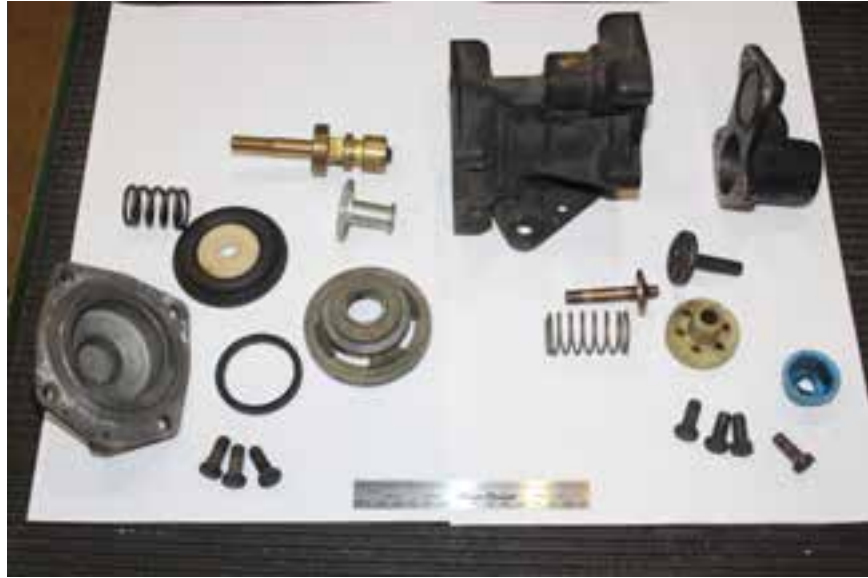
- 2.5.5 The valve was disassembled and its components were examined for indications of wear or damage that might have caused it to malfunction. Figure 17 shows the disassembled components of the valve. Visible damage was found on two components, the retaining hole inside the body (part #23) and the lifter (part#21).

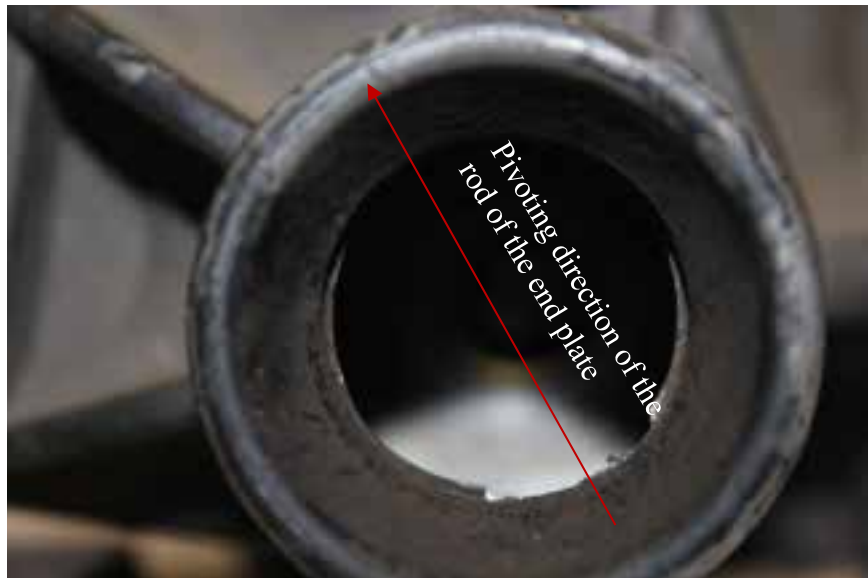
- 2.5.6 Figure 18 is a photo showing the damaged edge of the retaining hole of the valve's body as viewed from the outside. This hole has two functions: firstly it is the exhaust hole for the brake cylinder (air) release; secondly, it is designed to retain the end plate (part #22) and to provide a circular surface for the end plate to pivot to push the lifter (part #21) in order to release the air in the brake cylinder. The damaged spot was at the exact location where the end plate pivots to push the lifter when the rod is moved in the direction indicated by the red arrow on Figure 18.

Figure 18: Damage on the edge of retaining hole for the end plate on the QRB valve's body

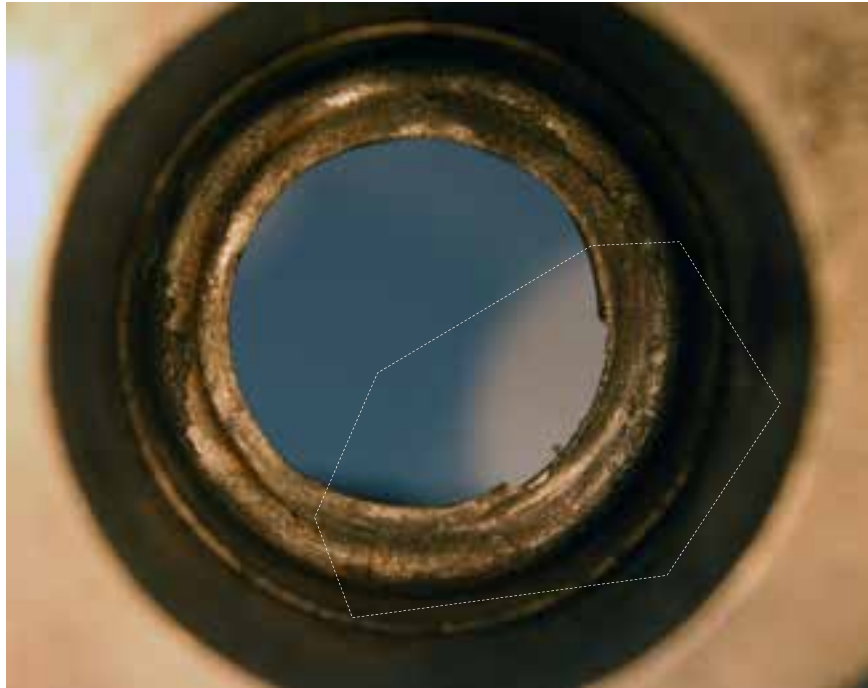
- 2.5.7 Figure 19 shows the damage on the retaining hole when viewed from the inside. The area highlighted by the white dotted line shows considerable wear and a damaged edge. The circular groove around the hole has disappeared in this area. It is considered that this wear damage would cause a small change (recession) in the position against which the end plate pivots, which would affect the pivoting stroke and potentially the quick release mechanism of the valve.

- the head of the stem, thus requiring an increase of the leverage angle of the end plate in order for the release mechanism to work.
- 3.5.4 The local wear and damage to the end plate retaining disc (Figure 19), against which the end plate pivots to push the lifter, is also expected to affect the operation of the valve because this wear amounts to a recession of the pivoting position along the primary axis of the valve, which would also require an increase of the leverage angle of the rod (thus, the lever) in order for the valve to work.

- 3.5.5 A test of the maximum pivoting stroke of the end plate indicated that the wear and damage to the retaining disc had resulted in a recession of the pivoting position by about 0.7 mm, amounting to an equivalent loss of pivoting stroke of 0.7 mm (see Appendix B).

Figure 19: Visible wear and damage on the QR valve's retaining disc where the end plate makes contact in order to pivot

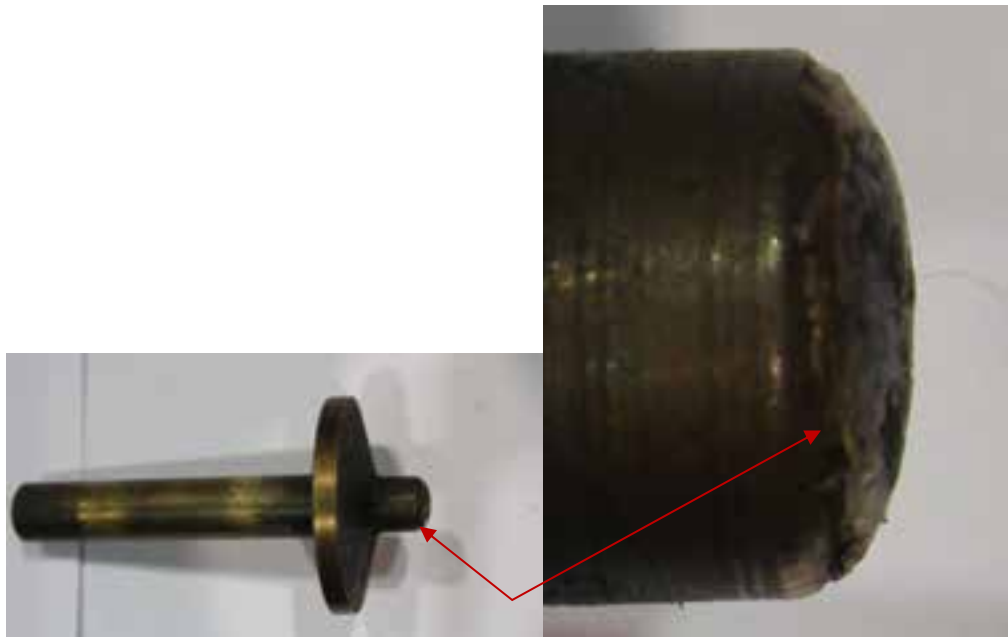
- 2.5.8 Figure 20 shows the lifter in the valve. The end of the lifter that is in contact with the end plate was slightly crushed. This would have resulted in a reduction of the length of the lifter. If this length reduction exceeded the tolerance for the device, it would have affected the functionality of the quick release mechanism.⁶

3.5.3 The working principle presented in the previous paragraph suggests that a reduction in the lifter's length due to damage (Figure 20) would be expected to affect the operation of the valve. It would increase the gap between the lifter and

- 4.5 Testing and examination of the QRB valve from locomotive unit MMA-5026 identified wear damage to the valve's lifter and to the inside surface of the retaining disc as the cause for the malfunction of the valve. Non-standard repairs had been applied to the valve's release mechanism, suggesting that the valve malfunction was known to the operator before the occurrence.

Figure 20: Photo of the QR valve lifter showing the damage to the head (see arrows)

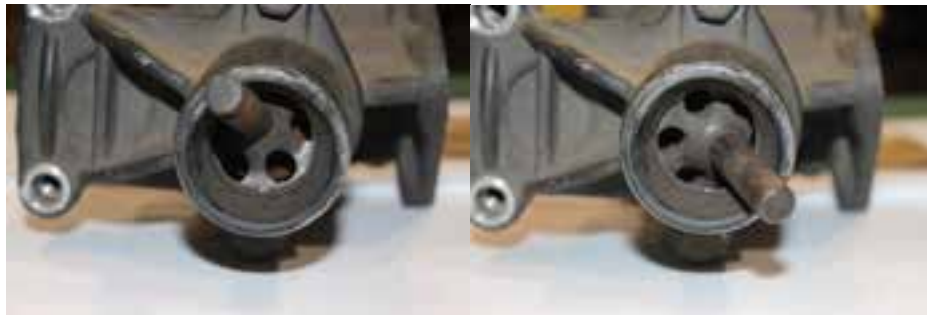
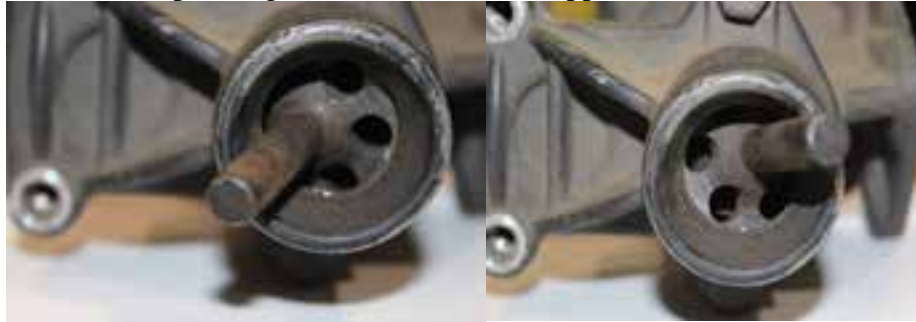
- B-1.4 It can be seen that the stroke in the nominal direction was consistently 0.7 mm shorter than in the 3 other directions. The smaller stroke was caused by the recession in the pivoting position that was experienced in the nominal direction but not in the 3 other directions.
