AVIATION OCCURRENCE REPORT

A99H0002

LOSS OF CONTROL AFTER TAKE-OFF

BEECH AIRCRAFT CORPORATION A100 C-GASW

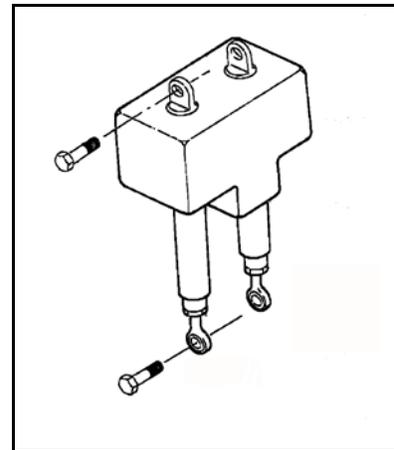
Thunder Airlines Limited maintenance personnel had performed work on the elevator and rudder controls during the weekend preceding the flight. In order to remove the rudder, the primary and secondary pitch trim actuators, connected between the stabilizer and the airframe, had to be disconnected from the airframe. This bracket, in the form of a double U, with the primary and alternate trim motors located in the middle, is attached to the airframe and the leading edge of the stabilizer. Four bolts are routed through the holes at each end of the actuators for attachment to the airframe and the stabilizer. After the occurrence, investigators found that the top of the actuators was not attached to the airframe. The two bolts did not pass through the actuator holes when reinstalled, only through the attachment holes in the airframe. When the bolts were tightened during installation, they squeezed the ends of the actuators to the attachment points on the airframe. Without the actuators attached to the airframe, the stabilizer was free to rotate to a full up or down position on its own.

The actions of the pilots did not contribute to the accident, nor did the weather, navigation aids, or airport conditions. Apart from the improper installation of the bolts that attach the trim actuator mechanism to the airframe, there was nothing remarkable about the condition of the aircraft.

The AME did not use a mirror or other devices, such as a centring punch, to ensure the proper alignment of the bolts during the installation. After completing the maintenance work, the AME and the crew chief carried out a control check and the control surface behaved normally. During take-off, when the pilot pulled the control column aft for rotation, air loads on the stabilizer caused the improperly attached trim actuators to separate from the airframe, which made the noise heard by the co-pilot on take-off. The separation of the actuator from the airframe rendered normal control of aircraft pitch impossible, even though the control column was still properly attached to the elevators.

1. The pilots were certified and qualified in accordance with current regulations.
2. The AMEs were certified and qualified in accordance with current regulations.
3. Records show that the aircraft was certified, equipped, and maintained in accordance with existing regulations and approved procedures.
4. The stabilizer trim actuator's two upper mounts bolts, which attach the mounts to airframe formers, were not properly installed by the AME.

The flight crew lost pitch control of the aircraft on take-off when the stabilizer trim actuators became disconnected because they had not been properly reinstalled by the AME during maintenance work conducted before the flight. The crew chief responsible for the inspection did not ensure correct assembly of the stabilizer trim actuators, which contributed to the accident.
