AVIATION INVESTIGATION REPORT

A00A0076

COLLISION WITH WATER

BELL 212 C-GCHG

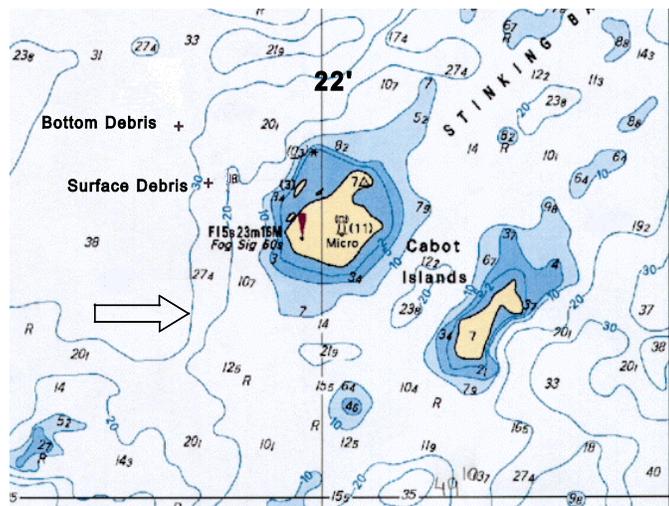
The floating debris was located immediately and recovered by local surface craft. Underwater search operations commenced on May 11 at 2300 using an underwater remotely operated vehicle. The underwater search, which was hampered by adverse weather, rough bottom conditions, and extensive underwater currents, continued until aircraft debris was located late in the evening on May 20. The main wreckage and the pilot were located the next day, 0.3 nm west-northwest of Cabot Island at a depth of 110 feet. The debris field was about 250 feet long, with the main cabin area to the northeast. The distribution of wreckage items was consistent with the tidal current. Less-dense components, such as the main rotor, panels, and the tail boom, were deposited to the southwest (see Appendix A). The wreckage was approximately 600 feet farther out from, and in line with, the estimated location of the floating netload of barrels observed immediately after the accident.
