AVIATION INVESTIGATION REPORT

ENGINE STOPPAGE ON TAKE-OFF

CESSNA 172N SKYHAWK C-GMHU

Report Number A01O0157

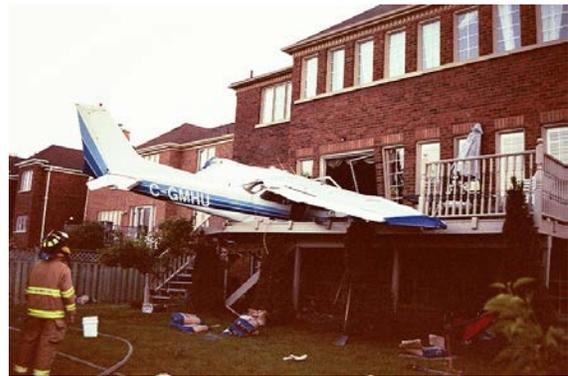
During the take-off and the initial climb, the pilot did not observe any abnormalities except that the carburettor heat control knob was slightly extended. He pushed the control knob in and kept his hand on it to ensure that it stayed fully in (OFF). He did not detect any degradation of power before the engine stoppage. During the forced approach, the pilot attempted two engine restarts without success. He then moved the fuel selector to OFF before impact. The aircraft turned left toward a residential area and struck a house approximately 1.4 nautical miles west-northwest of the Toronto / Buttonville Municipal Airport, Ontario. After the aircraft came to rest on the back deck of the house (Figure 1), one of the occupants of the house assisted the pilot in exiting the aircraft. The aircraft windshield broke during the crash, and the pilot exited through the front of the aircraft. Numerous suitable forced landing sites were available off the departure end of Runway 33 had the aircraft continued straight ahead or altered course slightly to the right.

The aircraft was removed from the residential area and examined at the Toronto / Buttonville Municipal Airport. While documenting the aircraft cockpit, it was noted that the fuel selector was OFF. All other controls and switches (mixture, magnetos, and master switch) were in the engine operating position and had not been moved. Damage to the fuel selector mechanism indicated that the fuel selector was OFF at impact. The aircraft fuel tanks were compromised at impact, and an undetermined amount of fuel leaked onto the residential yard. The local fire department responded to the scene, and the fuel remaining in the tanks was captured and contained. The propeller bent rearward when it struck the deck; there was no indication of propeller rotation.
