**AVIATION INVESTIGATION REPORT
A03C0094**

LOSS OF PITCH CONTROL AND COLLISION WITH TERRAIN

**TRANSWEST AIR LIMITED
BEECH 99A C-FDYF
PRINCE ALBERT, SASKATCHEWAN, 6 NM SW
23 APRIL 2003**

Report Number A03C0094

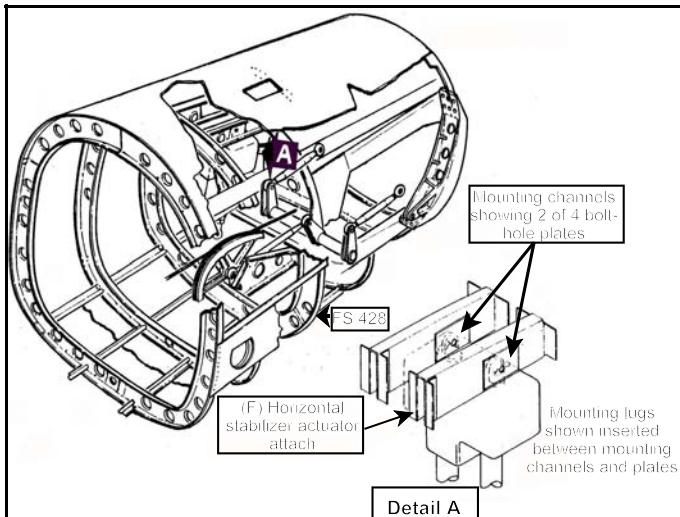
Figure 1. Horizontal stabilizer trim actuator mount structure

The airframe mounting structure for the horizontal stabilizer trim actuator consists of four channel-and-plate assemblies that are aligned fore-and-aft and installed between a former, located at station 418.900, and a bulkhead located at station 428.335, in the upper section of the aircraft tail. To provide a bolt hole through which close-tolerance mounting bolts are installed, a plate is riveted to each channel. There are two upper mounting lugs on the horizontal stabilizer trim actuator; both mounting lugs include a spherical bearing. To attach the trim actuator to the upper airframe structure, a separate high-tolerance bolt is installed through the holes in each set of paired channels and through the spherical bearing for each of the mounting lugs. The installer is on his knees, leaned forward and holding the actuator (approximately 10 pounds) in place, above and ahead. The mounting lugs are hidden from view between their respective channels and the bolts are installed by feel. At any time in the process, the spherical bearings may rotate slightly, making it difficult to insert the close-tolerance bolts. The normal procedure is to insert a bolt through one of the channel pairs and the mounting lug, suspending the weight of the actuator from the airframe mounting structure (see Figures 1 and 2).

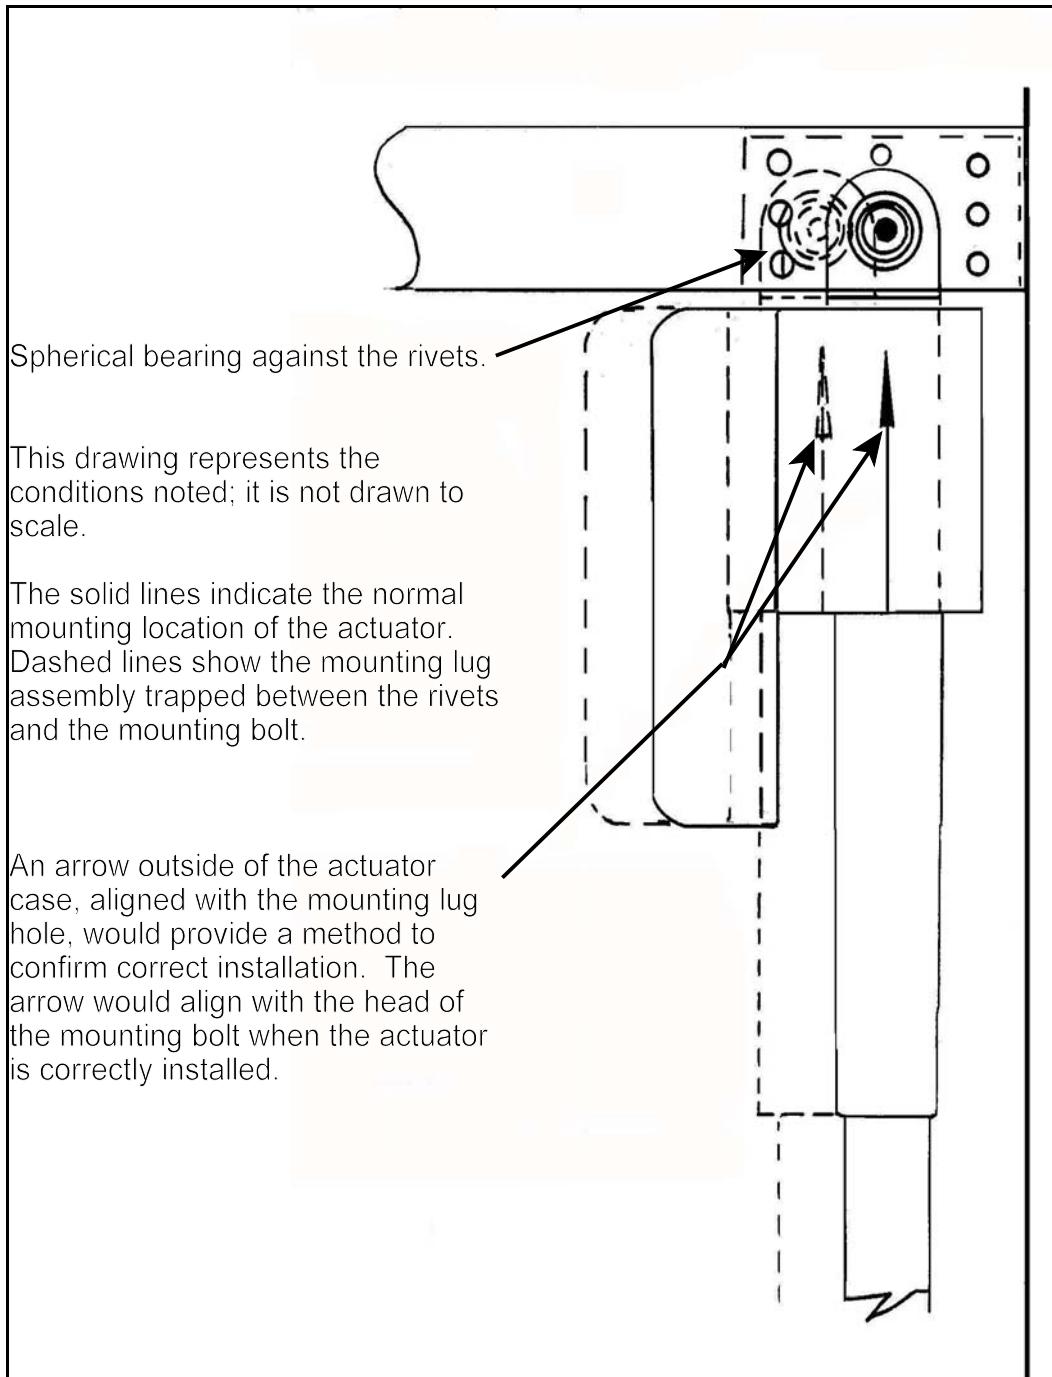
Appendix A – Representative Drawing of Actuator Installation

After the accident, inspection of the horizontal stabilizer trim control system revealed that the stabilizer trim actuator had fallen from the upper airframe mounting structure, allowing the stabilizer to move freely in flight. The mounting bolts had been installed through the airframe brackets but not through the mounting lugs of the trim actuator. Contact marks on the mounting lug assemblies, marks on the channel and plate assemblies, and worn rivets indicated that the upper mounting lugs had been positioned ahead of the normal mounting location. Placed in this manner, the spherical bearings of the lugs were positioned slightly above and in contact with the plate-to-channel attachment rivets. Marks on the rear of each mounting lug confirmed that the mounting bolts were installed behind the mounting lugs, trapping the mounting lug assemblies between the rivets and the bolt shanks. Positioned in this manner, the mounting lugs are approximately $\frac{3}{4}$ inch ahead of their appropriate location (see Appendix A).
