## AVIATION INVESTIGATION REPORT

A04A0148

### COLLISION WITH TERRAIN

PIPER PA-28-140 CHEROKEE C-FYKS

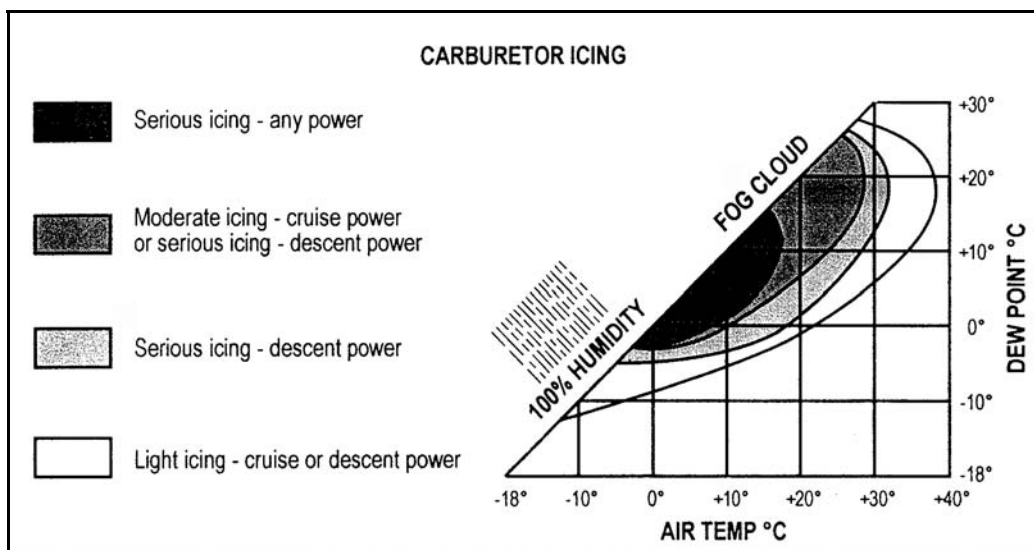
According to the *A.I.P. Canada*,<sup>2</sup> the temperature and dew point during the accident flight were conducive to serious icing effects at any engine power setting (see Figure 1). Carburetor icing may occur at any power setting, but is more likely at low power settings. It was not possible to determine if the carburetor heat was applied during the practice glide procedure or during the subsequent flight manoeuvres.

**Figure 1.** Carburetor icing diagram from A.I.P. Canada, AIR 2.3. Note: This chart is not valid when operating on MOGAS due to its volatility.
