AVIATION INVESTIGATION REPORT
A07Q0213

LOSS OF CONTROL AND COLLISION WITH TERRAIN

AIR CREEBEC INC.
BEEHCRAFT A100 C-FNIF
CHIBOUGAMAU/CHAPAIS AIRPORT, QUEBEC
25 OCTOBER 2007

Report Number A07Q0213

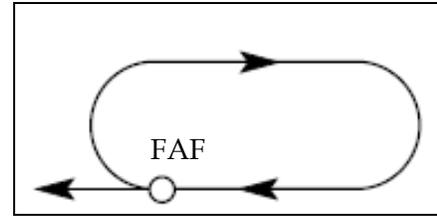
Figure 1. Race-track pattern

This type of pattern is usually done from a FAF (see Figure 1). When flying over the FAF, the aircraft turns and usually travels for one or two minutes on an outbound course parallel to the final approach path. It then turns approximately 180° again to intercept the final path. It is only by passing abeam of the FAF on the outbound course that the aircraft can descend to the minimum procedure turn altitude in order to maintain the minimum obstacle clearance. In the case of this occurrence, the crew descended to the procedure turn altitude once the aircraft passed abeam of the CHIBOO NDB, placing the aircraft 400 feet below the minimum sector altitude (MSA).

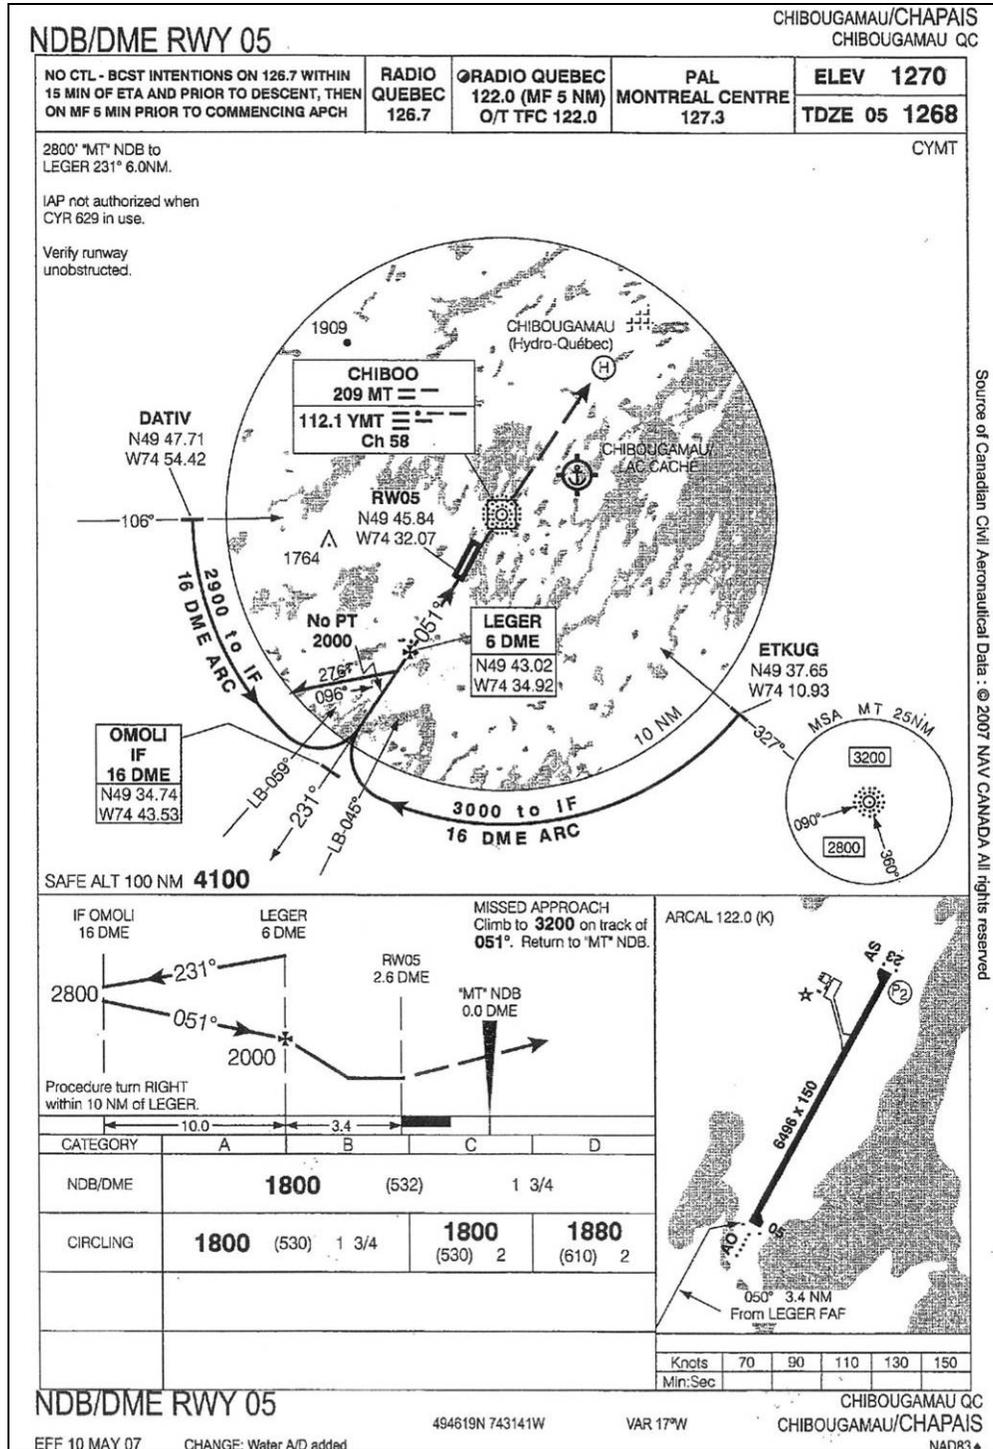
Appendix A – NDB/DME RWY 05 approach for Chibougamau/Chapais

The MDA published for the NDB/DME approach for Runway 05 is at 1800 feet asl, or 532 feet agl, and visibility at 1¾ miles. Because the weather conditions indicated a ceiling of 700 feet agl and visibility of two miles, an instrument approach was permitted according to regulations. The published NDB/DME 05 approach for Chibougamau/Chapais indicates an inbound course of 051° magnetic whereas the runway's orientation is 045° magnetic. This difference of six degrees means that the aircraft would not be directly in line with the runway centreline on final. The crew therefore had to expect to realign the aircraft with the runway centreline before landing.

The CHIBOO beacon was not the FAF for Runway 05. This could have caused confusion regarding the altitude at which it was permissible to descend. Consequently, on its return for a second approach, the flight crew did a race-track pattern using the CHIBOO beacon and descended to 400 feet below the safe obstacle clearance altitude, increasing the risk of a CFIT. In addition, the risk of conflict with the other aircraft was increased because the crew of the other aircraft expected the published altitudes to be followed. As a result, the two aircraft passed abeam in opposite directions with a distance of 1000 vertical feet and a horizontal distance of 3.1 nm between them without either crew being aware of this fact.

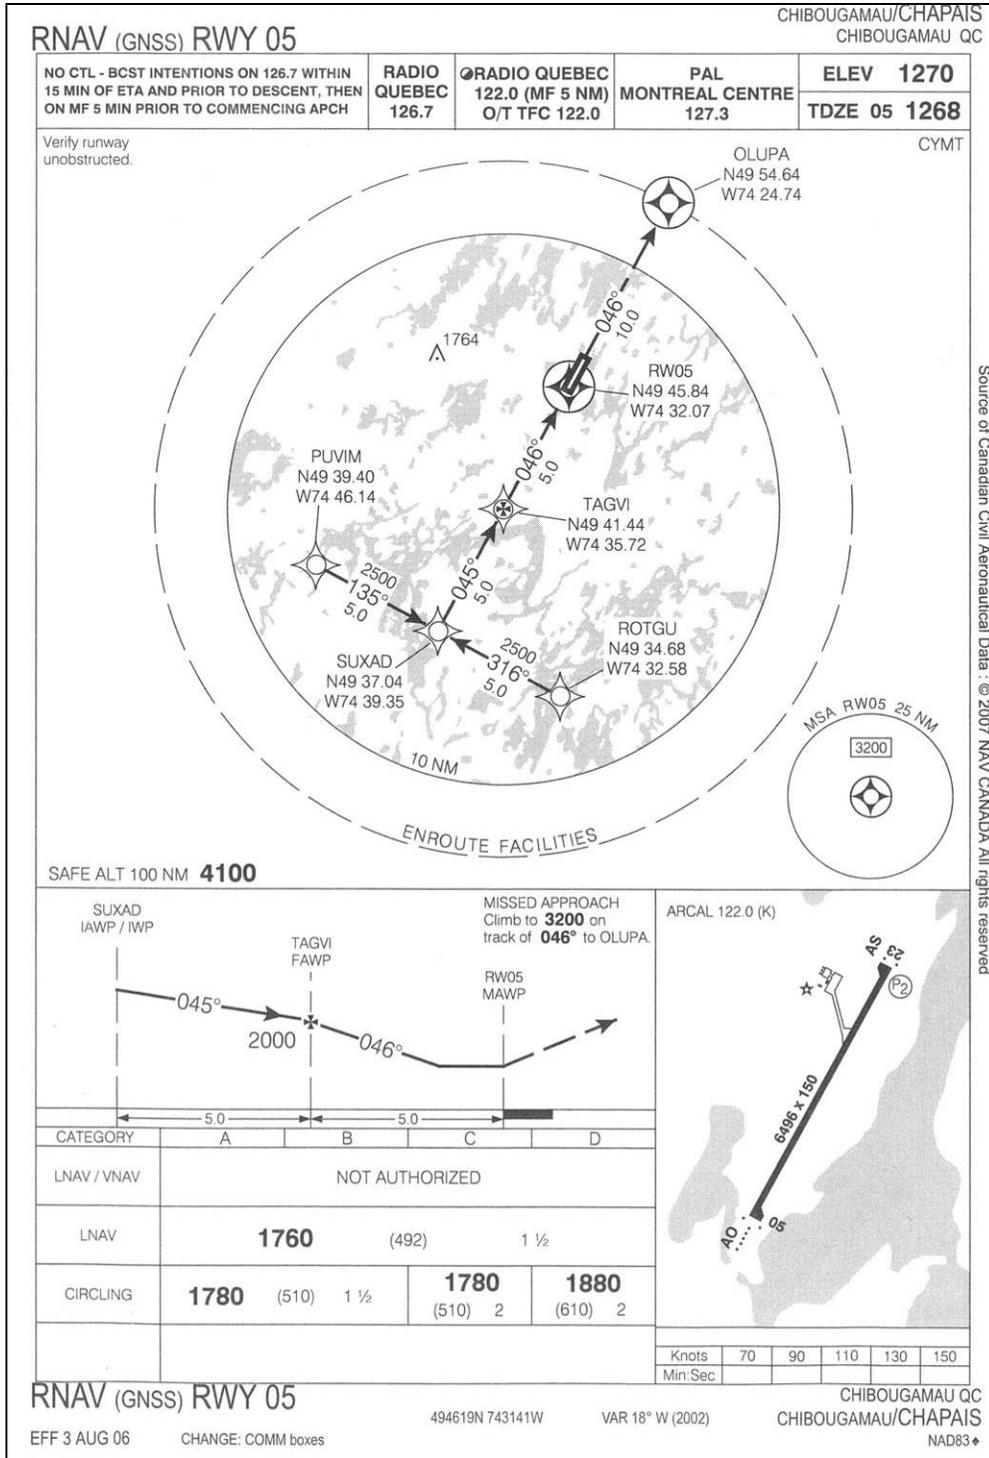
Appendix B – RNAV (GNSS) RWY 05 approach for Chibougamau/Chapais

Despite the briefing for the NDB/DME 05 approach, the pilot-in-command started programming the RNAV (GNSS) 05 approach (see Appendix B) in one of the GPSs. The investigation could not determine which GPS was used. Neither of the pilots was authorized nor trained to use the GPS as a primary source of navigation for an instrument approach. The programming was done during the descent over a period of about nine minutes. It was abandoned at about 15 nm from the runway threshold. At that time, the aircraft had a ground speed of about 210 knots and the crew had not started the aircraft's approach configuration. The approach configuration was obtained when passing final approach fix (FAF) LEGER and the pre-landing checklist was completed when the aircraft was about 2 nm from the Runway 05 threshold. According to the standard operating procedures (SOPs), these actions must be completed when the final inbound course is intercepted before passing the FAF.

The RNAV (GNSS) 05 approach made by the other aircraft, Propair 102, shows that a course of 046° magnetic and an MDA was established at 1760 feet asl, or 492 feet agl. Although this approach is considered a non-precision approach, like the NDB/DME approach, using a GPS and the approach design offer greater precision for alignment with the runway centreline. The crew of Propair 102 benefited from this and the aircraft landed without difficulty on Runway 05 about seven minutes after the go-around by CRQ 501.
