AVIATION INVESTIGATION REPORT
A09C0012

COLLISION WITH TREES ON MISSED APPROACH

SKY NORTH AIR LTD.
BEECH 100 C-GNAA
ISLAND LAKE, MANITOBA
16 JANUARY 2009

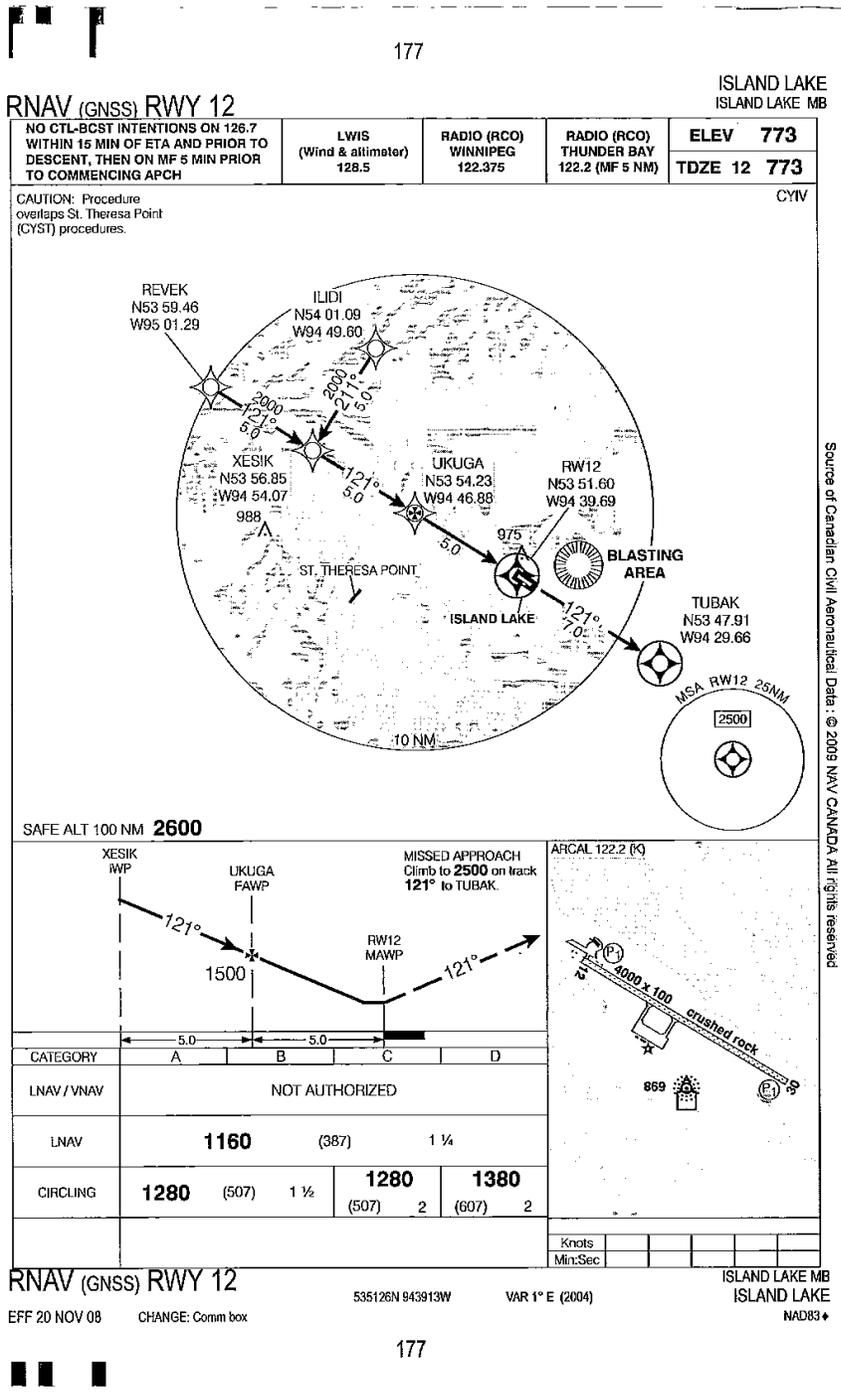
Appendix A – RNAV Approach Runway 12 Island Lake

There are three published instrument approaches at the Island Lake airport: a NDB approach to Runway 30; an Area Navigation (RNAV) approach to Runway 30; and a RNAV approach to Runway 12 (See Appendix A - RNAV Approach Runway 12 Island Lake). The wind and direction of flight were favouring Runway 12. Prior to commencing descent, the pilots decided that a straight in RNAV 12 instrument approach would be their best choice to avoid the NDB Runway 30 approach.

Descending 300 feet below the published MDA, all obstruction clearance protection provided by the RNAV 12 approach was removed. There was no single factor identified that caused the first officer to descend below the MDA, or to prevent the captain from making the required calls. There were a number of lapses, errors and adaptations which, when combined, resulted in the mismanaged approach.

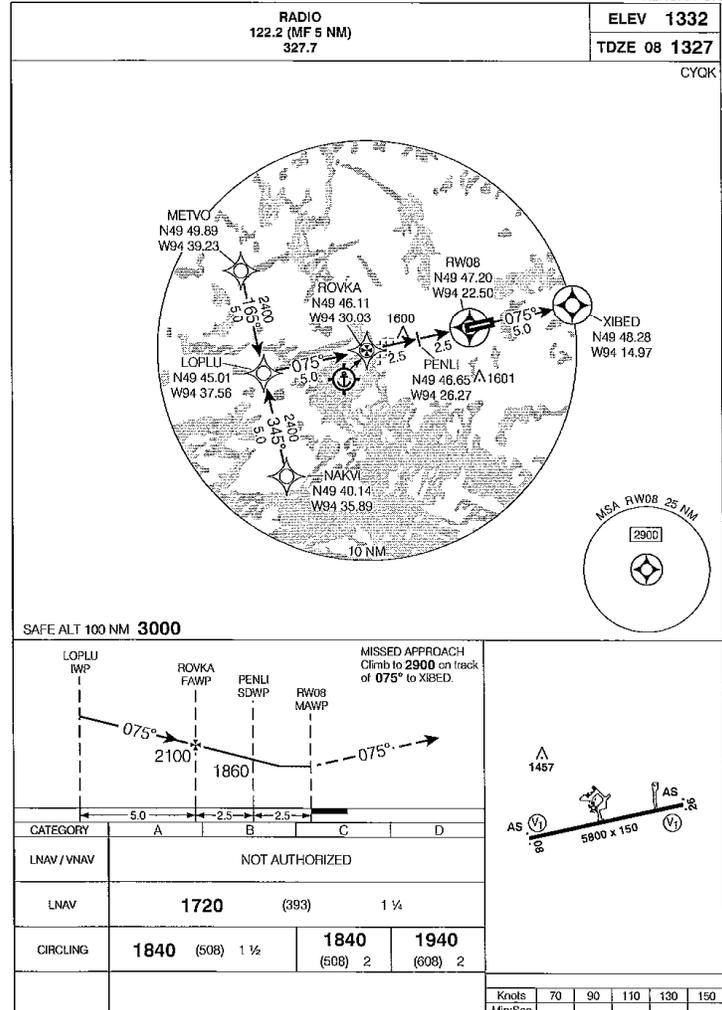
Appendix B – RNAV Approach Runway 08 Kenora

In the course of this investigation, a review of RNAV approaches in Canada revealed that some incorporate step-down fixes between the Final Approach Fix (FAF) and the missed approach waypoint (MAWP) (see Appendix B - RNAV Approach Runway 08 Kenora). Step-down fixes are used where hazardous terrain or obstacles exist between the FAF and the MAWP. While they are displayed on approach procedures charts, not all step-down fixes are contained in GPS databases and, as such, may not be depicted on the cockpit navigation displays.

Note: In the preceding diagram PENLI is a step down fix at 2.5 nm from the runway threshold. Descent must be arrested at 1860 feet until reaching PENLI at 2.5 nm. However PENLI is not contained in most GPS data bases, and is therefore not pictorially displayed in the GPS.
