**AVIATION INVESTIGATION REPORT
A09P0397**

LOSS OF CONTROL - COLLISION WITH WATER

**SEAIR SEAPLANES LTD.
DE HAVILLAND DHC-2 MK 1 (BEAVER) C-GTMC
LYALL HARBOUR, SATURNA ISLAND, BRITISH COLUMBIA
29 NOVEMBER 2009**

Report Number A09P0397

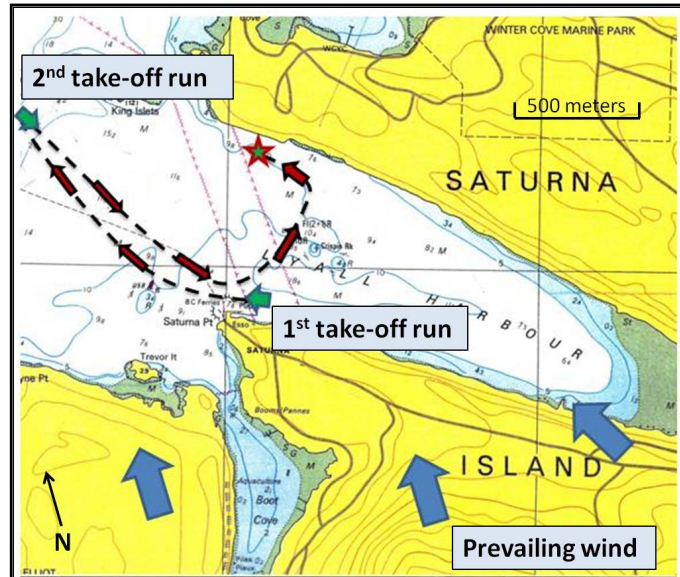
Figure 1. Lyall Harbour with Flight Route and Winds

Around the time of the accident, the wind was of particular significance in Lyall Harbour. While local recordings showed the wind direction varying from 082° to 165° true, it was estimated to be generally from the southeast at 18 knots with gusts to 26 knots. With the winds from the southeast, the area used by floatplanes is in the lee of high terrain on the island (see Figure 1). These conditions are conducive to the creation of mechanical turbulence and mountain waves.

Floatplane pilots departing Lyall Harbour typically take off in a westerly to northwesterly direction, which offers an unobstructed flight path and a more favourable route to Vancouver. After unsuccessfully trying to take off in a northwesterly direction (downwind), the pilot turned the aircraft into the wind and took off towards Lyall Harbour (see Figure 1).

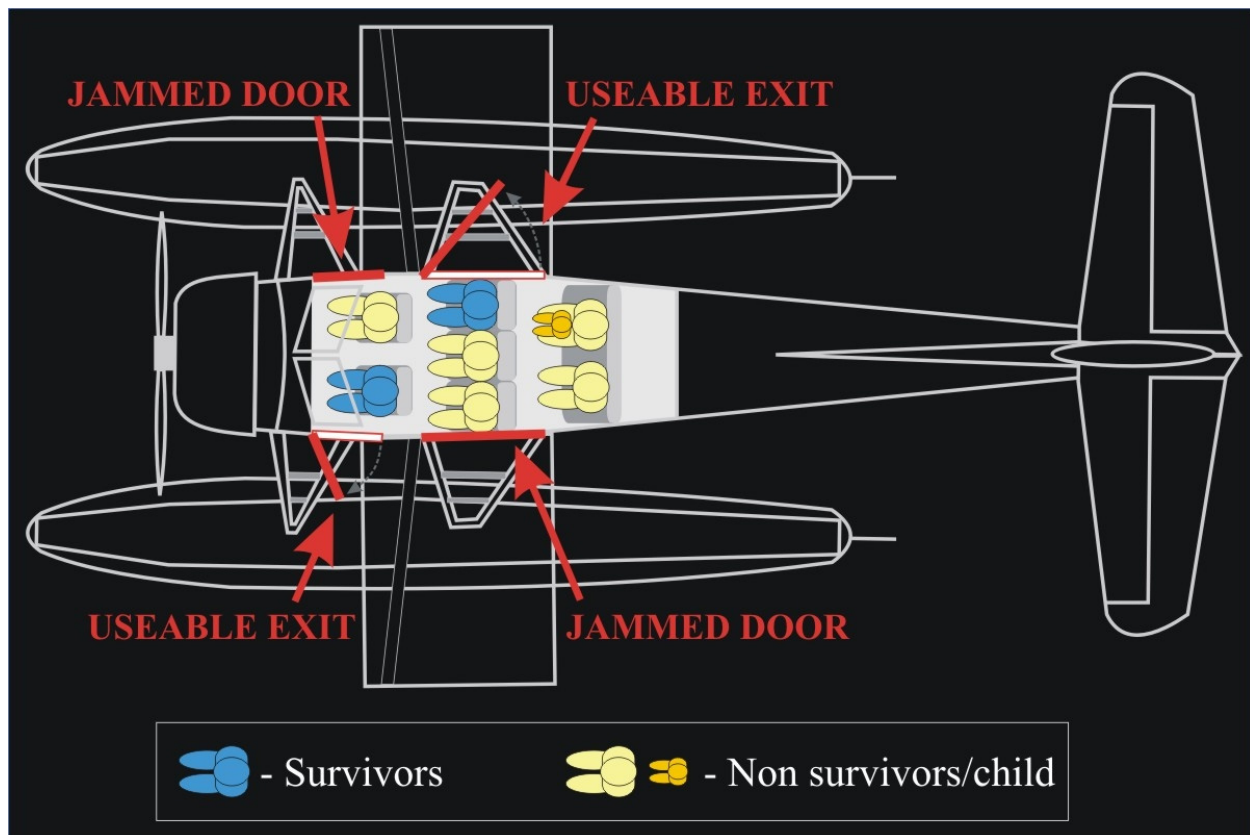
Figure 2. Seating Configuration and Egress Points

Rescue divers found the aircraft in 14 meters of water in a nose-down, tail-up position. The right cabin and left cockpit doors were both open. The right cockpit and left cabin doors could not be opened.

Four adult passengers had their seat belts undone. They were unable to exit the aircraft and drowned. The seating configuration is shown in Figure 2, which also indicates the useable and jammed doors.

In this occurrence, the aircraft was not equipped with jettisonable doors or windows. As a result, the only possible egress points were the 4 doors on the aircraft. However, impact damage jammed 2 of the 4 doors and restricted egress from the sinking aircraft, which meant all 7 passengers and the pilot would have had to exit via 1 of 2 usable egress points. Rather than deliberately attempting to open a door, the surviving passenger exited through the door that had opened as a result of impact forces. It is likely that the pilot's recent egress training contributed to him being able to open the door and escape from the aircraft. The lack of alternate emergency exits, such as jettisonable windows, increases the risk that passengers and pilots will be unable to escape a submerged aircraft due to structural damage to primary exits following an impact with the water.

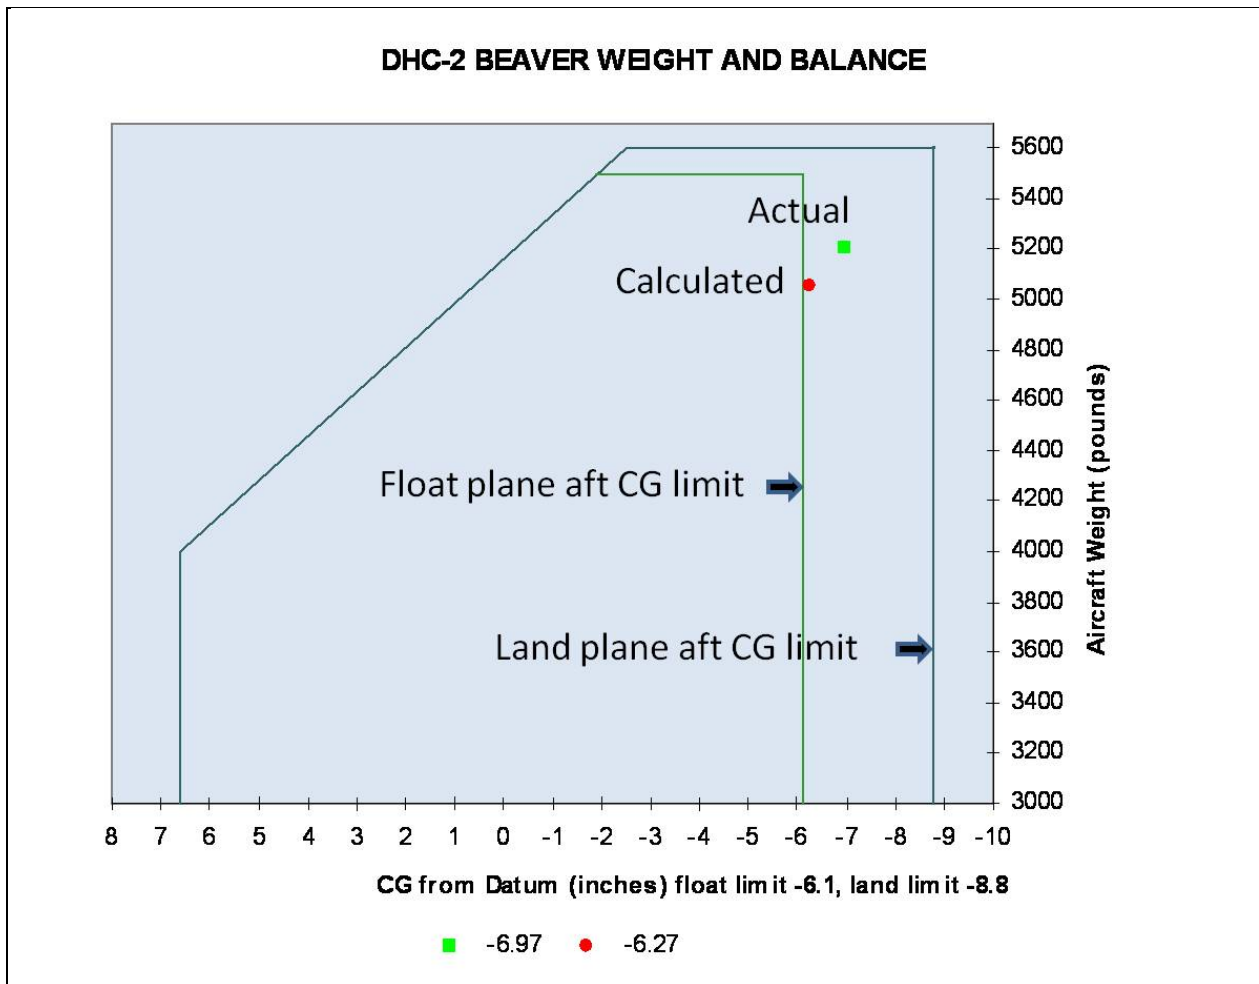
Appendix A - Weight and Balance Graph

Using the same data, TSB investigators initially calculated the CG to be at -6.27 inches (shown in red in Appendix A). The baggage was then dried and was found to weigh 214 pounds.⁶ The aircraft's actual weight and balance at the time of takeoff was 5204 pounds (296 pounds below the maximum gross takeoff weight) and -6.97 inches (0.87 inches aft of the aft CG limit and shown in green in Appendix A).
