**AVIATION INVESTIGATION REPORT  
A11A0035**

**RUNWAY OVERRUN**

**KELOWNA FLIGHTCRAFT AIR CHARTER LTD.  
BOEING 727-281, C-GKFJ  
ST. JOHN'S, NEWFOUNDLAND AND LABRADOR  
16 JULY 2011**

Report Number A11A0035

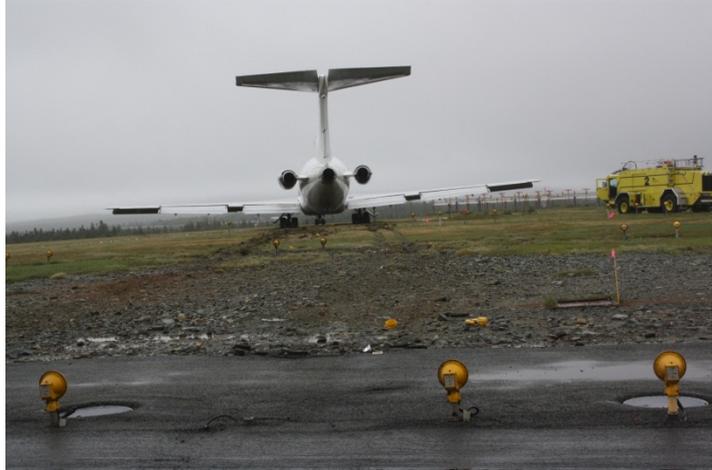
**Photo 1.** C-GKFJ in overrun area

The main landing gear doors, lower fairings, bottom surface of the aft inboard flaps, and aft lower fuselage had multiple dents and several punctures due to debris being thrown rearward from the main gear tires when the aircraft departed the runway surface. Engine number 1 inlet area was coated with dried mud and the low pressure compressor was damaged from ingesting debris. All 4 brakes had dirt and stones trapped within them, and the 4 main gear tires had multiple cuts, scrapes and patches of reverted rubber around their periphery. Both inboard tires also had large flat spots where the tire rubber had melted. While the aircraft was travelling through the overrun area, the 2 inboard tires burst at these flat spots. The aircraft came to rest with both of the flat spots against the ground.

The 2 inboard tires were hydroplaning, as evident by the steam cleaning marks, just before they departed the runway. Rubber debris, consistent with skidding tires, was noted on the asphalt portion of the runway end and the path that the 2 inboard tires left through the overrun area

had multiple scuffed rocks with imbedded rubber residue and rubber debris. Additionally, the sod was torn up in numerous locations and the grass remained flattened along the path. The grass in the path of the 2 outboard tires remained upright and the sod was less damaged.

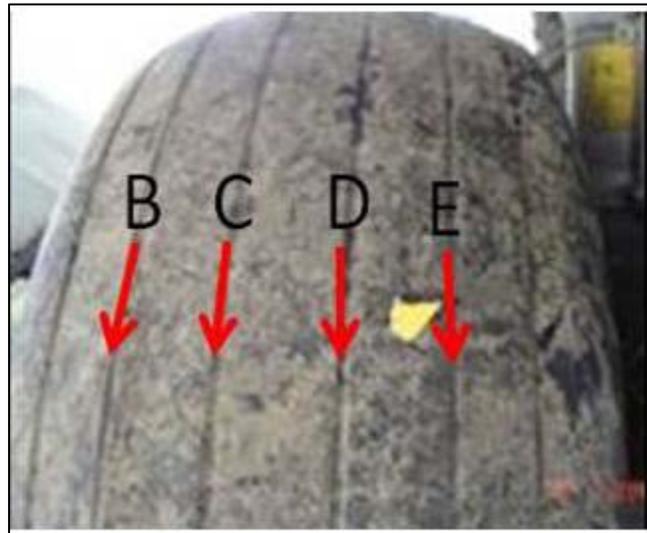
Photo 2. Tire groove indication

The TSB measured the remaining tire tread depth at each of the tire’s circumferential grooves<sup>8</sup> (Photo 2). The average tread depth was determined by taking measurements at 12-inch intervals and dividing by the number of measurements

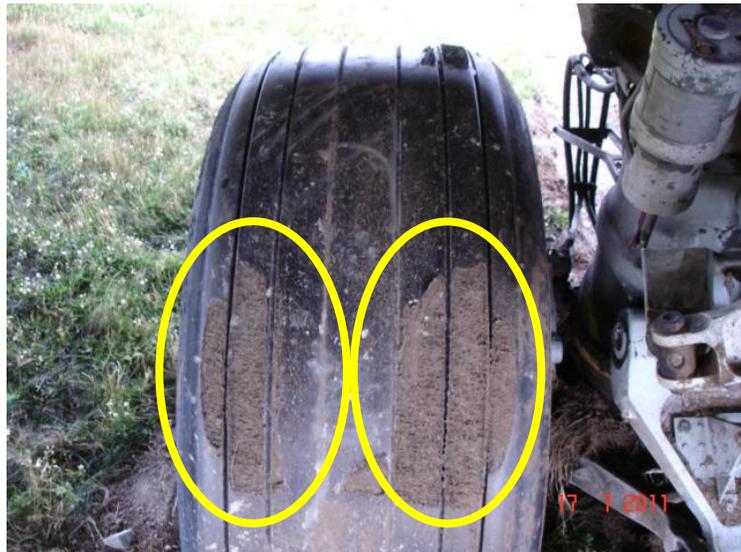
Photo 3. No. 2 tire

original uncured state (revert). Only this type of hydroplaning produces a clear mark on the tire tread in the form of a burn, i.e. a patch of reverted rubber (Photo 3).

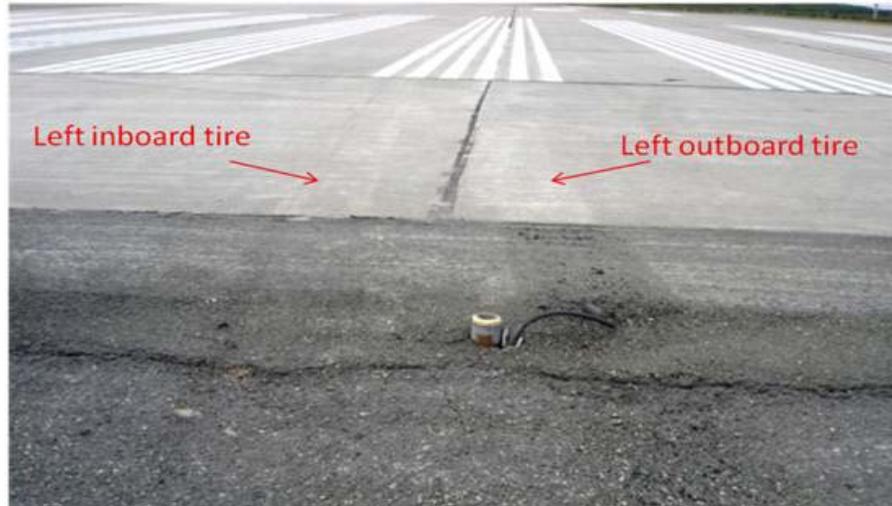
Signs of reverted rubber hydroplaning were observed on all 4 main tires. Numerous steam-cleaned marks from all 4 main wheel tires were observed on the runway (Photo 4) including about 2000 feet of marks made by the 2 left main landing gear tires when the aircraft was left of the runway centerline.

**Figure 4.** Steam-cleaned marks

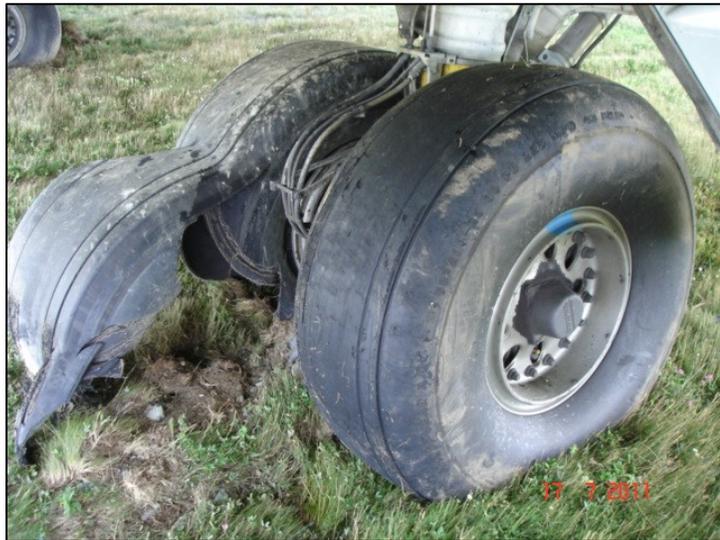
The TSB calculated the wear, based on initial retread depth of 0.43 inches and the average tread depth remaining, on the occurrence aircraft's No. 1 tire to be about 65%, No. 2 tire about 90%, and the No. 3 and No. 4 tires were in excess of 95% worn (Photo 5).

**Photo 4.** Tires 3 and 4
