AVIATION INVESTIGATION REPORT

A12W0088

LOSS OF CONTROL AND COLLISION WITH TERRAIN

ROBINSON HELICOPTER R44 II, C-GHZN

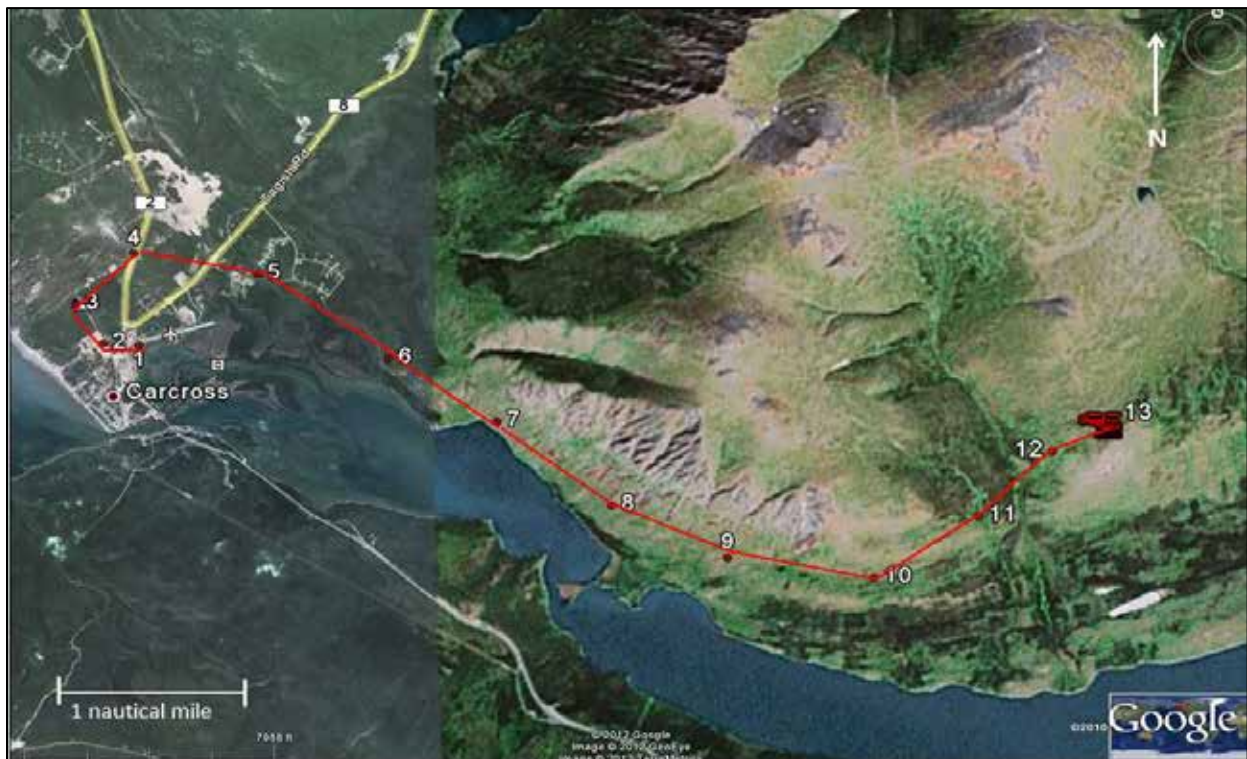
Figure 1. GPS track log for C-GHZN

The flight departed at 0853 ¹ and reached the first site at 0917, and visited another 9 sites in the region west of Carcross before stopping for fuel at 1148. At 1210, the helicopter departed the refuelling site, and proceeded to 9 more bait sites northwest and southwest of Carcross. Throughout the day, high winds prevented them from inspecting some sites at higher elevations. At 1442, the aircraft, registration C- GHZN, landed at Carcross and refuelled. Due to high winds, the pilot indicated that they would inspect as many of the outstanding sites as they could on the flight back to Whitehorse. The helicopter departed Carcross at 1501 for the final leg of the day, proceeding to a site east of Carcross. The flight followed the north shore of Tagish Lake and approached the wildlife survey site from the west. The pilot had been at this site numerous times in the past. The last GPS target² was recorded at 1507 (Figure 1).

² Numbers in Figure 1 are recorded GPS targets.

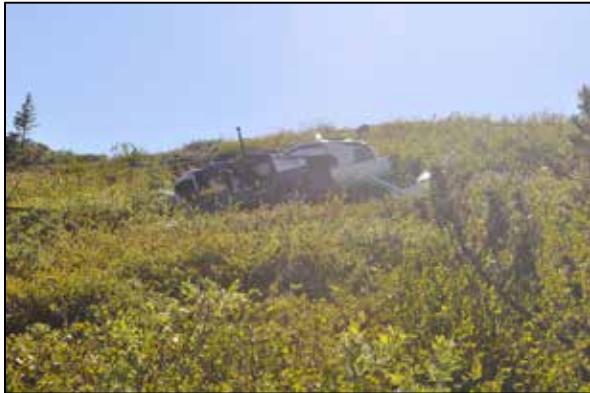
The investigation determined that the pilot overflew the site from the south and proceeded to turn 180° to the right. The helicopter then slowed to a hover, and began descending over the east side of the crest. Moments later, the helicopter experienced a gust of wind from the west, which caused it to drift to the left towards the eastern slope (lee side) of the crest. The helicopter then began an uncontrolled vertical descent. During this descent, the low rotor revolutions per minute (rpm) warning sounded and the main rotor tachometer dropped from 99% to 63%. The helicopter impacted the eastern side of the slope on the right-hand skid then rebounded down the slope before coming to rest nearly inverted on its left-side roof (Photos 1 and 2).

Photo 1. Accident site, view to west

The wreckage left impact scars on the ground, indicating an upright impact on the sloping terrain.³ The slope ran upwards to the right of the helicopter's right side. After impact, the fuselage bounced once and rolled to the left. The main fuselage came to rest at the same angle as the slope of the hill. The doors both appeared to have come off at impact. There was a transponder antenna, originally installed in the belly of the fuselage, embedded in the ground, indicating the exact place and attitude at impact. The right-side skid gear was broken off at the fuselage due to upward impact forces.

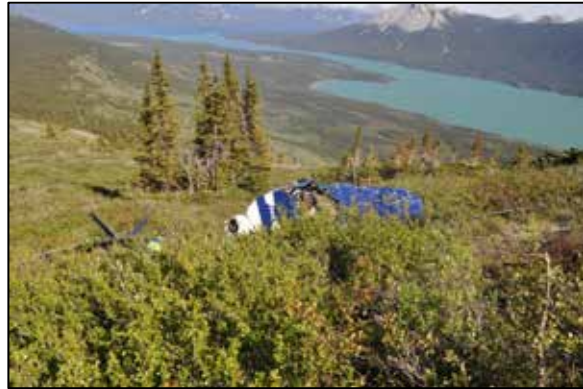
Photo 2. Accident site, view to east-southeast
