**AVIATION INVESTIGATION REPORT
A13F0011**

CONTROLLED FLIGHT INTO TERRAIN

**KENN BOREK AIR LTD.
DE HAVILLAND DHC-6-300 TWIN OTTER C-GKBC
MOUNT ELIZABETH, ANTARCTICA
23 JANUARY 2013**

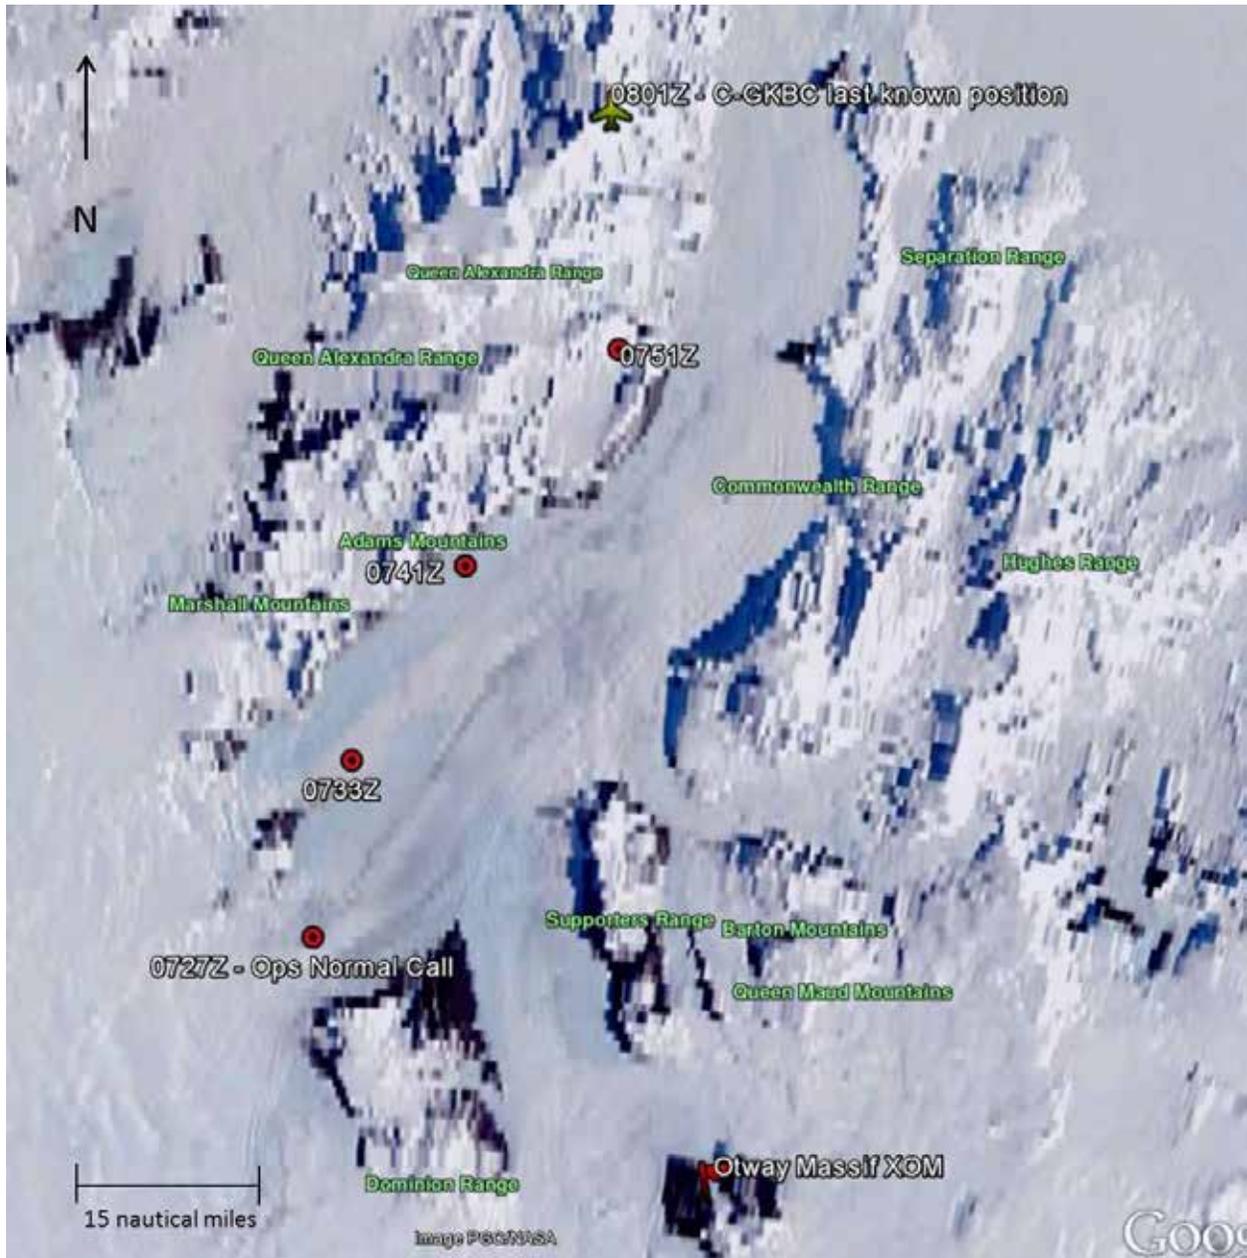
Figure 2. Route of C-GKBC in last minutes of the occurrence flight (Image: Google Earth with TSB notations)

Information recovered from the SkyTrac ISAT-100 tracking unit enabled the investigation to reconstruct C-GKBC's route. The reconstruction did not indicate any aircraft performance anomalies. Flight track, altitude, and ground speed remained relatively constant throughout the flight. At 0749, C-GKBC initiated a turn to the left that would have led directly to Terra Nova, but the aircraft's altitude was insufficient to clear Mount Elizabeth.

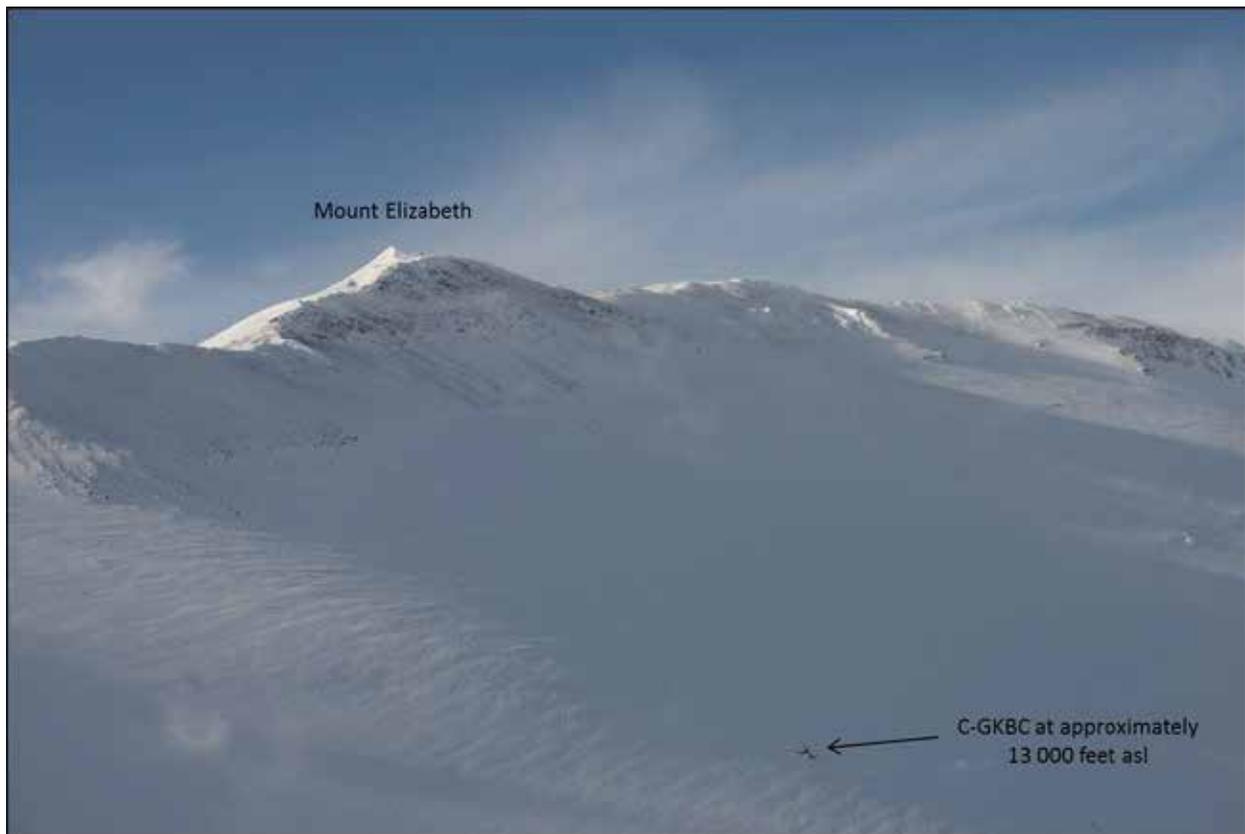
Photo 1. Wreckage of C-GKBC at about 13 000 feet asl on Mount Elizabeth, looking north (Photo: Alasdair Turner Photography)

On 27 January 2013 a search and rescue (SAR) team was positioned, via helicopter, on a ridge approximately 1000 feet above the accident site. The crash site was located at about 13 000 feet asl on a steep slope (Photo 1 and Photo 2). The crash area exhibited signs of crevasses and avalanche activity.

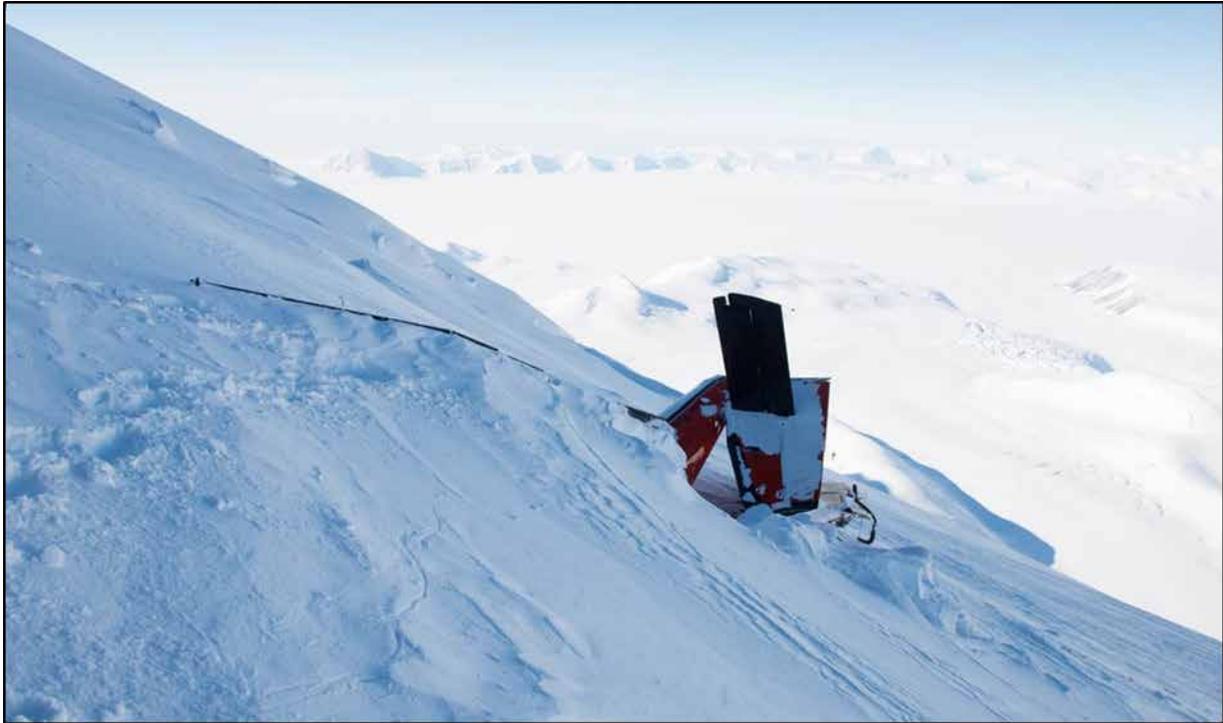
The cockpit voice recorder (CVR) and a satellite tracking unit were recovered from the tail section of the aircraft, which was exposed above the ice and snow. The aircraft was equipped with long-range ferry fuel tanks, which had crumbled on impact and blocked access to the cabin

area. Fuel was observed to be leaking inside the aircraft. The roof of the aircraft had collapsed into the cabin. The cabin was filled with, and surrounded by, packed snow.

Photo 2. Wreckage of C-GKBC at the occurrence site, looking southeast (Photo: Alasdair Turner Photography)
