AIR TRANSPORTATION SAFETY INVESTIGATION REPORT A17Q0030

MID-AIR COLLISION

Cargair Ltd., Cessna 152, C-GPNP

Cargair Ltd., Cessna 152, C-FGOI

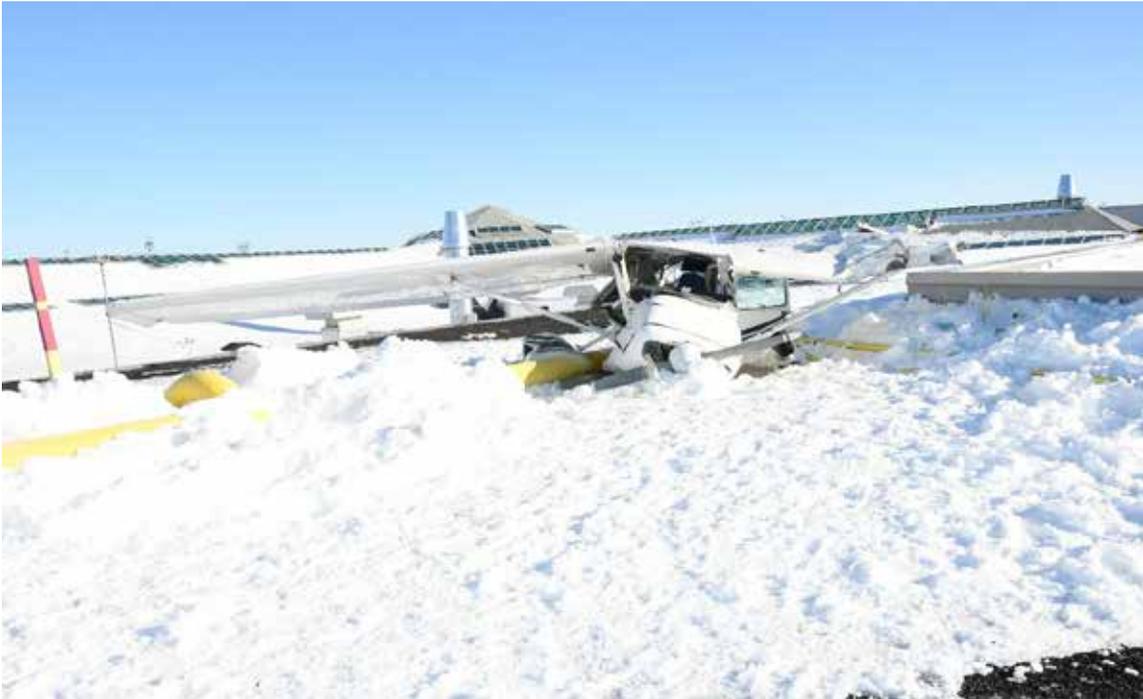
Figure 4. Wreckage of C-GPNP (Source: Service de police de l'agglomération de Longueuil)

C-GPNP was substantially damaged by the collision, which caused the outboard section of the left wing and the empennage to separate from the rest of the aircraft. There was no post-impact fire.

The main wreckage of C-GPNP was found on the roof of the Promenades St-Bruno shopping mall, in an upright and approximately level attitude, on top of a yellow gas line (Figure 4). At the time of the occurrence, the roof was covered in snow due to a heavy snowstorm 2 days earlier. There were no signs that the aircraft had skidded in the snow or struck any other area of the roof.

The outboard section of the left wing had separated from the aircraft and was found on the roof approximately 249 feet from the main wreckage, indicating that the separation had occurred in the air. The aft section of the fuselage and empennage had separated from the aircraft and were found embedded in C-FGOI's wreckage, also consistent with an in-air separation.

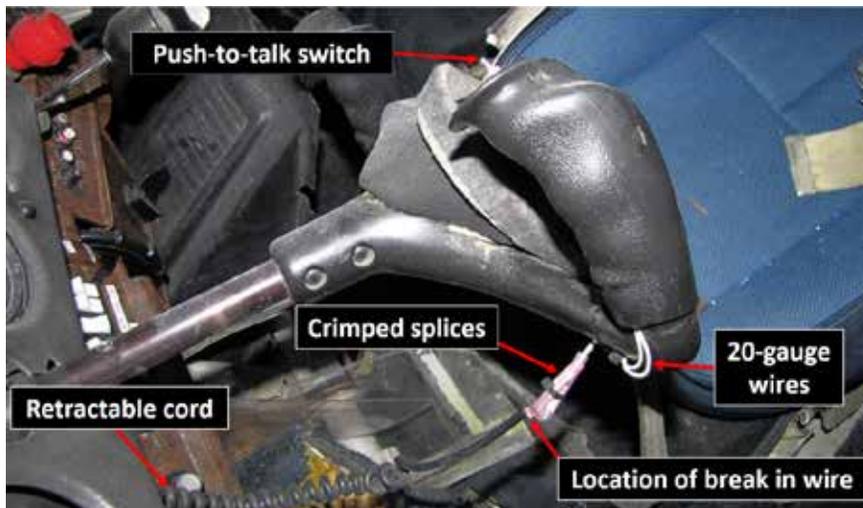
Figure 6. C-GPNP's push-to-talk switch installation

The aircraft's NAV/COM VHF transmitter/receiver and accompanying intercom system were examined for defects to determine the cause of the intermittency of the radio's transmissions. The pilot side of the cockpit was fitted with a headset, which was slipped over the aircraft's control yoke and included the intercom's PTT switch at the top. Tests conducted on the pilot PTT switch showed that it was necessary to depress the switch twice for the radio to be triggered into transmission mode. Further, movement of the control yoke caused transmissions to be intermittent.

The examination found that the retractable cord connecting the switch to the intercom was routed through terminals at the back of the pilot-side microphone and headset jack panel. Further examination of the PTT switch revealed a defect that originated from pre-existing crimped wire splices located just forward of the control yoke. The splices connected the wires running from the grip of the control-yoke headset to those in the retractable cord (Figure 6). The wire splices and adjoining wires were unsupported and had been left to hang, and were therefore bearing all motion and tension loads. The retractable cord was not secured to the control yoke.

The examination of C-GPNP's radiocommunication system demonstrated that the pilot-side (left) push-to-talk (PTT) switch had to be depressed twice to key the radio into transmission mode, and that movement of the control yoke caused transmissions to be intermittent. This was found to originate from pre-existing wire splices located just forward of the control yoke.

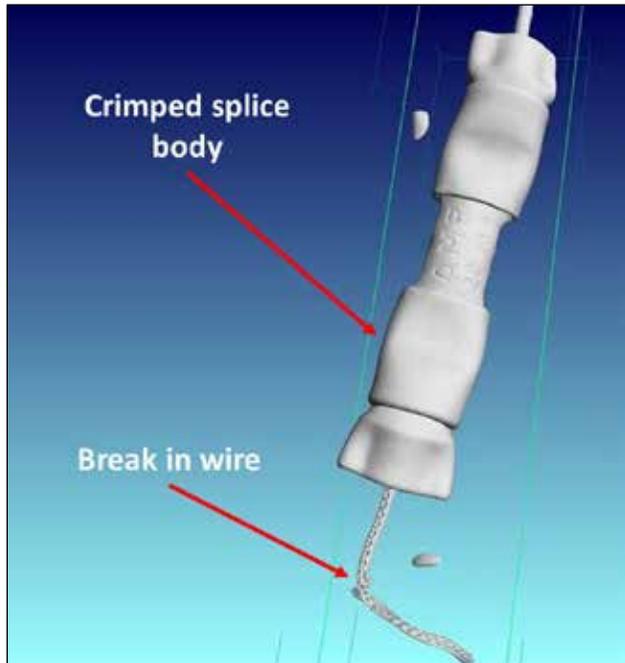
Figure 7. Computed tomography scan view of the broken wire

It was determined that the intermittency of the radio's transmissions was likely caused by the break found in one of the wires of the retractable cord, adjacent to the crimped splice. A detailed examination of the broken wire identified distinct necking (a localized narrowing resulting from reduction in the strand cross-section) at the location of the break. Necking at the point of a rupture is seen when wires have failed in overload due to disproportionately applied tensile loads (Figure 7 and Figure 8).

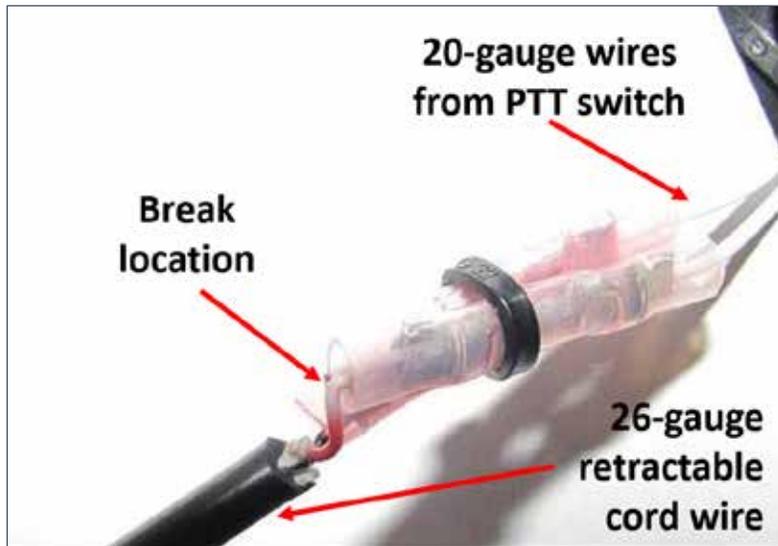
Figure 8. Detailed view of location of break in wire

Further examination revealed a break in a wire within the retractable cord of the pilot's PTT. It was also determined that the support provided to the wire splices and adjacent wires was inadequate for their location and intended use, and likely contributed to the break. A broken wire caused the PTT keying signal on C-GPNP's radiocommunication system to transmit intermittently prior to entering the control zone and immediately preceding the collision.

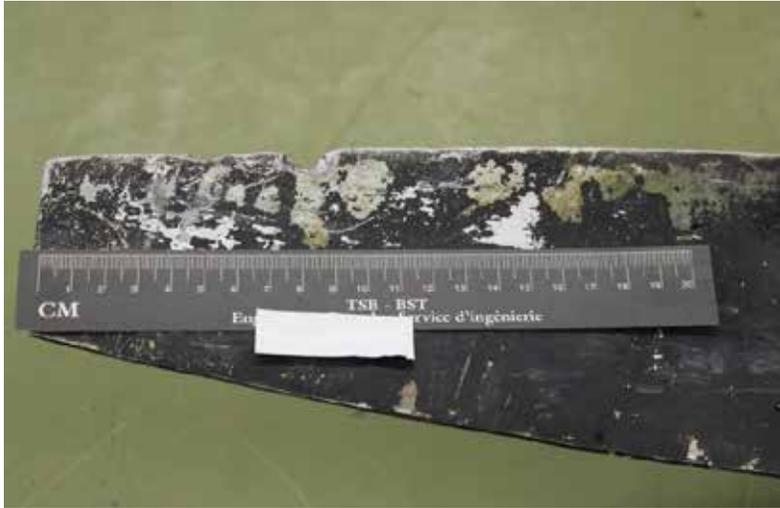
Figure 9. Impact dents on blade 1 of C-FGOI's propeller

Examination of C-FGOI's 2-bladed propeller showed impact dents on the leading edges of both blades, near their tips. The dents were consistent with the propeller blades cutting through a strong structure, such as the lower cap of C-GPNP's left-wing rear spar (Figure 9 and Figure 10).

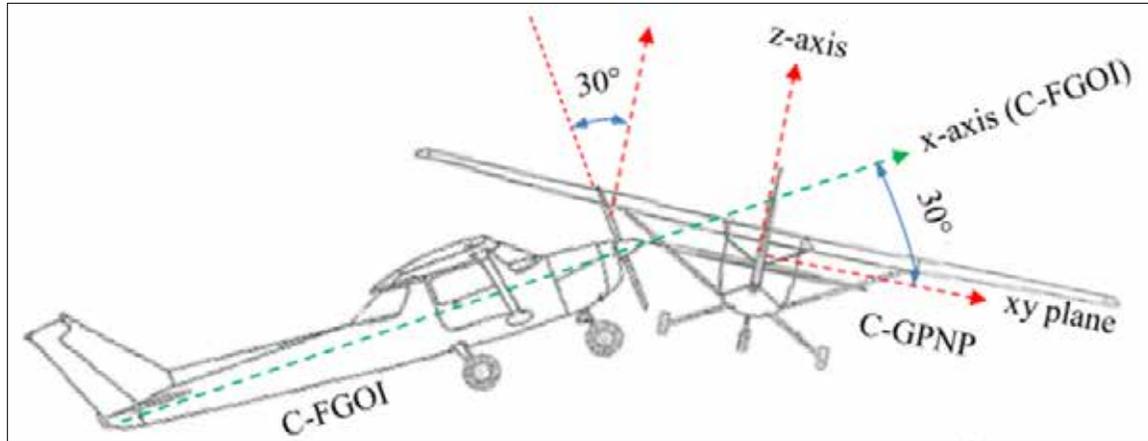
Figure 11. Illustration of the geometric relationship between the angle of the cut to C-GPNP's wing and the comparative attitudes of the 2 aircraft (relative to C-GPNP's z-axis)

Further analysis established that C-FGOI was likely pitching nose-up while C-GPNP made a right banking turn in an effort to avoid the collision (Figure 11).
