Air Transportation Safety Investigation Report A17P0149

LOSS OF CONTROL AND COLLISION WITH TERRAIN

ASAP Avionics Services Ltd.
Robinson R44 Astro, C-FMBO
Campbell River, British Columbia
01 October 2017

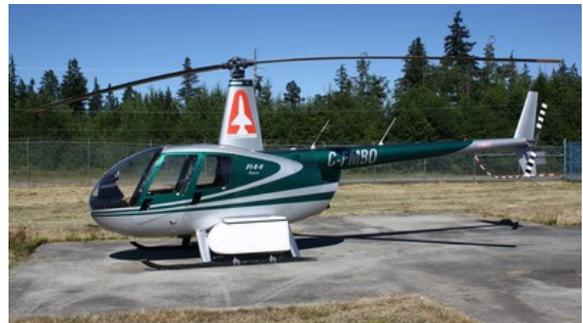
Figure 1. C-FMBO (Source: Willy Dahmen)

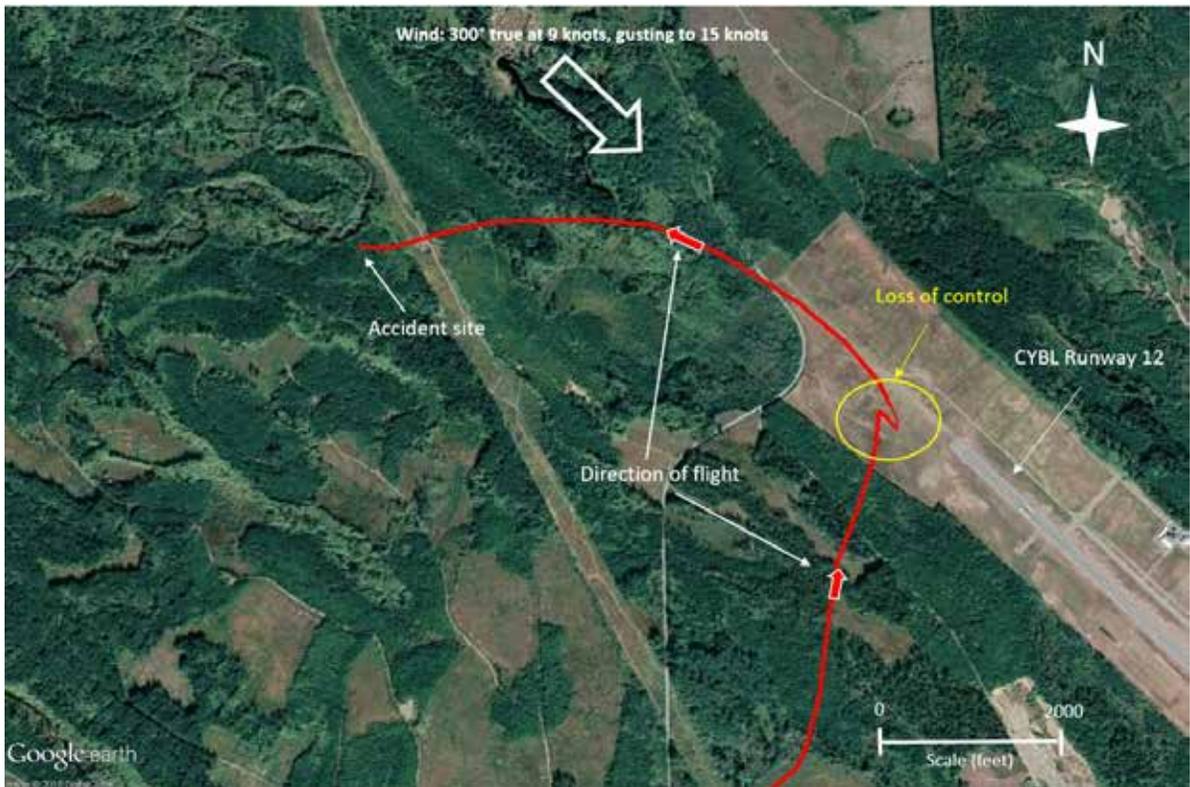
At approximately 1555, the helicopter collided with trees about 1.2 nm northwest of Runway 12. The damage to the helicopter, trees, and terrain indicated that the aircraft had been on a relatively level flight path when it first struck the trees. It had then pitched to a steep nose-down attitude and struck the ground in a vertical profile. Analysis of the wreckage indicated that the rotor had been turning during the first impact with the trees and was still turning, though at a slower rate, on final impact with the terrain. After coming to rest, the helicopter's engine continued to run for an undetermined period. The left-seat pilot was fatally injured, and the right-seat pilot was seriously injured. The helicopter was destroyed. There was no post-impact fire.

Figure 2. Depiction of C-FMBO's flight path based on aircraft global positioning system data, showing the approach to CYBL, the area where the loss of control occurred, and the accident site (Source: Google Earth, with TSB annotations)
