AVIATION INVESTIGATION REPORT

A17Q0050

Collision with wires

Piper PA-31, C-FQQB

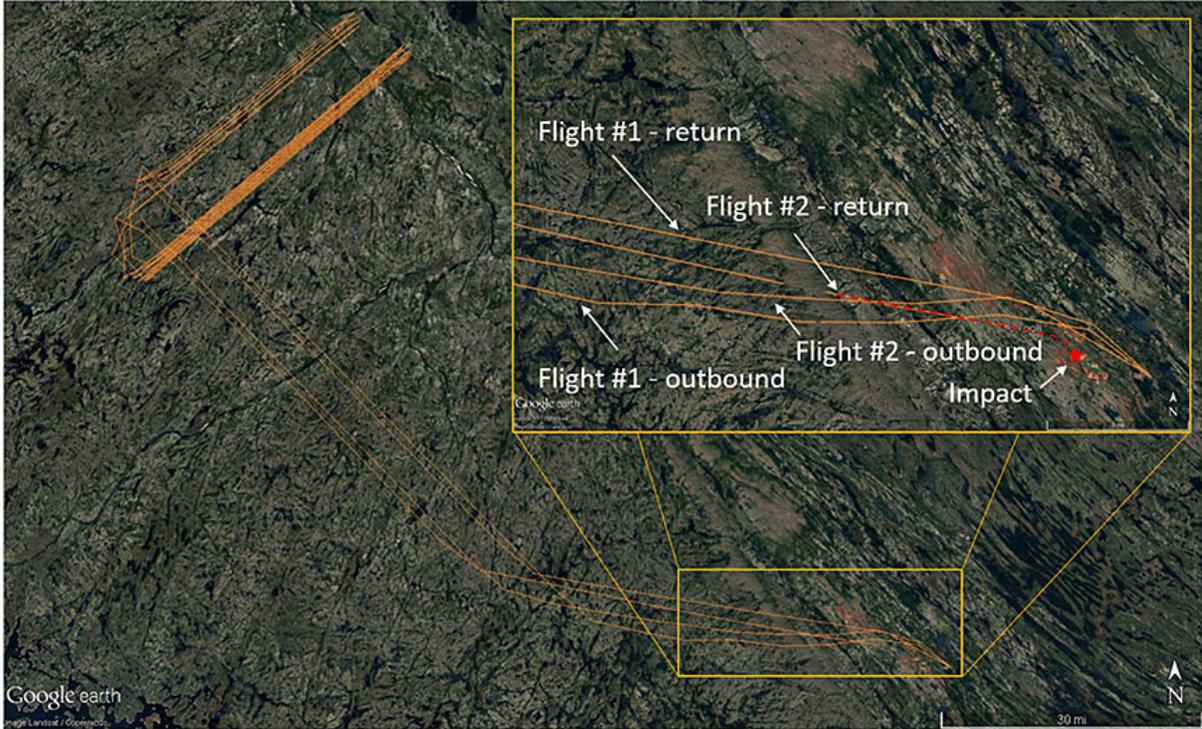
Figure 2. The 2 flights conducted by C-FQQB on the day of the accident, with detail showing the very-low-altitude flight segments (Source: Google Earth, with TSB annotations)

Over a period of 19 days before the accident, the pilots had conducted 21 magnetometric survey flights at low altitude. During these flights, analysis of GPS data shows that the occurrence pilots had conducted 27 segments of flights involving very-low-altitude flying (less than 100 feet AGL) during round trips without incident (Figure 6).

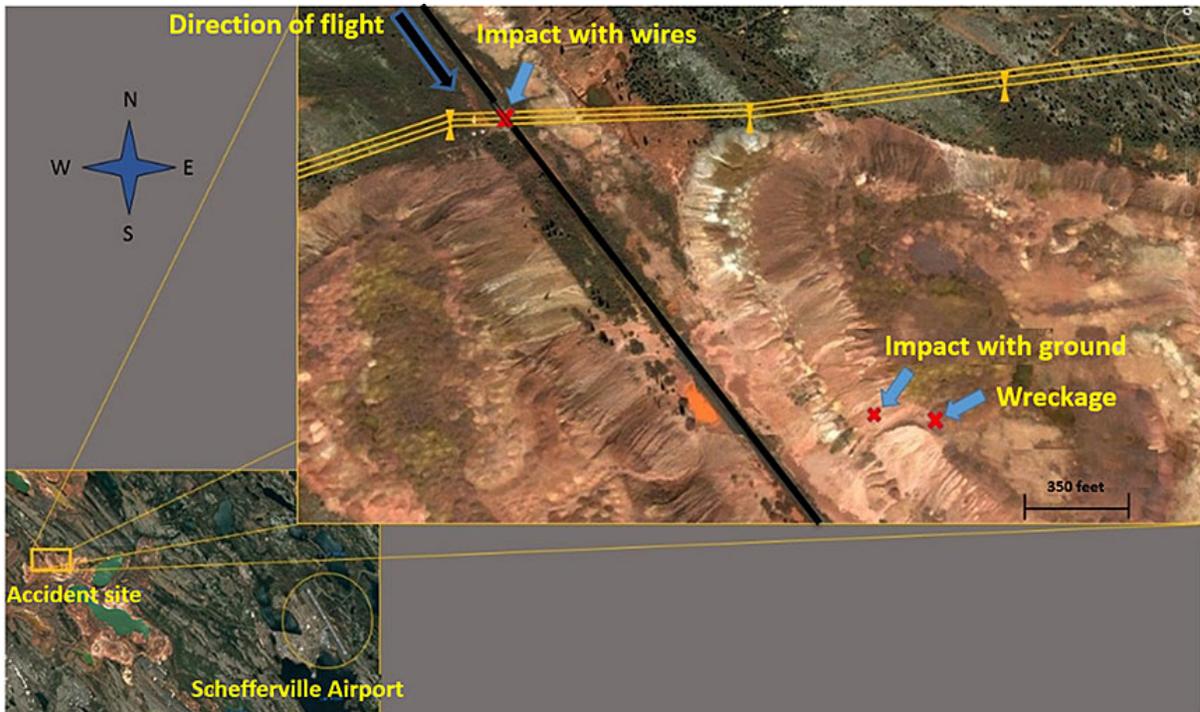
Figure 3. Accident site details (Source: Google Earth, with TSB annotations)

The 69 kV auxiliary power transmission line that was severed by the aircraft is operated by Hydro-Québec.¹⁰ At the point of impact, the line crosses the railway tracks at a height of 70 feet and an angle of approximately 45°. The segment of the severed wires spanned 944 feet and was suspended between 2 wooden structures (pylons) that supported the 3 conductor cables, which were 0.56 inches in diameter and composed of 6 aluminum strands and 1 steel strand. At the time of the accident, the cable was subject to a failure analysis and was therefore not energized.

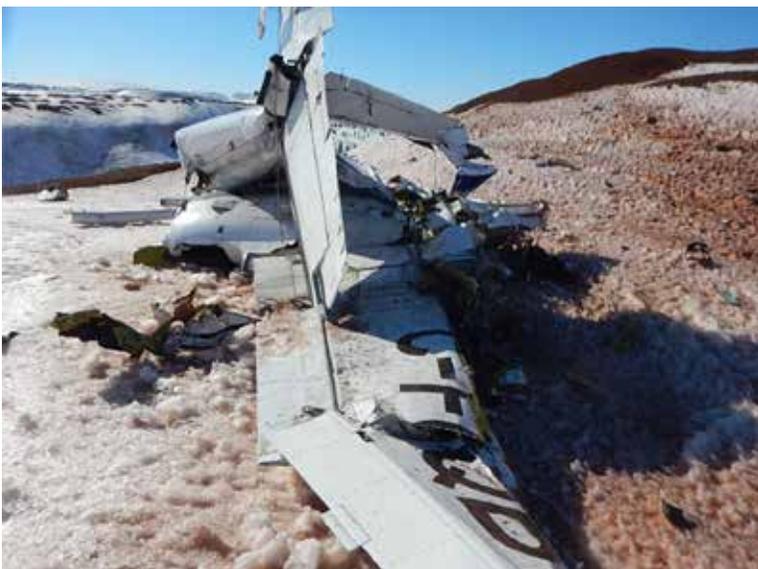
Figure 4. Wreckage of C-FQQB

The aircraft wreckage was found at the top of the plateau, about 134 feet east of the initial point of impact with the ground (Figure 4). The left engine was separated from the wreckage (Figure 5) and was found slightly farther away, with the propeller. Sections of the conductor cables were wrapped around the left engine propeller drive shaft. All main sections of the aircraft were accounted for. The flaps and landing gear were in the retracted position. The throttle levers were at maximum power.

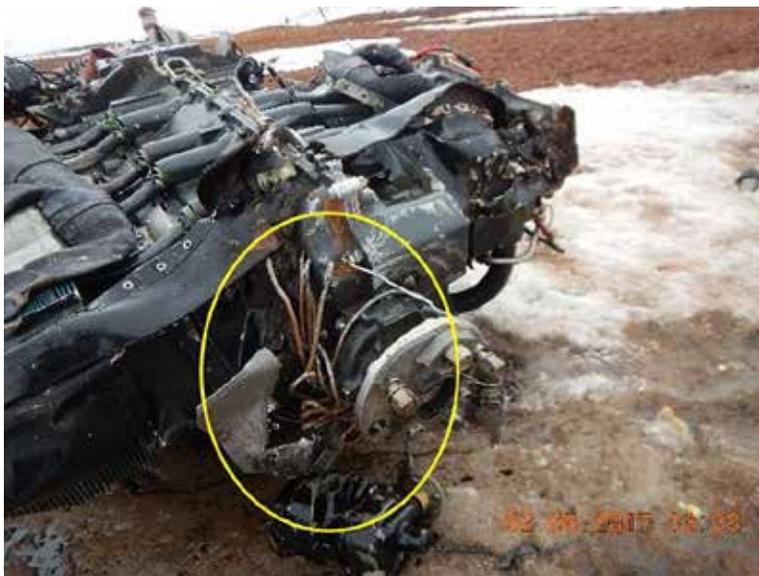
Figure 5. Left engine of C-FQQB: the circle shows the severed pieces of cable wrapped around the propeller drive shaft

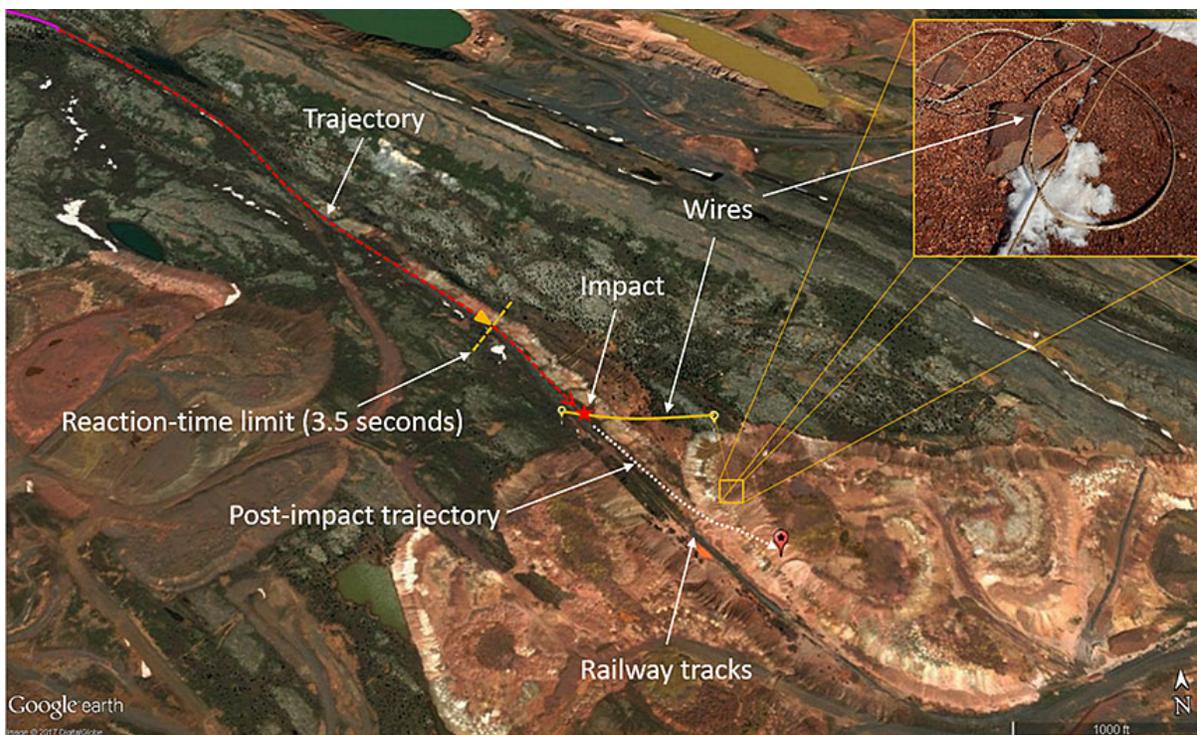
Figure 7. Occurrence aircraft path immediately prior to impact (Source: Google Earth, with TSB annotations)

The mines operated in the area where the accident occurred were iron mines, and the mine tailings deposits there gave the terrain a reddish tint typical of iron oxide. In addition, the conductor cables were dusted with the same colour, reducing their contrast with the surrounding terrain (Figure 7). There was also very little contrast between the wooden pylons and the terrain. At the time and place of the occurrence, the top of the mine tailings deposit was about 75% covered in snow, but the sides exposed to the sun and the runoff water were free of snow.

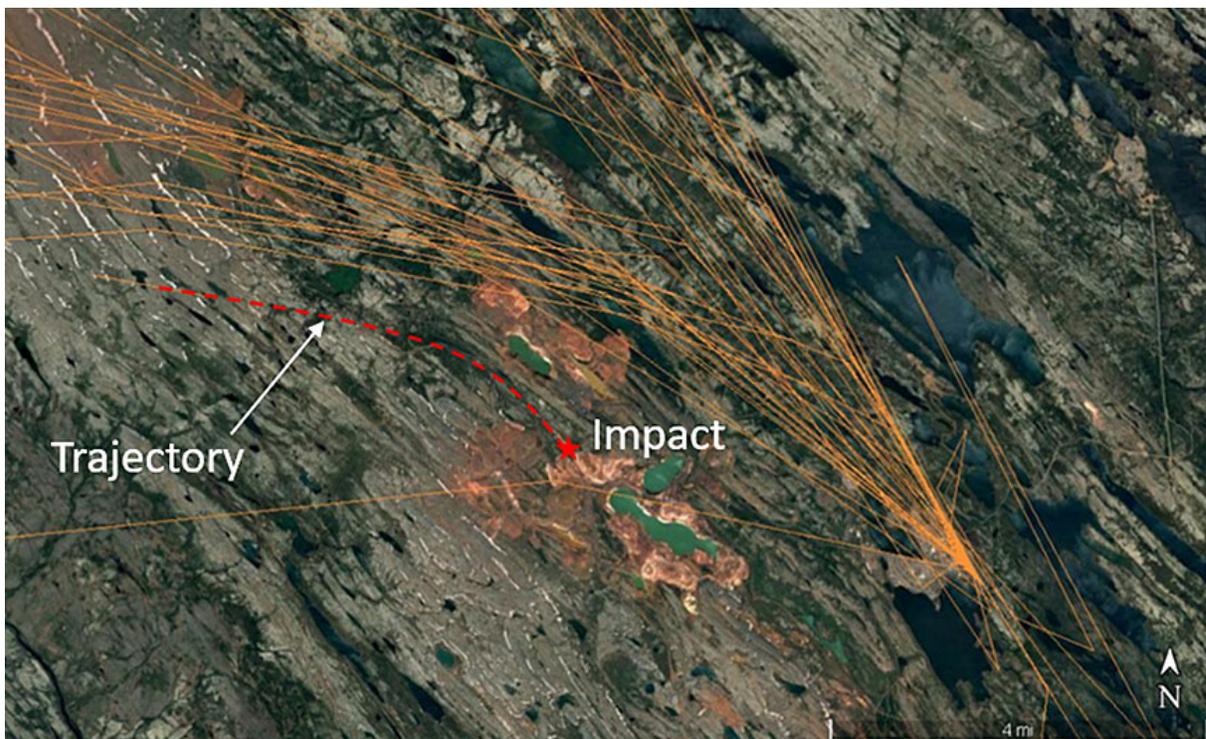
Figure 8. Area of the occurrence aircraft's last very-low-altitude flight (Source: Google Earth, with TSB annotations)

Because magnetometric survey flights are conducted at low altitude, the crew had conducted a reconnaissance flight over the survey area to identify potential hazards; however, reconnaissance was not required for the outbound and inbound segments, and the investigation determined that no flight over the accident site had been conducted (Figure 8).

The power transmission line was not depicted on the chart, the wires were not marked, and no reconnaissance flight had been conducted. As a result, it is highly likely that the pilots were unaware that there was a power transmission line in their path.

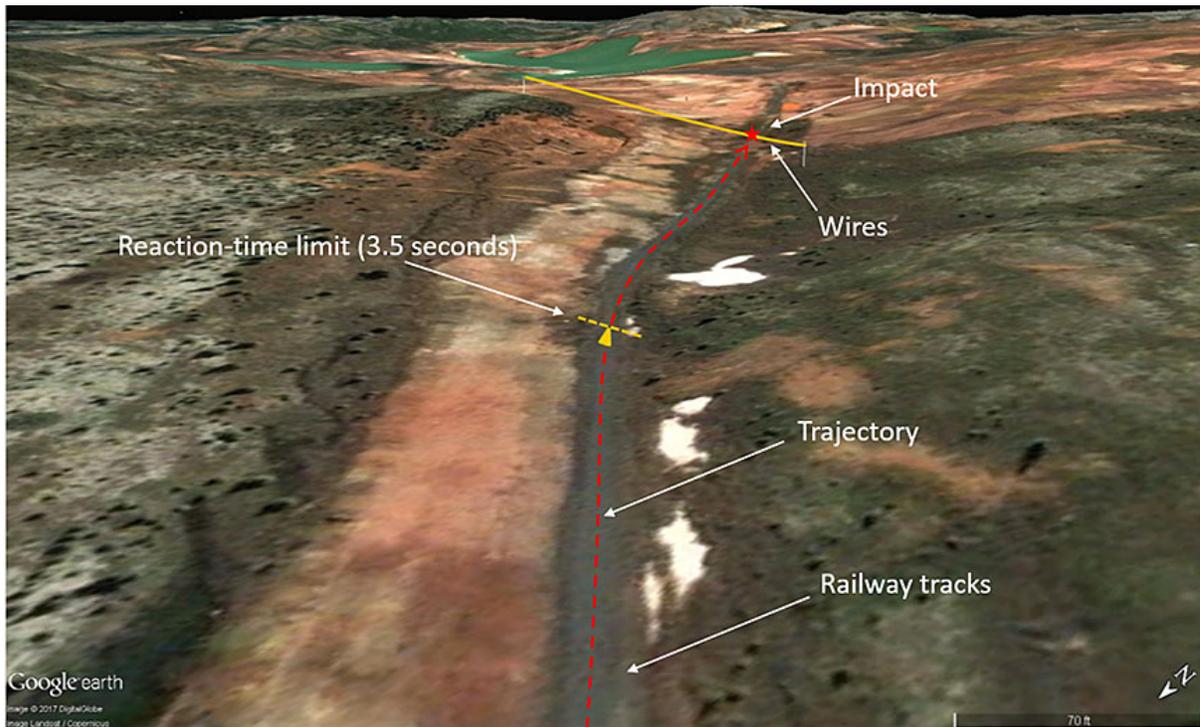
Figure 9. Trajectory prior to impact (Source: Google Earth, with TSB annotations)

As the aircraft was approaching this limit, the pilot had to turn right to remain above the railway tracks, creating a situation that was not conducive to a longer-distance visual scan to detect the wires. During the turn, the aircraft passed the point (Figure 9) at which there was insufficient reaction time to avoid the wires.

Consequently, as the aircraft was flying at very low altitude above the railway tracks, the pilot flying did not detect the power transmission line in time to avoid it, and the aircraft collided with the wires, which were 70 feet above the ground.
