Air Transportation Safety Investigation Report A1800134

CONTROLLED FLIGHT INTO TERRAIN

Robinson R44 Raven II (helicopter), C-GMCT

Toronto/Buttonville Municipal Airport, Ontario, 9 nm N

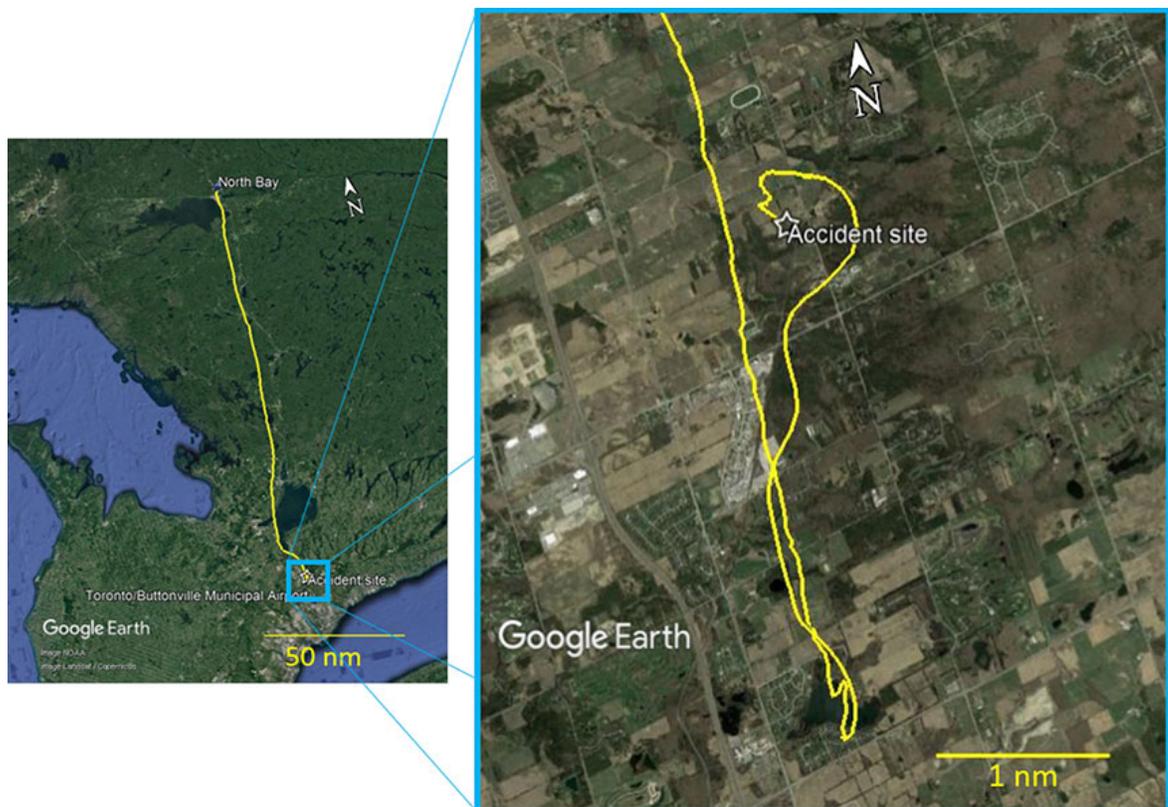
The helicopter started to turn toward the west and continued turning toward the south, over mostly cleared farming fields (Figure 1). The helicopter's altitude varied between 200 and 300 feet AGL, and its ground speed varied between 5 and 40 knots. At no time did the pilot indicate that he was experiencing any difficulties.

Figure 1. Occurrence helicopter's flight path with expanded view of accident site (Source: Google Earth, with TSB annotations)

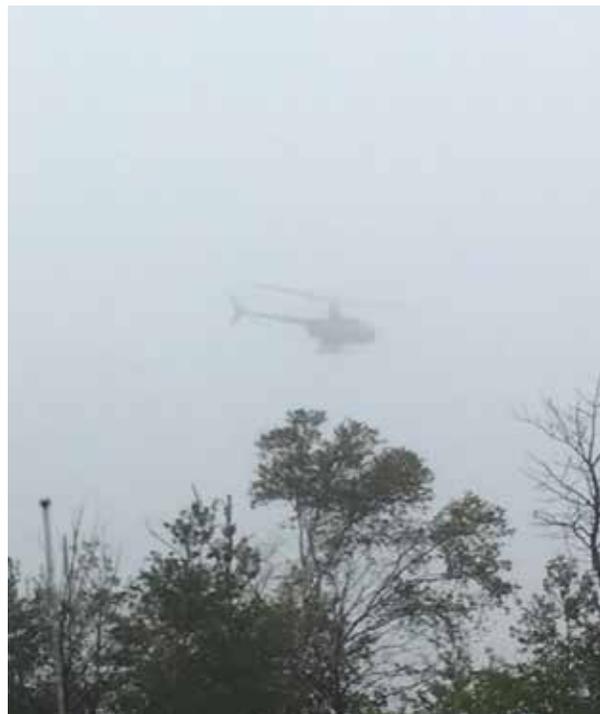
First responders described the weather at the time as foggy and misty with light rain (Figure 2).

Figure 2. The occurrence helicopter seen at about 100 feet above the ground, 10 minutes before the accident, about 9 nm from CYKZ (Source: J. Snowden)
