Air Transportation Safety Investigation Report A18P0042

IN-FLIGHT EMERGENCY DUE TO SMOKE IN COCKPIT AND CABIN

WestJet Encore Ltd.
Bombardier DHC-8-402, C-GJEN
Nanaimo Airport, British Columbia
20 March 2018

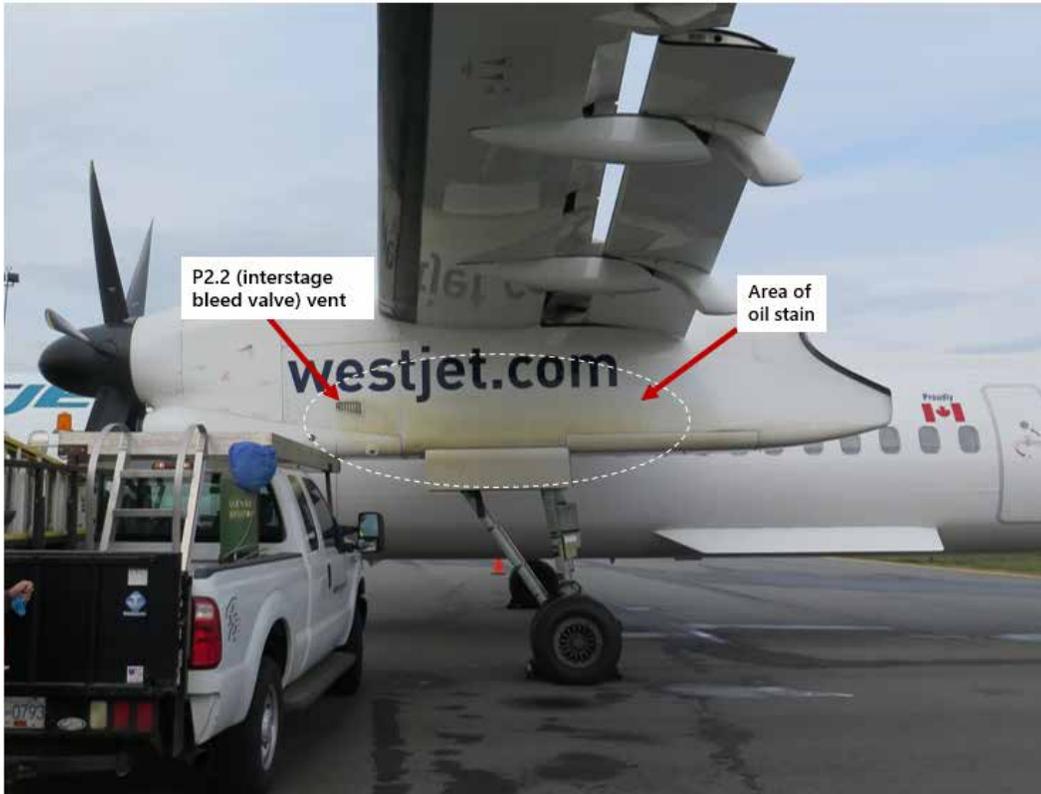
The outboard side of the left engine nacelle had a significant quantity of oil on it, originating primarily from the P2.2 (interstage bleed valve) vent in the engine cowl (Figure 1). Oil was also observed in the engine air-intake plenum and on the chin cowl immediately above the air intake.

Figure 1. Oil on left engine nacelle

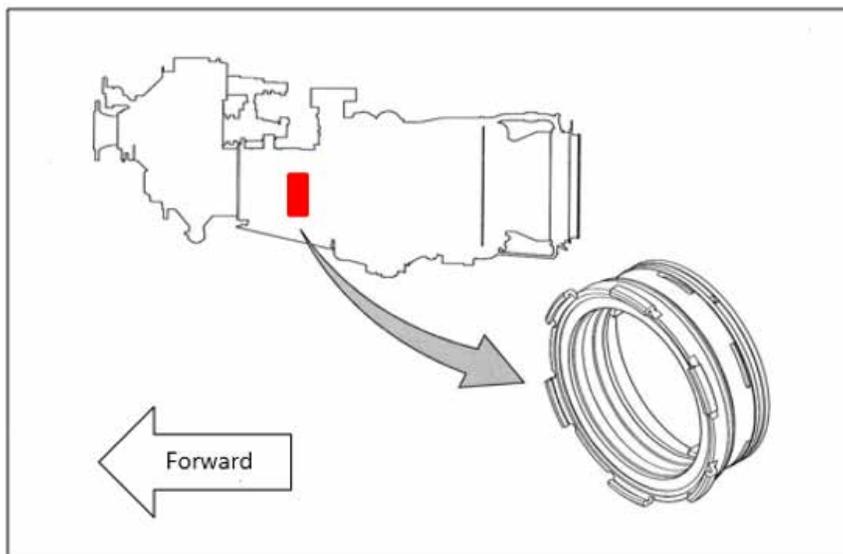
Following the occurrence, the engine was removed from the aircraft and shipped to P&WC in Montréal, Quebec, for teardown and inspection. The inspection revealed that a steel spring (wave washer) in the 2.5 bearing carbon seal had disintegrated, compromising the efficiency of the carbon seal. That deficiency had in turn allowed turbine oil to leak past the carbon seal and enter the compressor airstream and the cabin pressurization system. The 2.5 bearing is located at the forward end of the low-pressure compressor (Figure 2). As a result of previous 2.5 bearing carbon seal failures, P&WC issued Service Bulletin (SB) 35342 on 06 October 2016. Revision 1 of the SB was issued on 24 January 2018.

Figure 2. PW150A engine schematic, showing approximate location of 2.5 bearing carbon seal (Source: Pratt & Whitney Canada, Service Bulletin 35342 R1)

The original SB had called for modification of the bearing carbon seal (part number 3071831-01). The revised bulletin (SB 35342 R1) recommends that operators “[r]eplace the No. 2.5 bearing seal with one

that has an increased minimum spring load to prevent potential spinning of the air/oil bearing seal ring.”² The part number of the new bearing carbon seal is 3127372-01.
