AIR TRANSPORTATION SAFETY INVESTIGATION REPORT A19O0063

GROUND COLLISION AND EVACUATION

Jazz Aviation LP
DHC-8-311, C-FJXZ
and
Menzies Aviation
Rampstar Fuel Tanker
Toronto/Lester B. Pearson International Airport, Ontario
10 May 2019

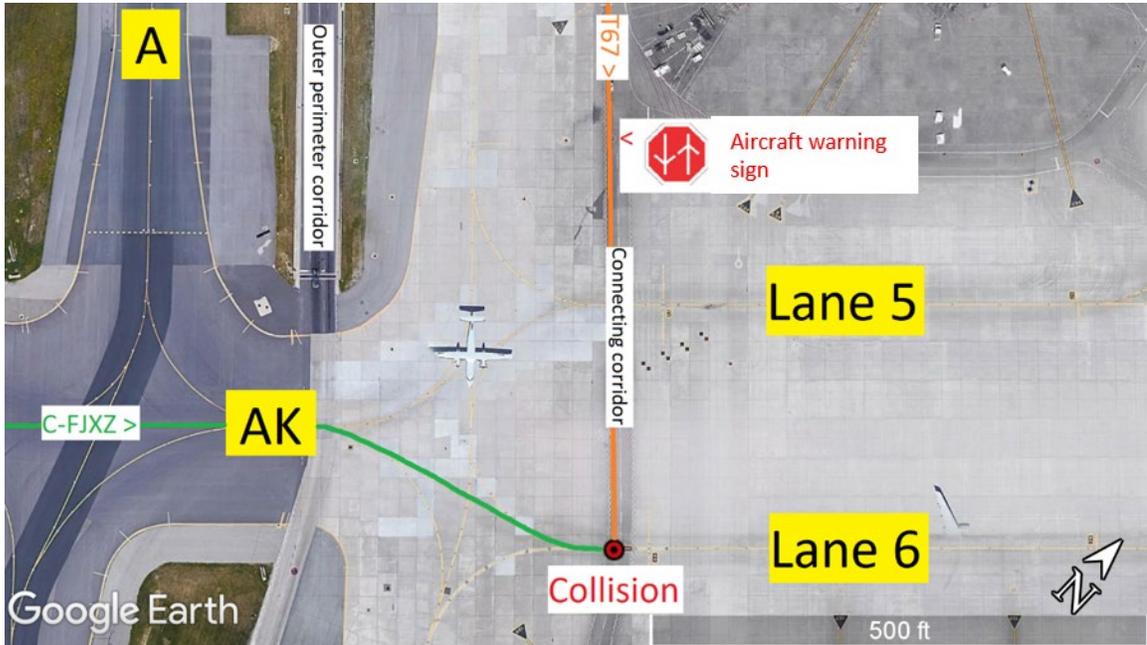
Figure 2. Overhead view of collision site (Source: Google Earth, with TSB annotations)

At 0133:36, the fuel tanker crossed an aircraft warning sign painted on the apron surface just before the connecting corridor (Figure 2). These signs serve as a reminder for drivers that they are about to cross an aircraft taxilane, and that they are to exercise vigilance. Drivers are not required to slow or stop in the absence of aircraft traffic. The fuel tanker did not slow or stop near the aircraft warning sign, and continued southbound at a speed of approximately 40 km/h, which is the speed limit.

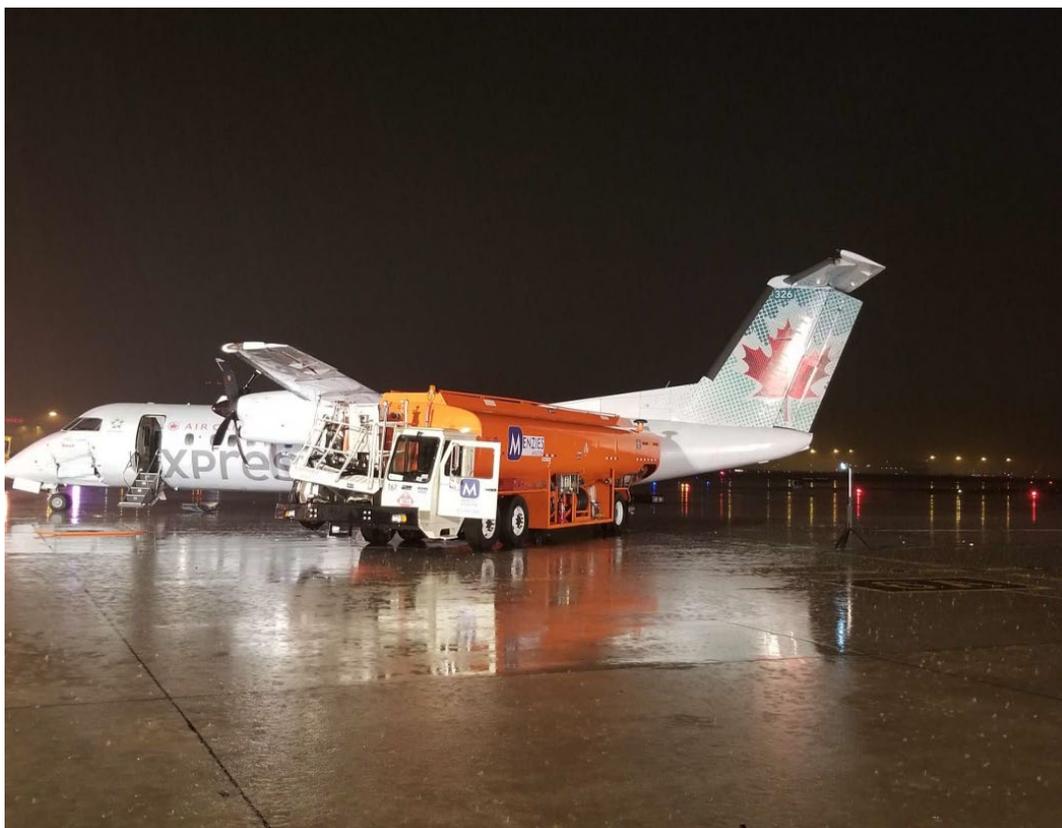
Figure 3. Photograph of the aircraft and the fuel tanker post-collision, taken facing west-northwest (Source: Menzies Aviation)

Given the orientation of the 2 vehicles after the collision sequence (Figure 3), neither the flight crew nor the flight attendant could see the fuel tanker, nor could the driver of the fuel tanker see the aircraft.

The left-side cockpit area was the first point of contact on the aircraft during the collision. It sustained significant damage immediately below the left-side window of the flight deck. There was some deformation to the interior of the aircraft in the vicinity of the captain's left armrest and the circuit breaker panel located aft of the armrest area, which extended from floor height to the armrest. Some of the systems relevant to this occurrence, which are electrically powered through this panel, include the CVR, the FDR, and the PA system.

As the aircraft rotated away from the collision, the left-side propeller (which was feathered) and the outboard flap track fairings under the wing made contact with the top of the fuel tanker. The rotating motion of the aircraft was arrested when the left rear fuselage hit the back of the fuel tanker. There was significant damage to all 4 blades of the left-side propeller, the left-side flap track fairings, and the cargo door area of the rear left fuselage.

The front right corner of the fuel tanker, which contains the elevating service platform, was substantially damaged during the collision. The top of the main tank was struck by the feathered left-side propeller of the aircraft; it was damaged, but not punctured. The rear of the fuel tanker was struck by the rear fuselage of the aircraft at the end of the collision sequence; it received impact damage to the rear bumper and the tank access ladder.

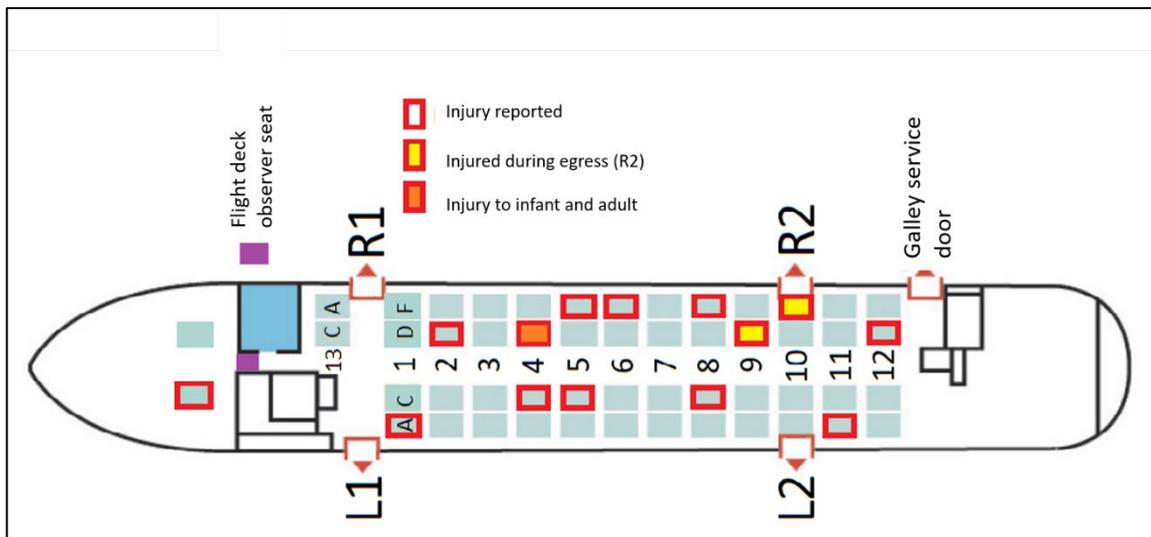
Figure 4. Injury map (Source: Jazz Aviation LP, with TSB annotations)

Of these injuries, 2 occurred while evacuating, both as a result of jumping from the right-hand rear emergency window exit (exit R2) (Figure 4).

The captain received a fractured rib due to direct impact forces, as he was seated adjacent to the point of impact; there was some deformation to the interior of the aircraft in the vicinity of his left armrest and the circuit breaker panel located aft of the armrest area. The captain was able to exit the aircraft without assistance once the passengers had deplaned.

Due to the direction of both the initial impact and the secondary impact with the back of the fuel tanker, occupants of the aircraft were exposed to lateral impact forces, which led to back, shoulder, hip, head, and neck injuries. These types of injuries can be caused by flailing while being restrained only by a lap belt.

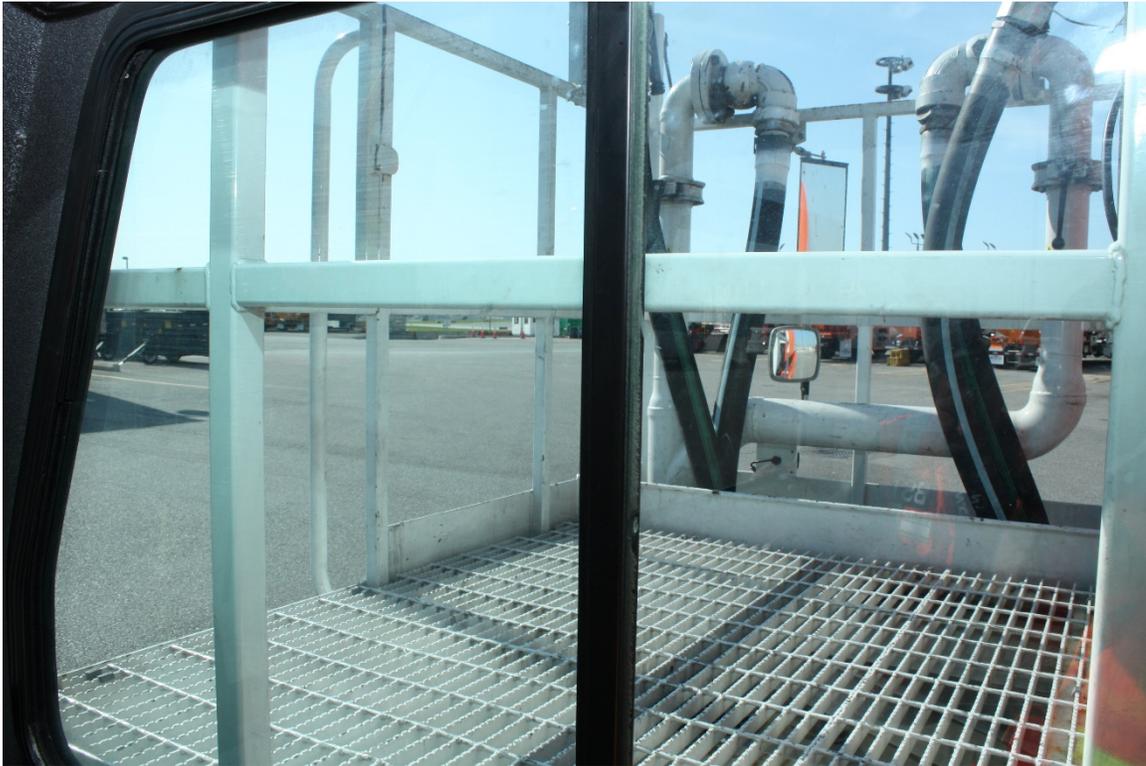
Figure 8. View from inside an identical tanker, looking through the right-hand window with the service platform stowed (Source: TSB)

There is a side-view mirror attached to the right side of the platform: the mirror occupies one of the few areas where a sightline to the right is available to the operator. The lower horizontal bars of the guardrail, located immediately adjacent to the right-hand window in the driver's cab, directly obstruct the field of view; they are located at a position where they block a direct line of sight from the eye height of many drivers (Figure 8).

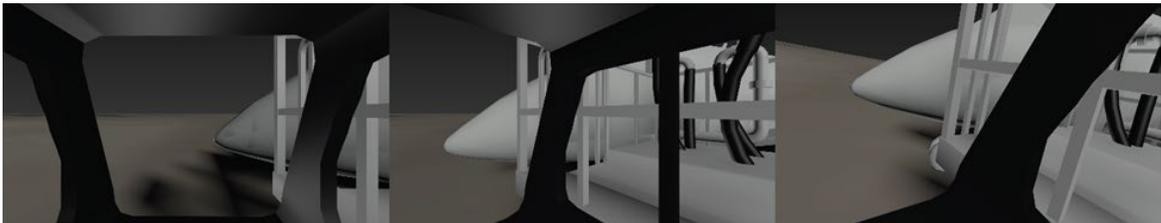
Figure 11. 3D views from inside the fuel tanker cab 1 second before impact. The images show the driver's view of the aircraft hindered by the elevating service platform when facing forward (left image), facing right (middle image), and leaning forward while facing right (right image). (Source: TSB)
