Air Transportation Safety Investigation Report A19W0094

HARD LANDING

WestJet Encore Ltd.
Bombardier DHC-8-402, C-FKWE
Edmonton International Airport, Alberta
19 July 2019

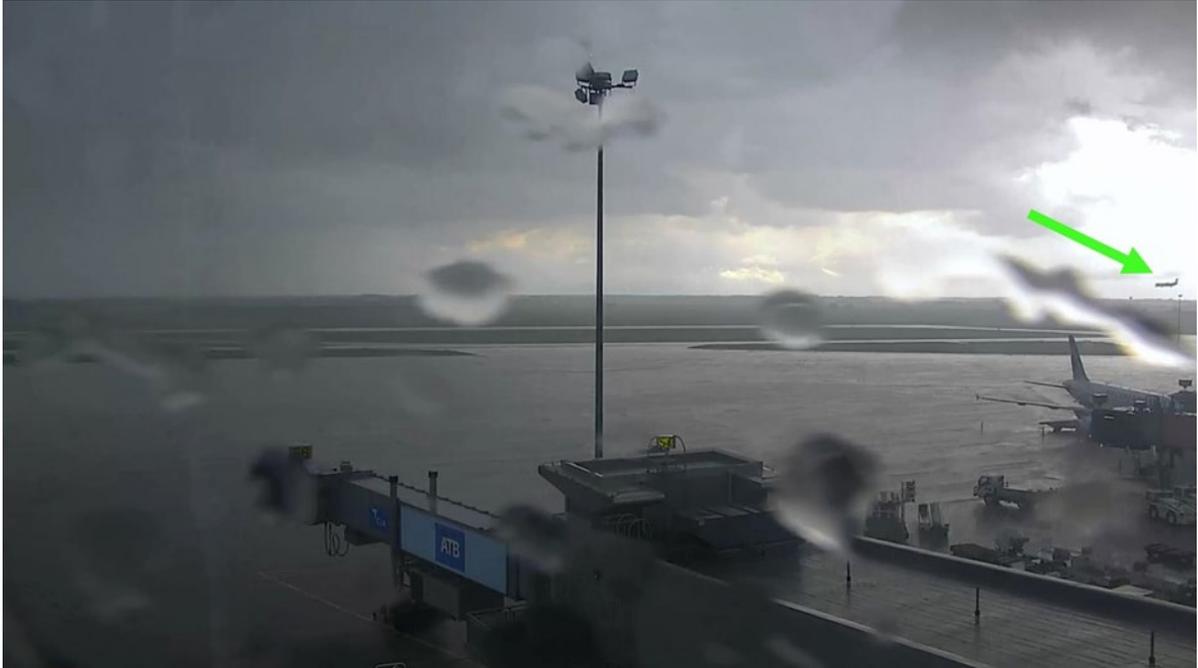
A large thunderstorm cell situated to the northeast of the airport was advancing to the southwest and was over the departure end of Runway 12 as the occurrence aircraft landed (Figure 1).

Figure 1. Closed-circuit television image of Runway 12 taken from Gate 54, looking south, just before the occurrence aircraft (identified by green arrow) landed (Source: Edmonton Airport Authority, with TSB annotation)

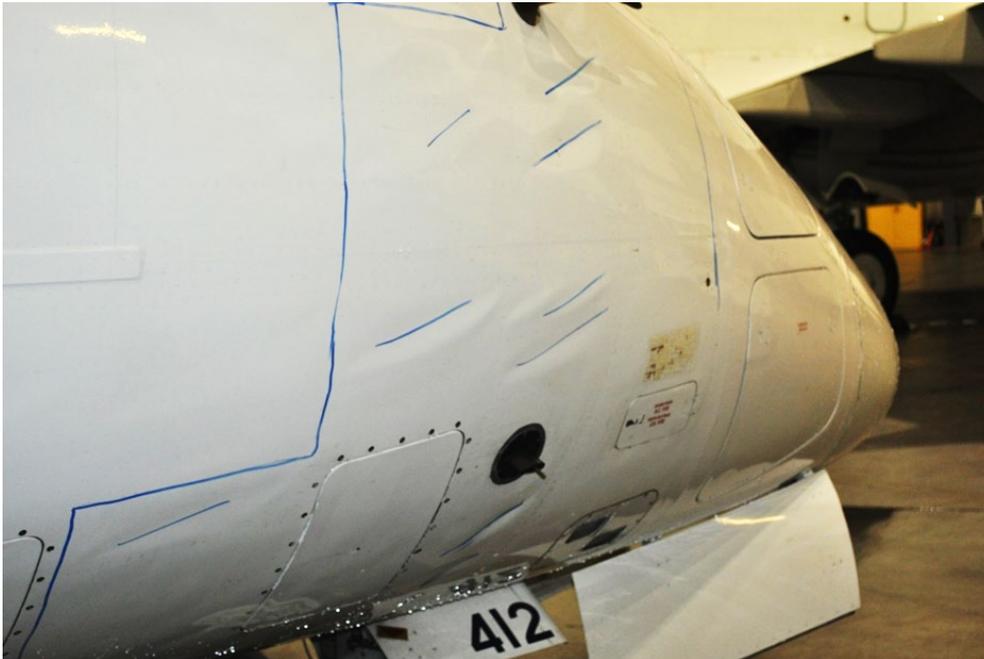
After the passengers deplaned at the gate, WestJet Encore Ltd. maintenance personnel performed a more detailed inspection of the occurrence aircraft, which revealed wrinkled fuselage skins (Figure 2) as well as damage to the left nose-gear door, the forward pressure bulkhead, and the nose-gear assembly.

Figure 2. Wrinkled skin on the right side of the nose (blue dry-erase marker added for clarity) (Source: TSB)

The data also indicated that the large nose-down elevator deflection at touchdown resulted in the nose being lowered at approximately 10 degrees per second, compared with 4 degrees per second, which was the highest rate of nose-lowering recorded during prior landings.

In this occurrence, the aircraft's speed was not reduced from its approach speed ($V_{REF} + 20$ KIAS) to the touchdown speed (V_{REF}). The nose of the aircraft was lowered at a higher rate than normal, resulting in damage to the aircraft. These highlight the importance of flight crews adhering to operational procedures and techniques.
