AIR TRANSPORTATION SAFETY INVESTIGATION REPORT A20O0029

RUNWAY INCURSION – RISK OF COLLISION

Air Canada Embraer ERJ 190-100 IGW, C-FMZW
and

Air Canada Boeing 777-333ER, C-FJZS

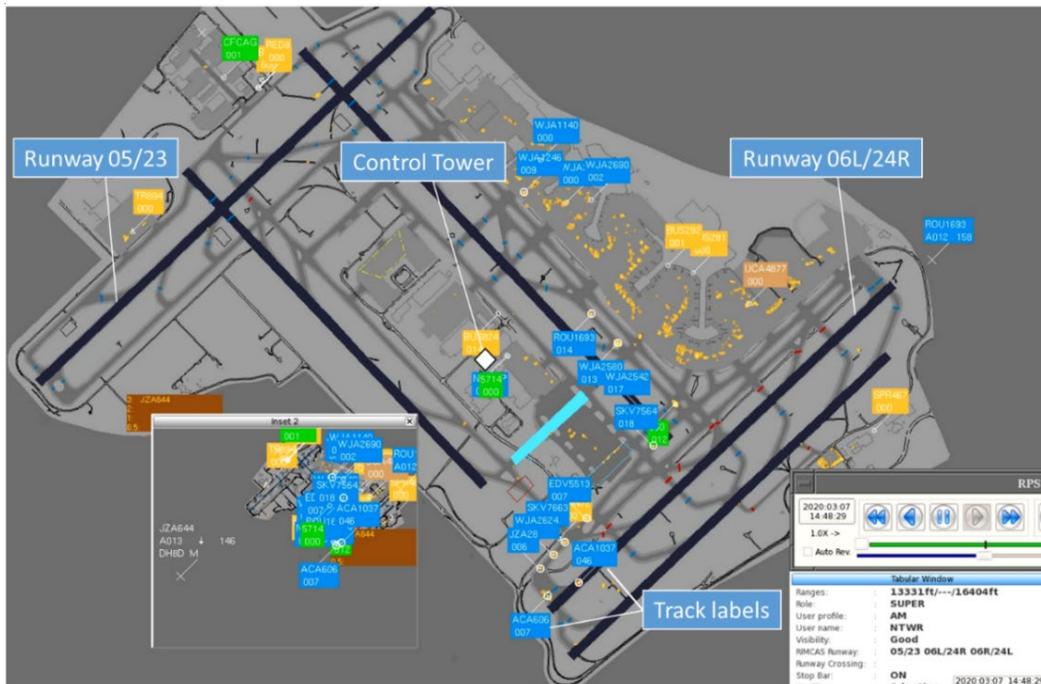
At 0948:27, the Embraer 190 reached 50 knots indicated airspeed (KIAS)⁷ and continued accelerating. Three seconds later, the track label from the advanced surface movement guidance and control system (A-SMGCS) on the display monitor at the controller working position (CWP) showed that the Embraer 190 was in air⁸ with an altitude tag of 500 feet above sea level (ASL) (depicted as A005) (figures 1 to 3).⁹ However, the aircraft was still on the ground at this time.

Figure 1. Screen shot of the display monitor at the controller working position showing information from the advanced surface movement guidance and control system (Source: NAV CANADA, with TSB annotations)

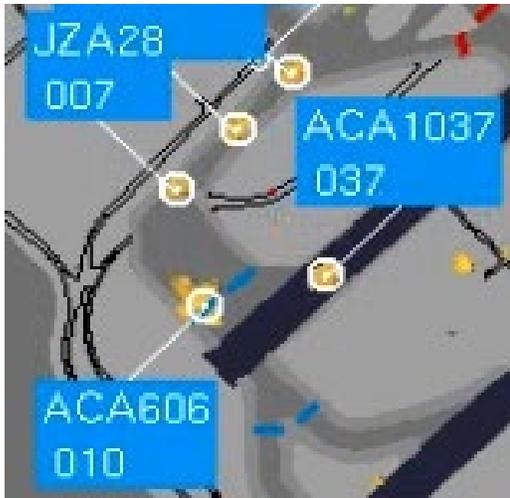
Figure 2. Screen shot magnification, taken at 0948:27, showing the track labels of a de Havilland DHC-8 (JZA28) travelling at 7 knots (007), the Boeing 777 (ACA606) travelling at 10 knots (010), and the Embraer 190 (ACA1037) travelling at 37 knots (037) (Source: NAV CANADA)

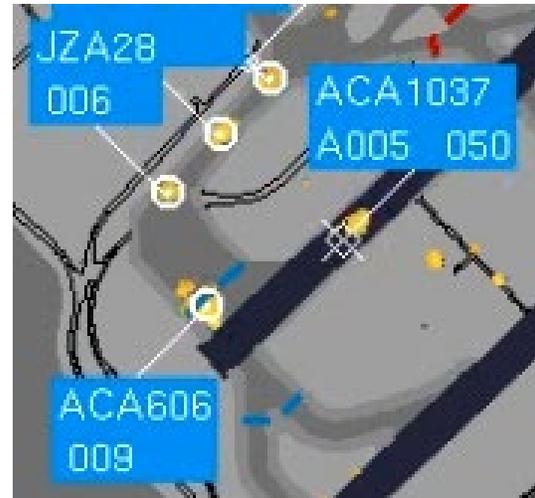
Figure 3. Screen shot magnification, taken at 0948:30, showing the change in status of the Embraer 190 (ACA1037) to in air at an altitude of 500 feet ASL (A005) and travelling at 50 knots (050) and the Boeing 777 (ACA606) travelling at 9 knots (009) (Source: NAV CANADA)

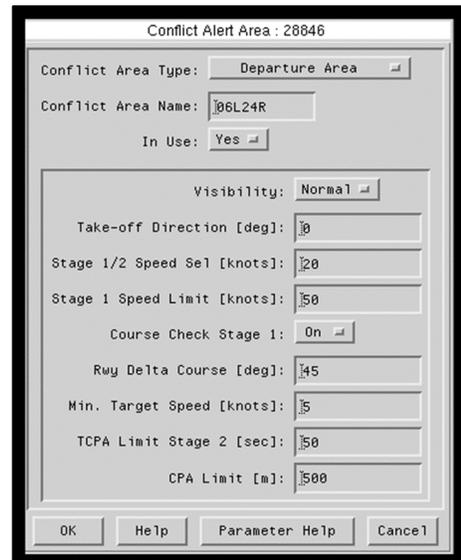
The cause of these 2 delays within the MST was due to the “Ground speed” parameter which was set 10 knots lower than the configured take-off speed, that is to say 10 knots lower than the “Minimum speed for takeoff when GBS is OK” parameter of 50 knots.

Figure 9. Screen shot of configurable runway incursion monitoring and conflict alert sub-system settings (Source: NAV CANADA)

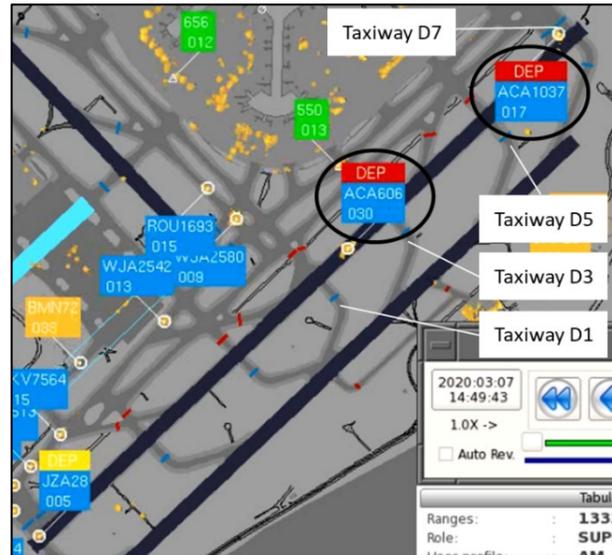
At 0949:43, while the stage 1 alert was still active, the RIMCAS generated a stage 2 alert – departure. With the Embraer 190 approaching the end of the runway and the Boeing 777 decelerating, the MST determined that both aircraft were on ground (Figure 10). These aircraft were now separated by approximately 3950 feet. The stage 2 alert – departure was visible for 2 seconds and then subsided when the next alert was generated.

Figure 10. Stage 2 alert – departure at 0949:43 with red DEP track labels (Source: NAV CANADA, with TSB annotations)

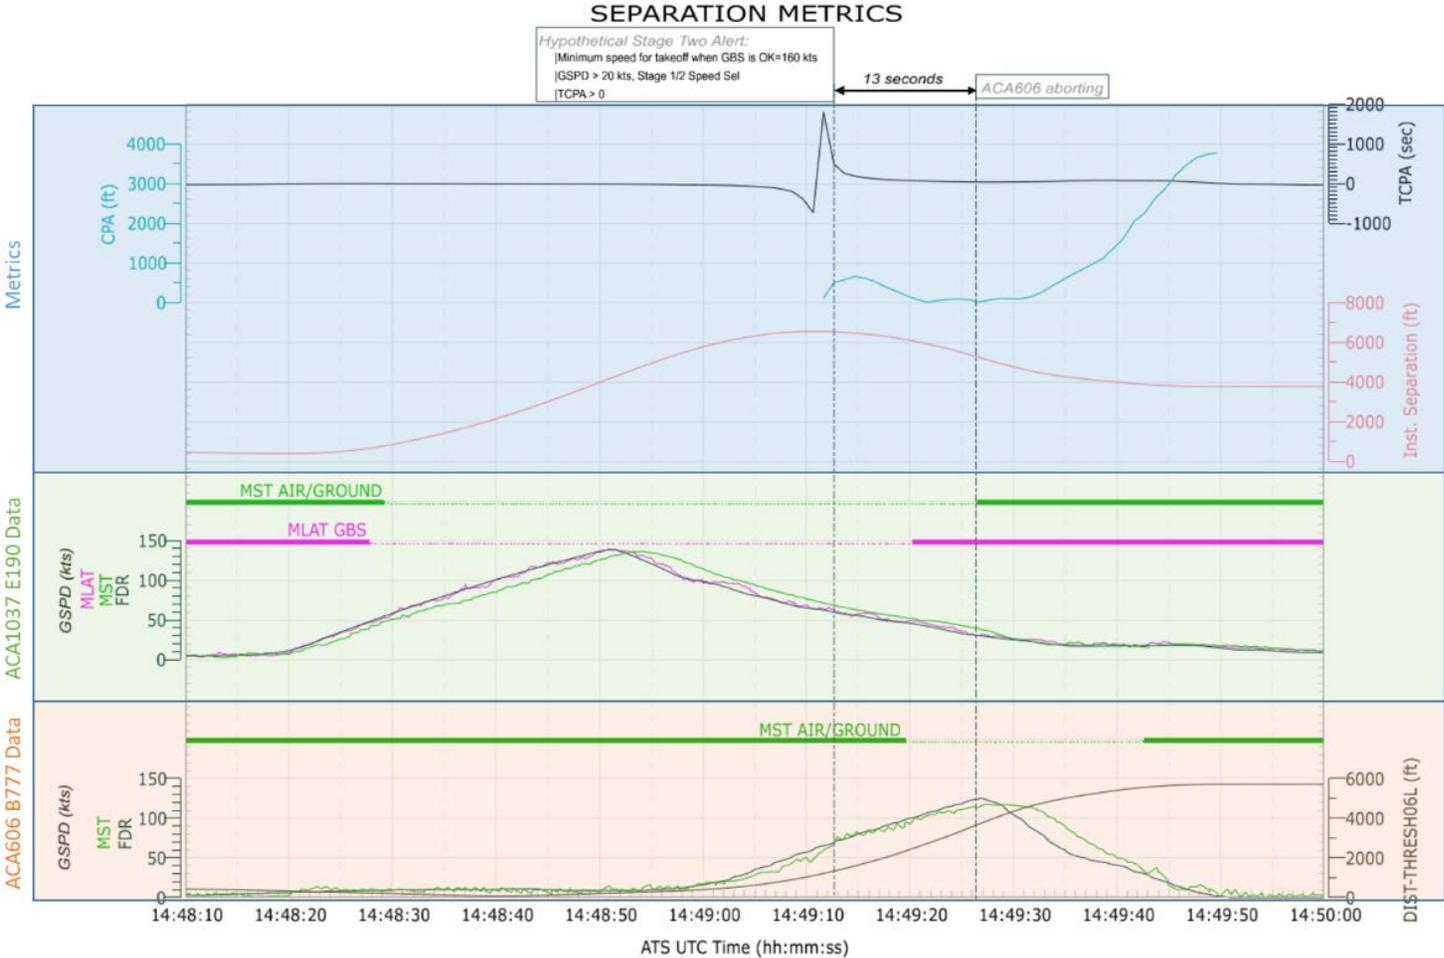
Appendix A – Graph depicting separation metrics and the time delay between the indications for the Embraer 190 from the multi-sensor tracker (line labelled MST AIR/GROUND) and from the multilateration system (line labelled MLAT GBS)

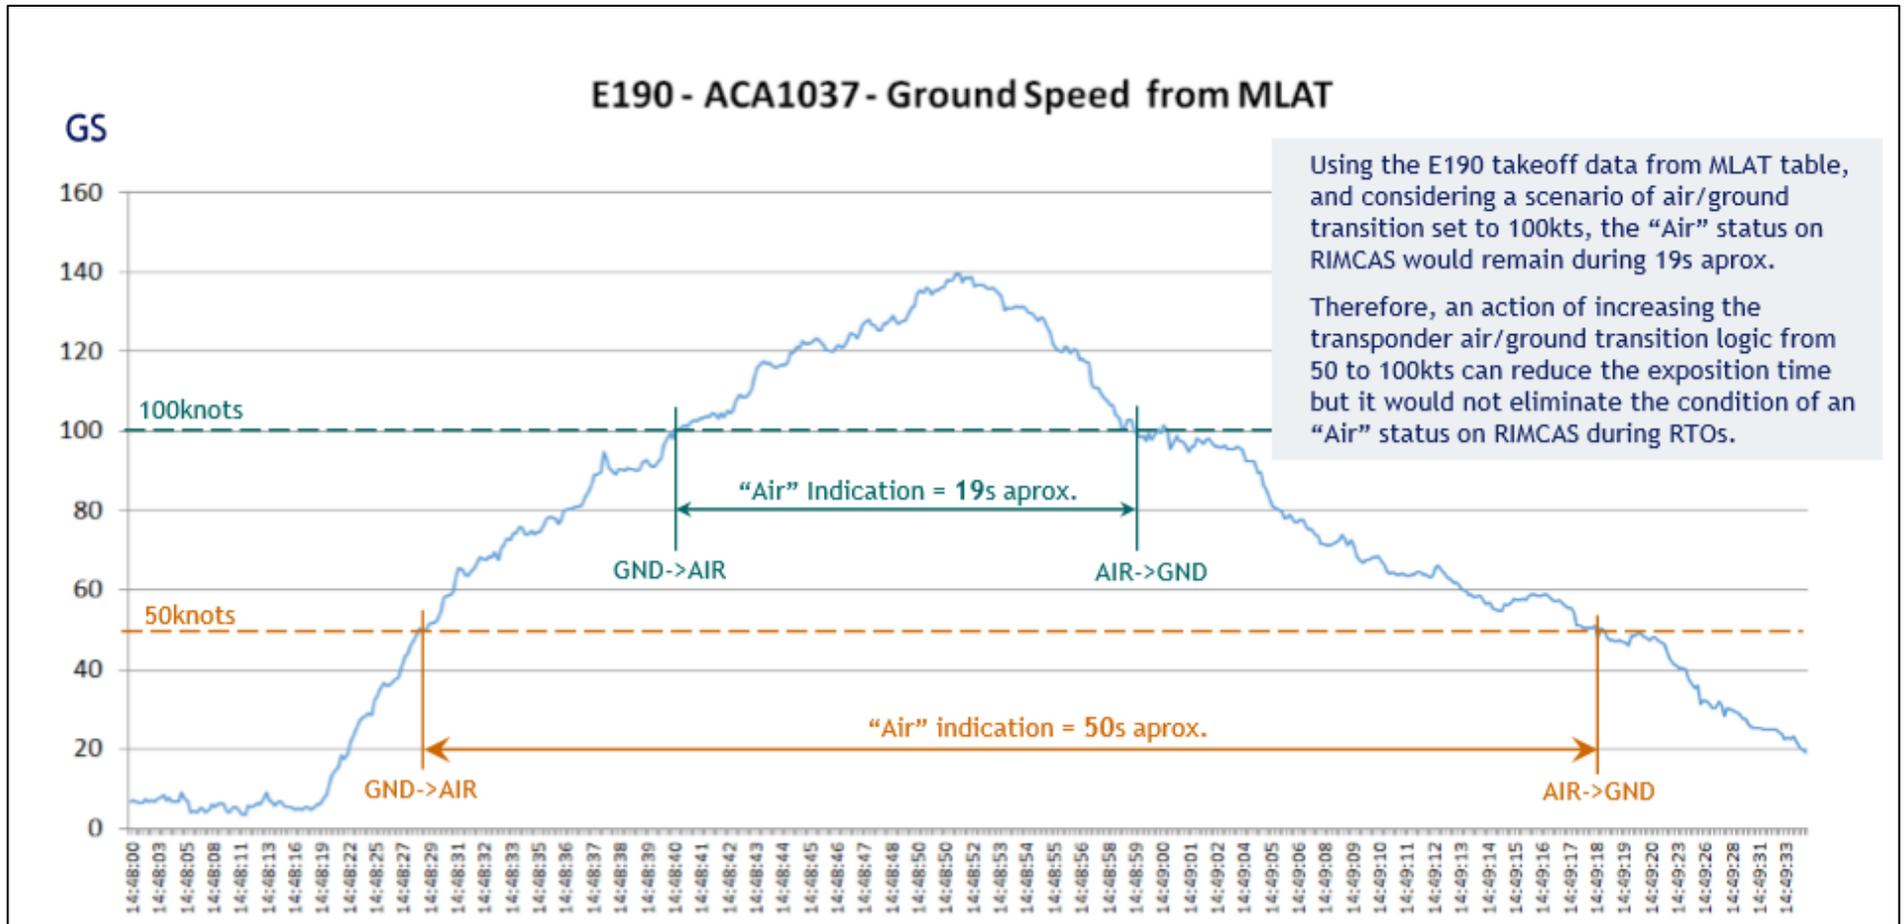
The Brazilian Aeronautical Accidents Investigation and Prevention Center conducted an examination of the occurrence Embraer 190’s in-air/on-ground status (Appendix B) and found that it would have transmitted an in-air status for approximately 50 seconds during the event. The analysis showed that even if the value had been increased to 100 knots, the aircraft would still have been inaccurately depicted as in air for approximately 19 seconds.

Appendix B – Graph depicting the approximate time the Embraer 190 is identified as in air at 50 and 100 knots
