## **AIR TRANSPORTATION SAFETY INVESTIGATION REPORT A20C0037**

### **RUNWAY EXCURSION**

Buffalo Airways Ltd.  
Beechcraft King Air A100, C-FCBZ  
Kugaaruk Airport, Nunavut  
28 April 2020

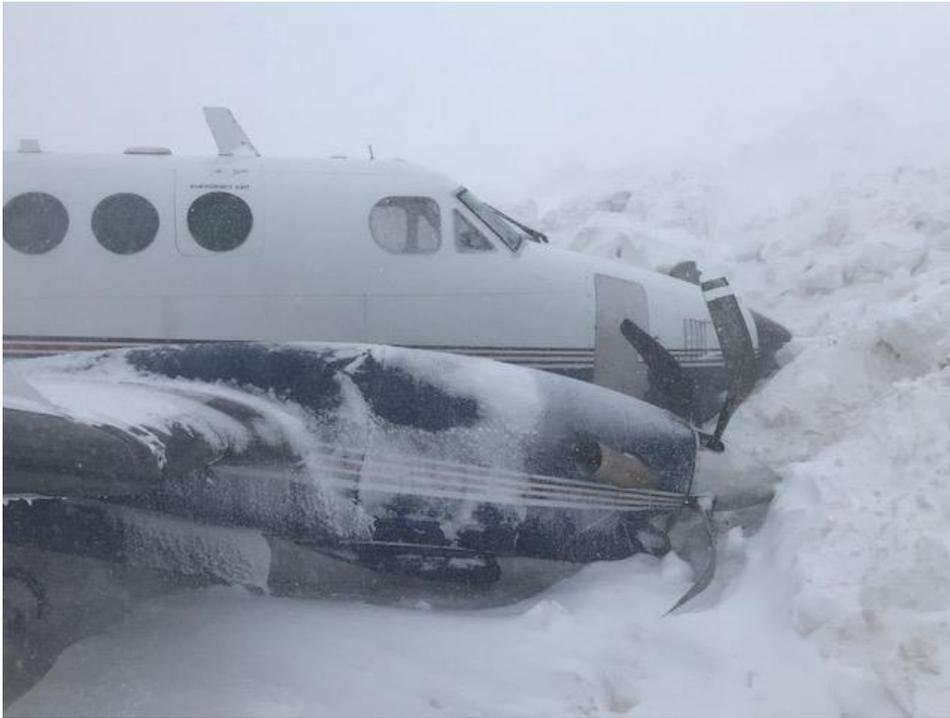
Figure 1. Wreckage of the occurrence aircraft (Source: Third party, with permission)

The aircraft's fuselage, nose, engines, propellers, nacelles, flaps, wing centre section, and right wing spar were damaged (Figure 1). The right wing was bent up and aft. The nose landing gear leg collapsed aft and to the right. The right outboard main-wheel tire had detached when the wheel rim broke; it was found close to the aircraft. The fracture surfaces of the broken wheel indicated that the wheel rim had broken in overload during the runway excursion.

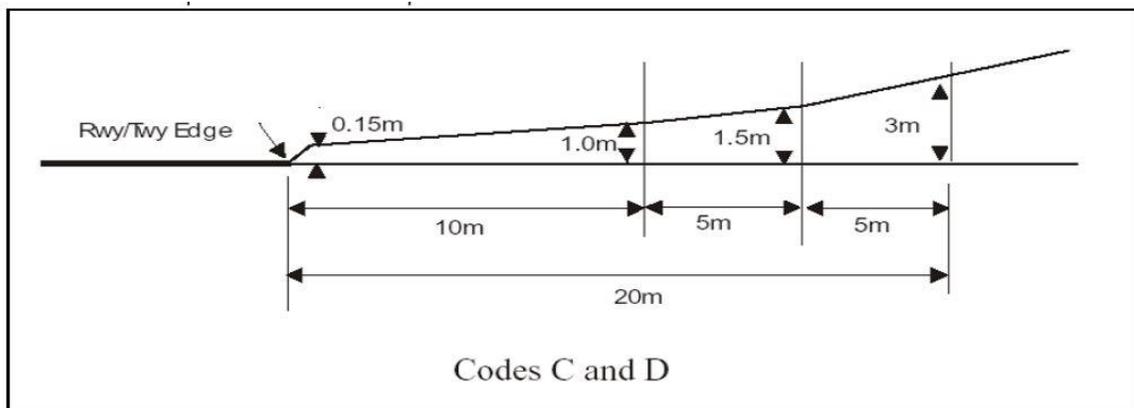
Figure 2. Maximum snow accumulation on the edge of a runway or taxiway for code C or D airports (Source: Transport Canada, Advisory Circular 302-013: Airport Winter Maintenance and Planning, Appendix A)

The Nunavut Airports Division's Winter Maintenance Plan<sup>6</sup> is common to all airports operated by the Division. The Winter Maintenance Plan was prepared using the TC Advisory Circular 302-013<sup>7</sup> as a guide. All Nunavut airports, with the exception of Grise Fiord Airport (CYGZ) and Kimmirut Airport (CYLC), are listed as code C and D airports.<sup>8</sup> The code refers to either the maximum wing span or the outer main gear wheel span of aircraft that may operate from the airport.<sup>9</sup> The Winter Maintenance Plan contains an International Civil Aviation Organization (ICAO) diagram indicating that the maximum snow depth can be 0.15 m near the runway edge, increasing to 1.0 m at a 10.0 m distance from the runway edge (Figure 2).

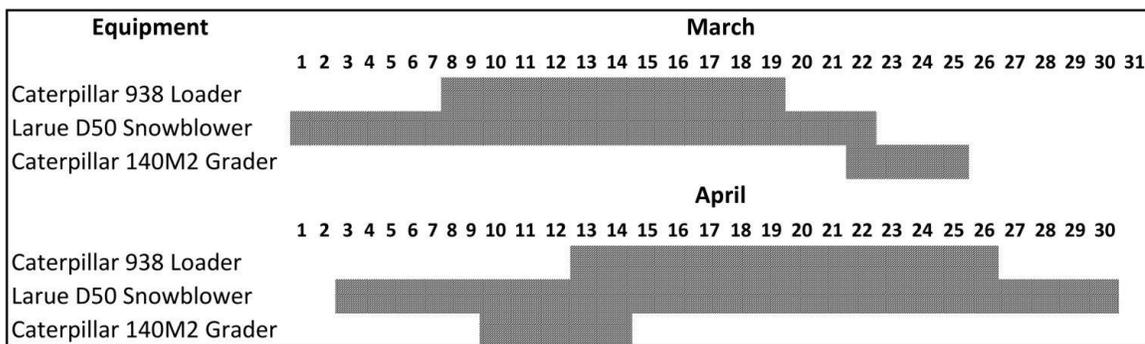
Figure 3. Out-of-service dates for snow removal equipment at Kugaaruk Airport in March and April 2020, indicated by shaded areas (Source: TSB, based on information provided by Nunavut Airports Division, Department of Economic Development and Transportation)

Since the beginning of February 2020, the CYBB daily reports, that were submitted to the airport operator by the airport maintainers, referred to snow buildup near the runway and the inability to move it with the grader. A number of daily report entries mentioned that the operator was made aware of unserviceable equipment and the need for parts required for repairs. An entry on 27 March 2020 indicated that the snowblower had been out of commission for 2 months and also mentioned problems with the loader. In addition, on the same day, an SMS report was generated by an airport maintainer and submitted to the airport operator, regarding snowbanks that were building up close to the runway.

The snowblower was needed to allow the maintainers to move the snow away from the runway, taxiway, and apron and spread it out over a wider area.

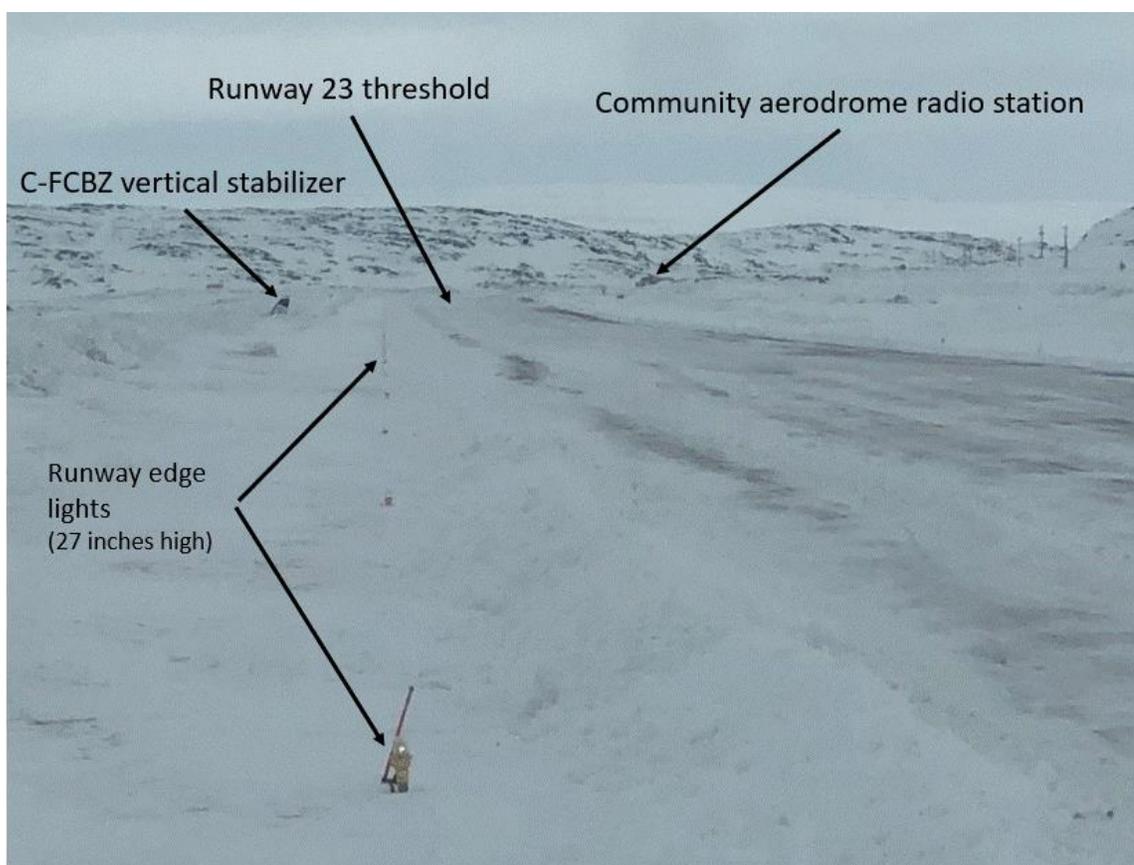
Figure 4. View toward the threshold of Runway 23 (Source: Third party, with permission and TSB annotations)

At the time of the occurrence, the snowbank height and proximity to the runway edge lights was in excess of TC guidance<sup>12</sup> in some areas along the length of the runway. The aircraft came to rest in an opened up area where the snowbanks were further from the edge lights than they were along the rest of the runway, but were noted to be above head height.

A photo of the runway was taken the day following the occurrence, after snow clearing had begun (Figure 4). Due to the presence of snowbanks along the runway, the only portion of the aircraft that is visible in the photo is the vertical stabilizer. The photo also shows that the snow accumulation along the runway is almost as high as runway edge lights, which are 27 inches high.

The TSB Engineering Laboratory attempted to analyze the photo to determine the height of the snowbanks along the runway and their proximity to the runway lights. However, there were insufficient data and geographic references to derive accurate measurements.

The snow depth adjacent to the runway was allowed to exceed the limits dictated by the airport operator's Winter Maintenance Plan. Consequently, the aircraft sustained additional damage when it departed the runway surface.
