Air Transportation Safety Investigation Report A20P0060

COLLISION WITH POWER LINE, MISSING AIRCRAFT

International Flight Centre Inc.
Cessna 172M, CF-CCV
Abbotsford Airport, British Columbia, 9.7 NM NNW
06 June 2020

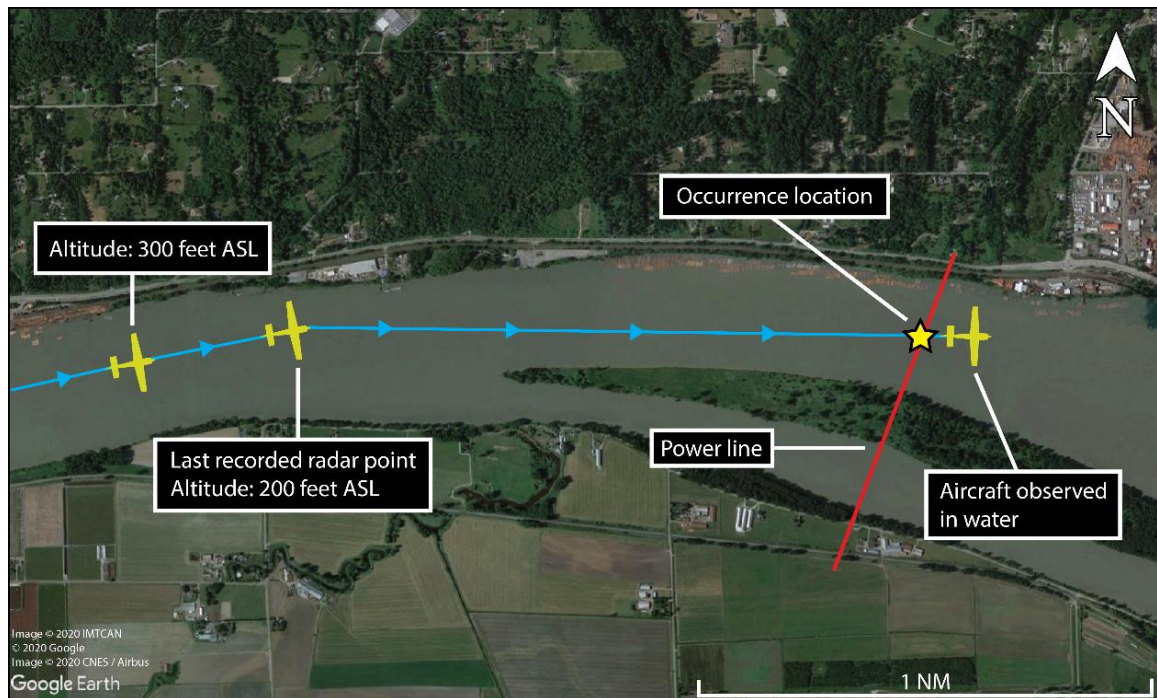
At 1309, the aircraft began a descent from 2200 feet ASL, flying over the Fraser River near Fort Langley Water Aerodrome (CAS4), BC, levelling briefly at 1500 feet ASL and 300 feet ASL before it levelled at 200 feet ASL over the river when radar contact was lost at 1312:29. The aircraft's last recorded position was approximately 9.7 nautical miles (NM) north-northwest of Abbotsford Airport (CYXX), BC, travelling eastbound at 200 feet ASL, with a groundspeed of 80 knots. At

approximately 1313, the aircraft flew into a power transmission line that was strung across the Fraser River, approximately 125 feet above the water (Figure 1).

Figure 1. Occurrence aircraft's flight path and site of collision with power line (Source: Google Earth, with TSB annotations)

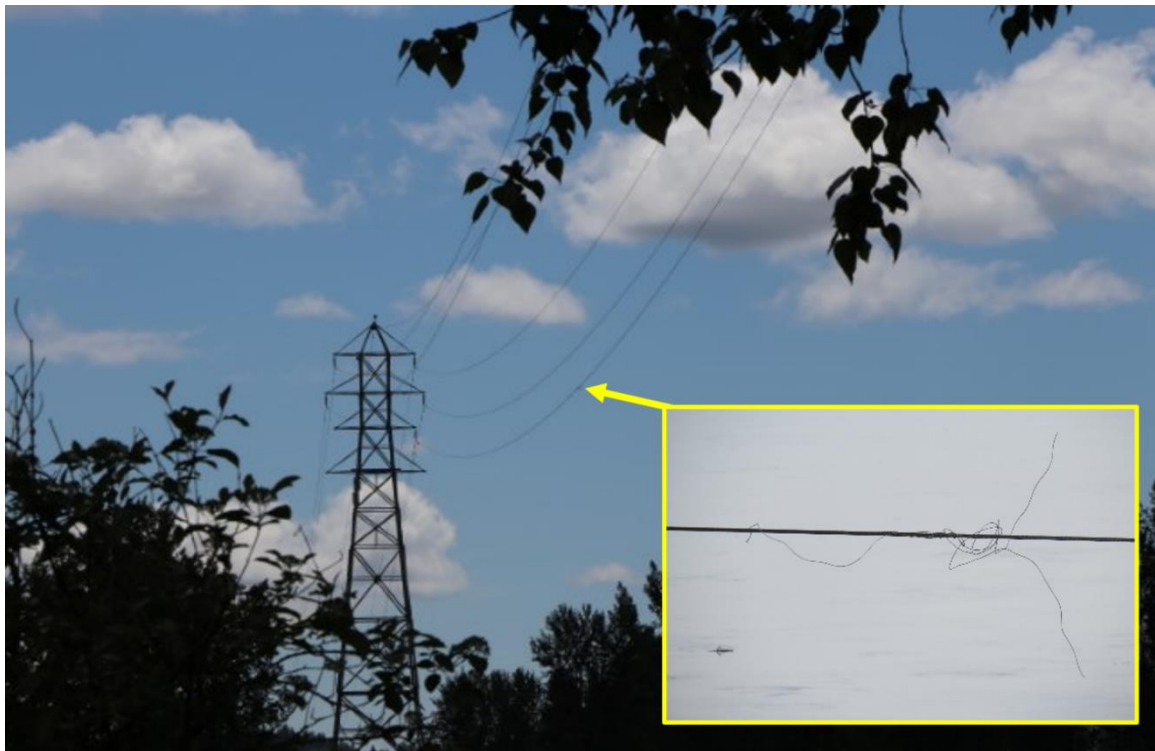
The aircraft collided with the span between the North and the Middle suspension towers, which is 2077 feet long and was approximately 125 feet above the river at the time of the occurrence.⁶ The lowest line was damaged and was disabled by circuit protection (Figure 2).

Figure 2. South-facing view of Middle suspension tower with inset image of damaged transmission line (Main image source: TSB. Inset image source: BC Hydro)

⁶ Conductor span sag varies depending on the ambient temperature and electrical load. For this conductor, the span could be as low as 90 feet above the river. (Source: BC Hydro)

BC Hydro has prioritized the schedule for the commissioning of the daytime strobe lights, which should be completed in 2021. Once this work has been completed, the NOTAM will be rescinded.

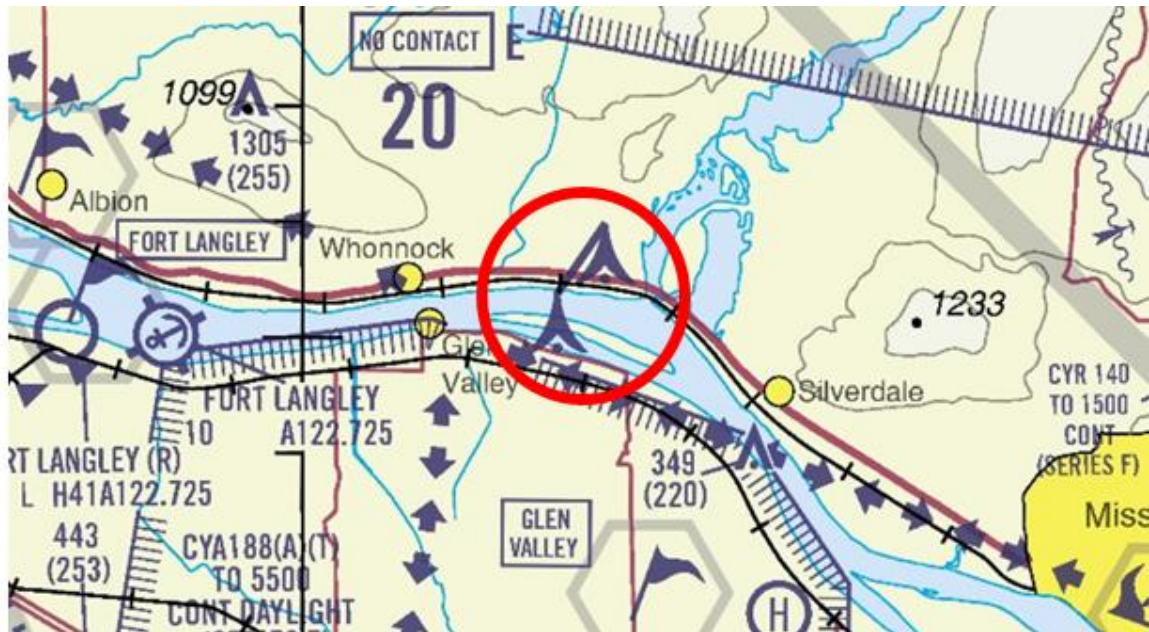
Therefore, given their height above the water, the power transmission lines did not constitute an obstacle to air navigation according to that regulation; however at an undetermined date prior to 2008, Transport Canada (TC) deemed the crossing to be an obstacle to navigation as the power lines were in close proximity to the VFR route through the Glen Valley practice area. As a result of this determination, lights were installed on the suspension towers, and the power transmission lines were depicted on the VFR navigational chart for the area (Figure 3).

Figure 3. Visual flight rules navigational chart for the area. The power lines crossing the Fraser River are circled. (Source: NAV CANADA, with TSB annotations)

As a result of the inactive suspension tower lighting, a recurring NOTAM was issued in 2015, indicating that the cable crossing was unmarked. This NOTAM was still valid at the time of occurrence. The investigation was unable to determine if the flight instructor or student were aware of the NOTAM, or if they were aware that the power transmission lines were indicated on the navigational chart.
