AIR TRANSPORTATION SAFETY INVESTIGATION REPORT A21C0088

DYNAMIC ROLLOVER

Canadian Helicopters Limited (doing business as Acasta HeliFlight Inc.)
Bell 206L-1 (helicopter), C-GIKX
Hope Bay Aerodrome, Nunavut, 8 NM SSW
14 September 2021

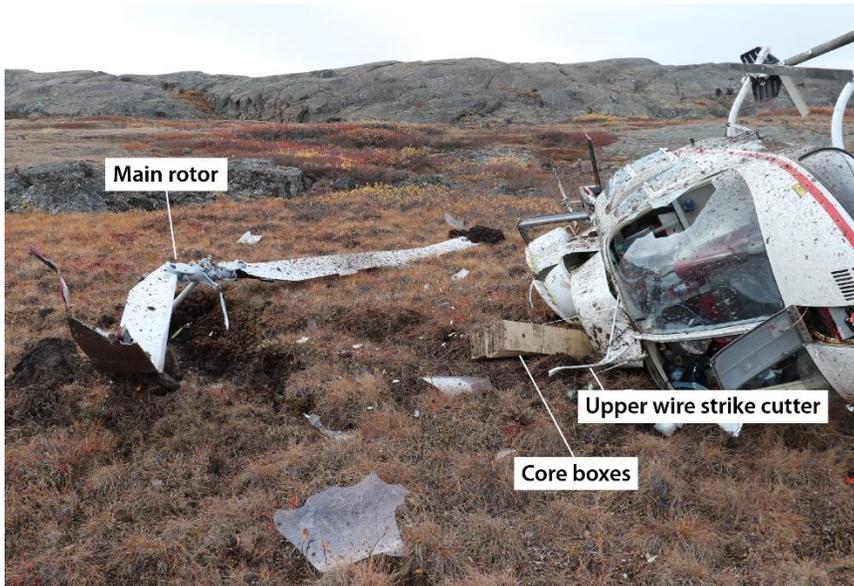
The helicopter sustained significant damage and was lying on its right side on an easterly heading. Most of the debris was located within a small area near the helicopter; however, pieces of the main-rotor blades were found further away. The main-rotor blade assembly and mast separated from the transmission and were found lying beside the helicopter. The engine exhaust duct and cowling were crushed, and deformation of the upper wire strike cutter indicated that the helicopter may have rolled almost 180° before falling back and coming to rest on its right side (Figure 1).

Figure 1. Photo of the wreckage showing the helicopter on its right side, the main rotor and the core boxes (Source: Royal Canadian Mounted Police)

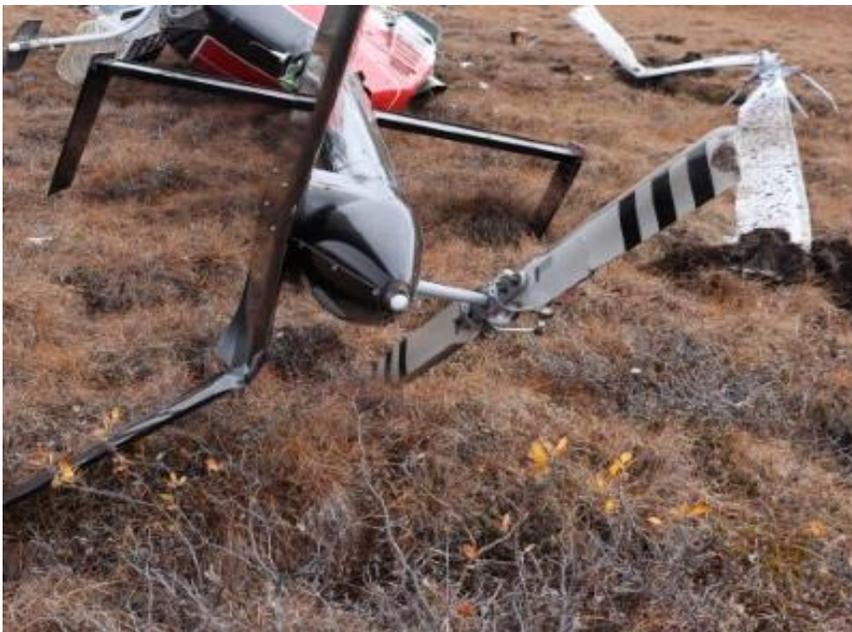
The helicopter tail boom was damaged, with the vertical fin and tail boom rotated 180°. The tail rotor remained attached with damage to one blade indicating a low-energy impact with the ground (Figure 2).

Figure 2. Photo of the tail rotor (Source: Royal Canadian Mounted Police)
