AIR TRANSPORTATION SAFETY INVESTIGATION REPORT A21Q0090

COLLISION WITH WATER AND CAPSIZING

Privately registered
Piper PA-18S-150 (floatplane), C-FVPZ
Rivière du Lièvre, Ferme-Neuve, Quebec
24 September 2021

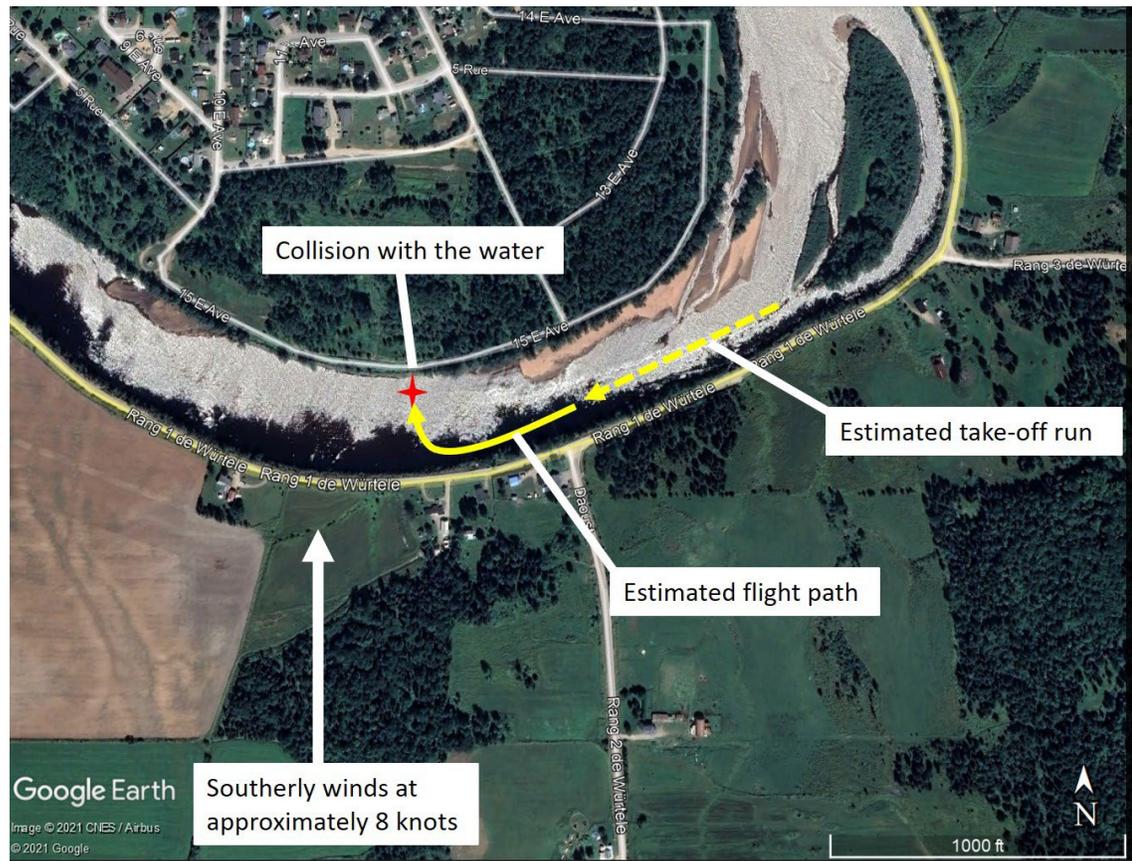
A person on the south bank of the river observed the aircraft near the surface of the water, in a steep right bank, shortly after takeoff. After briefly losing sight of the aircraft, the person then saw it inverted in the river (Figure 1). The person immediately called 911 to contact emergency services, which quickly arrived on the scene. The 2 occupants were found drowned. The passenger was partially out the door. The aircraft sustained major damage to the left wing.

Figure 1. Satellite image illustrating the occurrence aircraft's estimated take-off run and flight path, as well as the winds and the site of the collision with the water (Source: Google Earth, with TSB annotations)

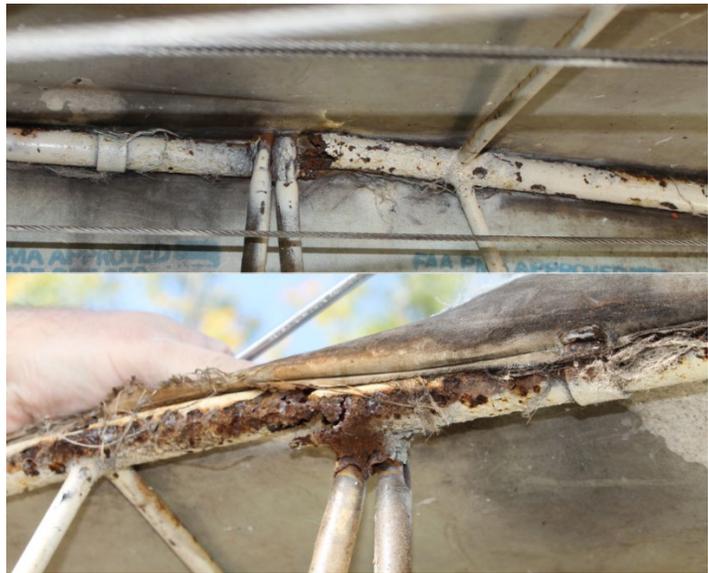
The wooden block supporting the battery showed significant signs of deterioration over time. Also, the steel tube structure below the battery showed significant signs of corrosion; it was severed in 2 places due to this corrosion (Figure 3). The technical record for the airframe made no mention of structural corrosion following the annual inspection of the aircraft in June 2021. One area of corrosion was visible from the outside, and another area was visible through a hatch that could be opened by an aircraft maintenance engineer during an annual inspection. There is no indication that the corrosion found during the investigation played a role in this occurrence.

Figure 3. Photos of the steel tube structure below the battery that were severed by corrosion, taken from 2 different angles (Source: TSB)

It is crucial that any deficiencies noted during an annual inspection be recorded in the aircraft's technical records so that they can be rectified to ensure the safety of flights.

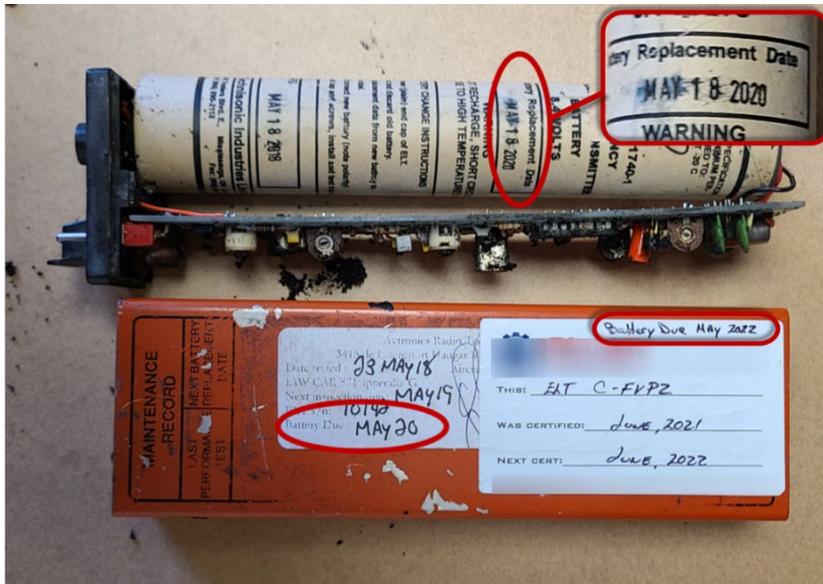
A more detailed examination by the TSB Engineering Laboratory in Ottawa, Ontario, revealed that the ELT functioned despite the low voltage in the internal battery. According to the tag affixed to the ELT when maintenance was last carried out in June 2021, the battery was due for replacement in May 2022. However, the replacement date indicated on the internal battery itself was 18 May 2020,

which matches the date indicated on the tag affixed when the previous maintenance was carried out on 23 May 2018^{4,5} (Figure 4).

Figure 4. Photo of the emergency locator transmitter showing the replacement date of the internal battery in the close-up (Source: TSB)
