AIR TRANSPORTATION SAFETY INVESTIGATION REPORT A21O0069

MID-AIR COLLISION

Toronto/Buttonville Municipal Airport, Ontario, 1.2 NM NW

10 August 2021

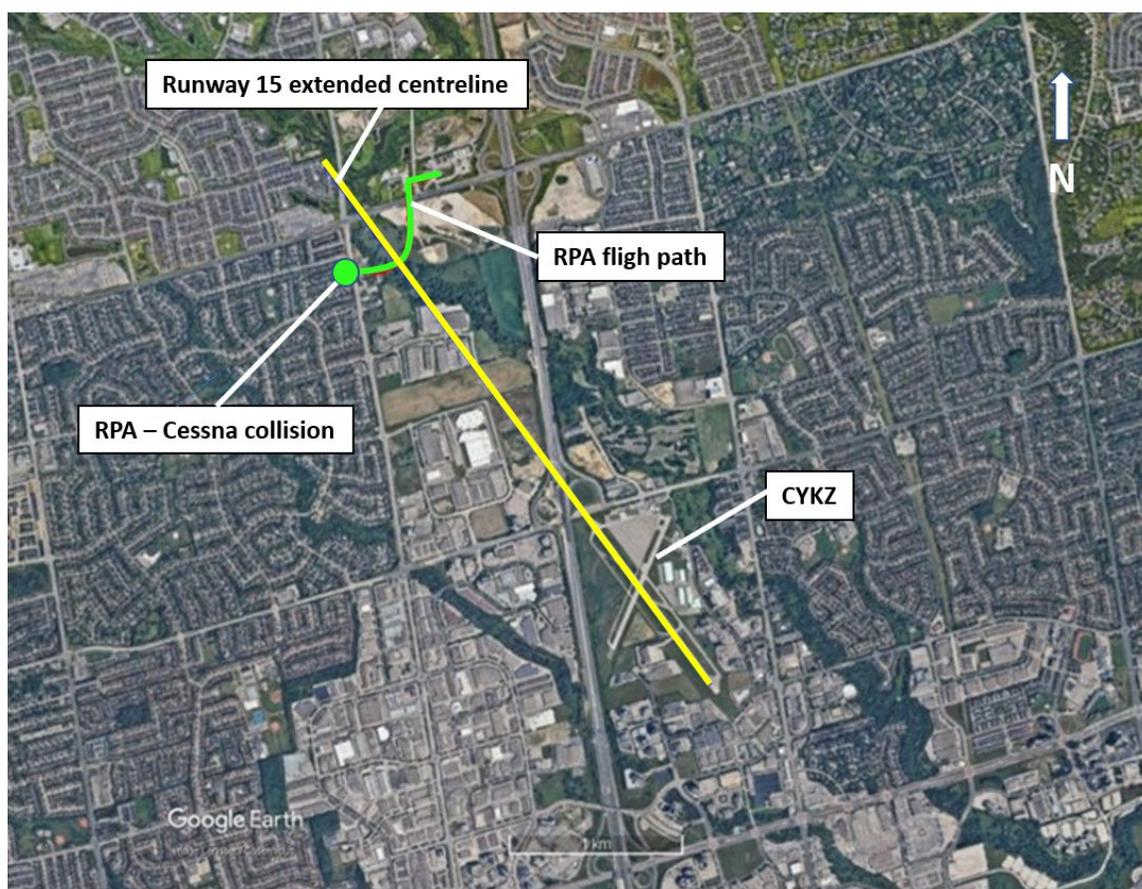
The RPA was in a stationary hover for more than 2 minutes when, at 1301, a collision occurred with the Cessna, which was on final approach for Runway 15 (Figure 1), approximately 1.2 NM from the threshold, and travelling at approximately 65 knots.

Figure 1. Overview of Toronto/Buttonville Municipal Airport, Ontario, and surrounding area, showing the collision location, the Runway 15 centreline, and the remotely piloted aircraft's flight path (Source: Google Earth, with TSB annotations)

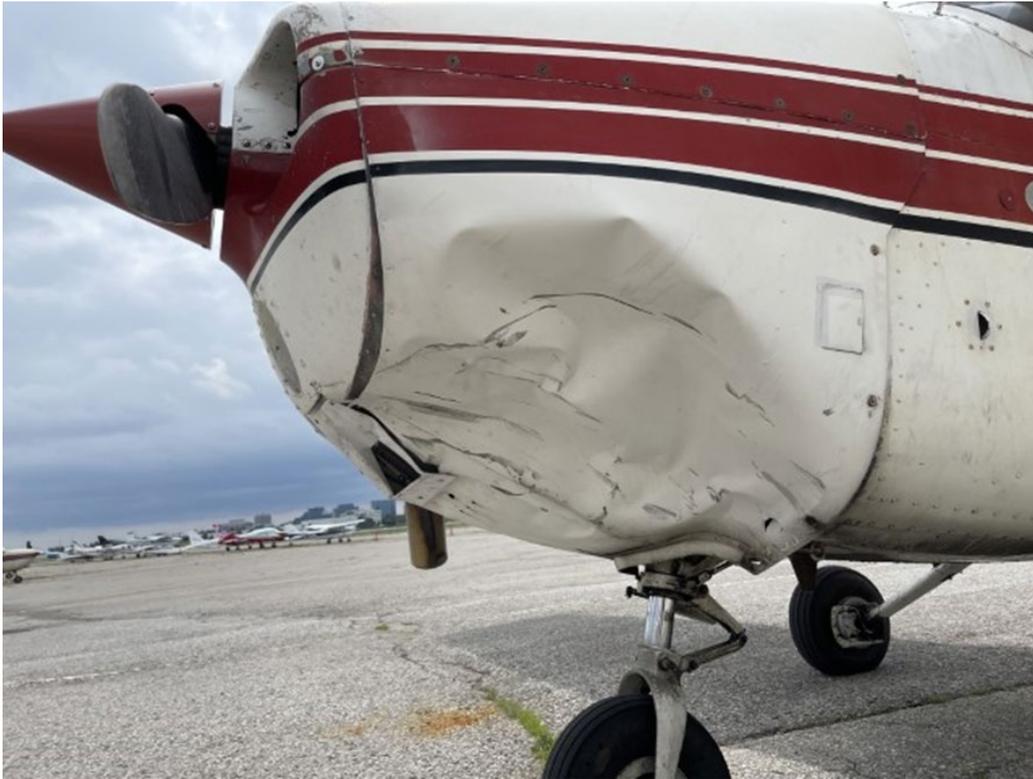
The Cessna had damage to the left lower engine cowling and carburetor air-box and minor scratches on the propeller (Figure 2).

Figure 2. Photo of the damage to the occurrence airplane (Source: Canadian Flyers International Inc.)

The Cessna sustained damage to the front cowl and the carburetor air box. The propeller sustained some minor scratches.

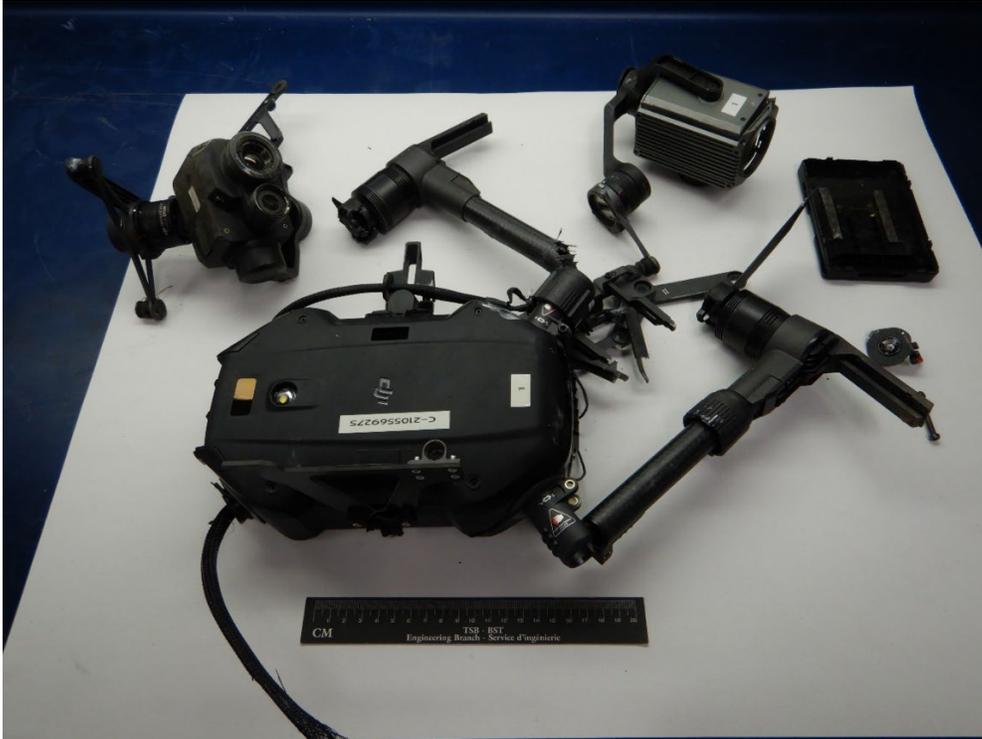
The RPA was destroyed (Figure 3).

Figure 3. Photo of the occurrence remotely piloted aircraft parts that were recovered (Source: TSB)

The DJI Matrice M210 was destroyed as a result of the collision. Most of its parts were recovered near the site of the police operation by YRP members following a brief search. The parts were sent to the TSB Engineering Laboratory in Ottawa, Ontario. The non-volatile memory recovered from the RPA yielded data about the exact location of the RPA at the time of the collision. The location corresponds to the position of the Cessna, and was along the standard final approach path to Runway 15.
