AIR TRANSPORTATION SAFETY INVESTIGATION REPORT A21P0124

LOSS OF CONTROL AND COLLISION WITH TERRAIN

Privately registered
Cessna R182, C-FBKJ
Hope Aerodrome, British Columbia, 18 NM NE
15 November 2021

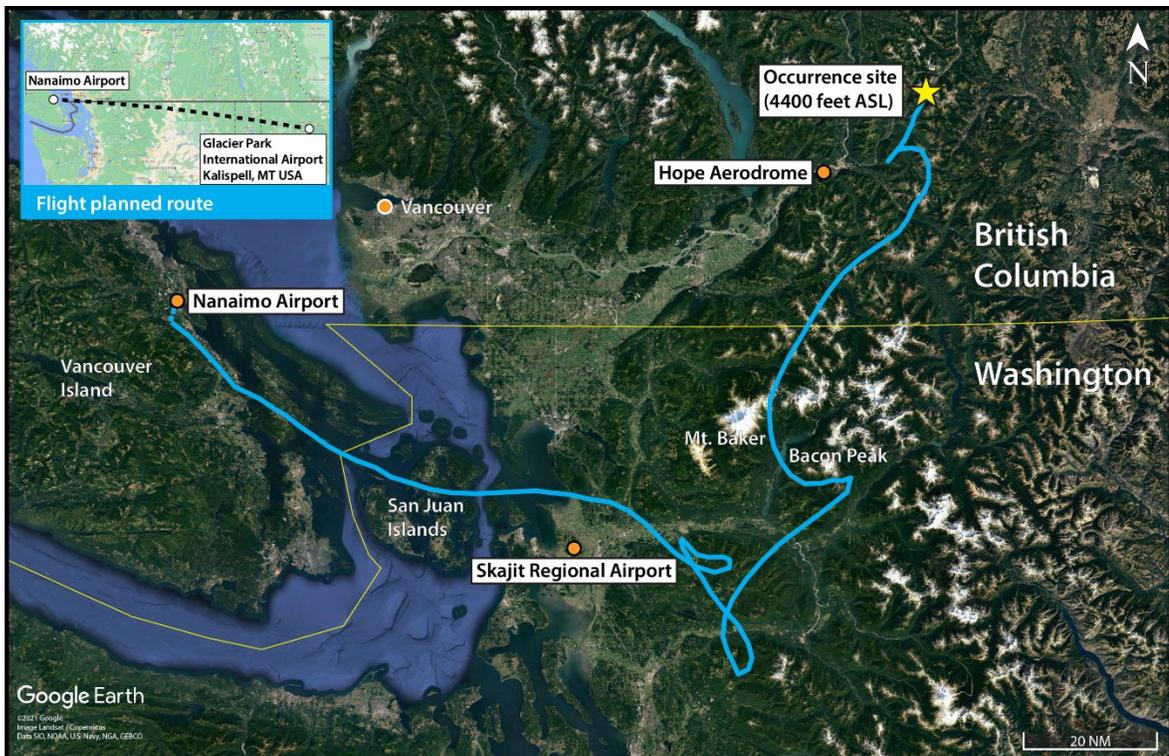
Figure 1. Occurrence aircraft's flight path, with the intended flight path in inset (Source: Google Earth, with TSB annotations)

spiral pattern from which it did not recover. The last recorded radar target was at 1541, at which time the aircraft was at an altitude of approximately 8700 feet ASL heading toward Needle Peak, BC (Figure 1).

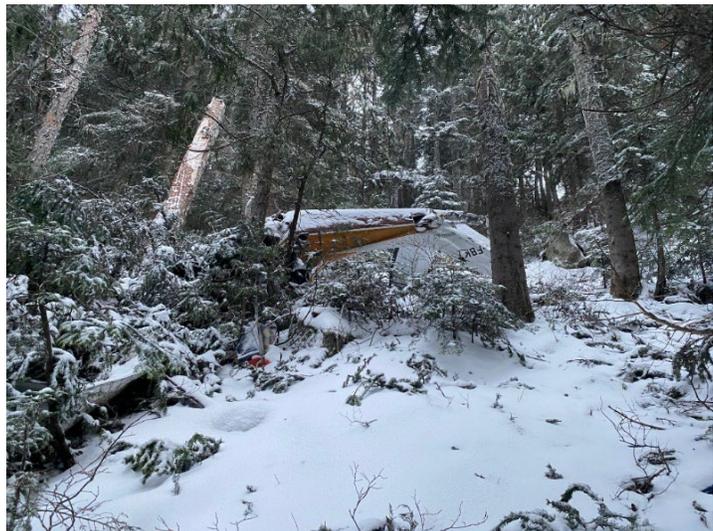
The aircraft was found upside down on a forested 39° slope (Figure 2). Damage to the aircraft was consistent with the aircraft striking trees in a steep nose-down attitude. Both wings and the engine had come off the main fuselage. The aircraft collided with the ground approximately 40 feet from where it first struck the trees. This impact is consistent with a loss of control of the aircraft.

Figure 2. Accident site (Source: Joint Rescue Coordination Centre)

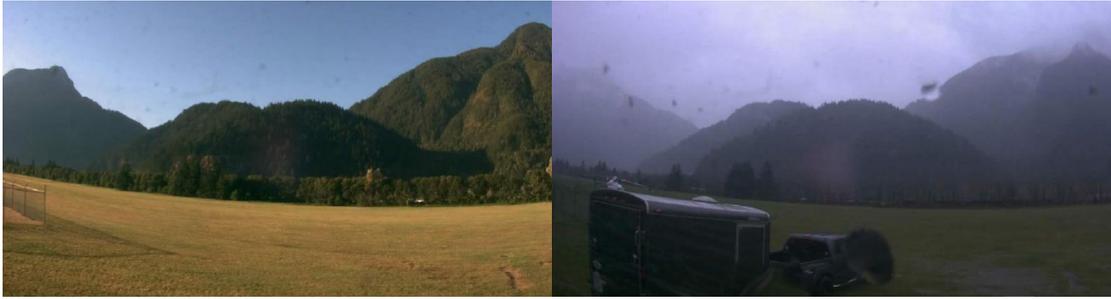
NAV CANADA operates automated weather cameras at CYHE. Figure 3 shows the southeast view taken by the cameras on both a clear day and on the day of the occurrence.

Figure 3. Southeast view taken at Hope Aerodrome on a clear day (left) and at approximately 1500 on the day of the occurrence (right) (Source: NAV CANADA)
