AIR TRANSPORTATION SAFETY INVESTIGATION REPORT A21Q0092

LOSS OF ENGINE POWER AND COLLISION WITH TERRAIN

Cessna 172M, C-FFRV

02 October 2021

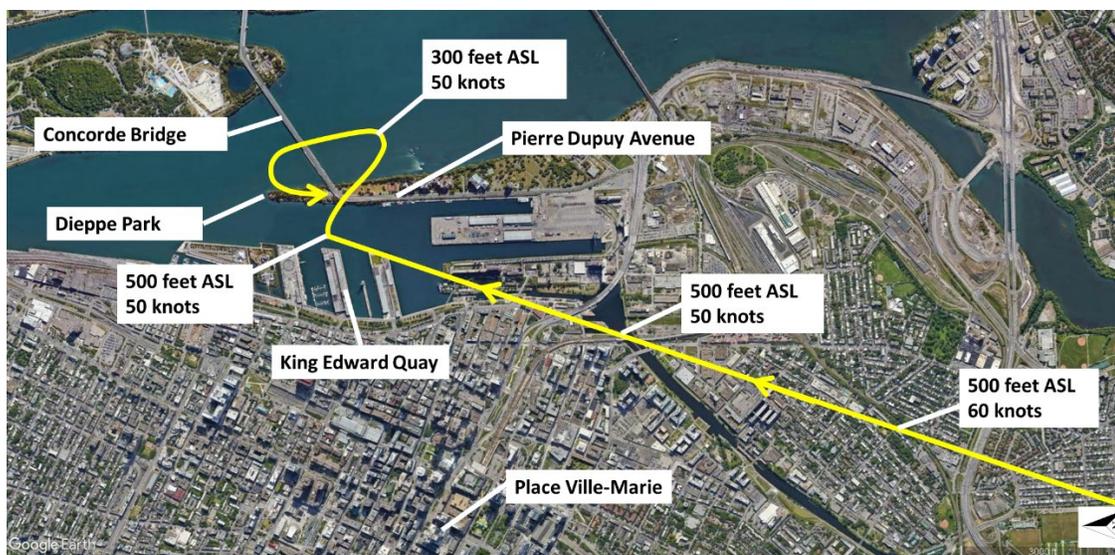
Shortly thereafter, while the aircraft was flying over the river, the engine sputtered and the pilot turned on the carburetor heat control. The engine seemed to regain some power, but then sputtered and lost power again. The aircraft was no longer able to maintain its altitude. The pilot then began a left turn and released the banner in preparation for an emergency landing on the Concorde Bridge. However, after noticing concrete barriers on the bridge indicating that construction work was in progress, which prevented a safe landing, the pilot continued the turn with the intention of landing on Pierre-Dupuy Avenue (Figure 1). At the time of the emergency landing, CYUL was reporting winds from the northeast at 6 knots.

Figure 1. Image showing the occurrence aircraft’s final path (Source: Google Earth, with TSB annotations)

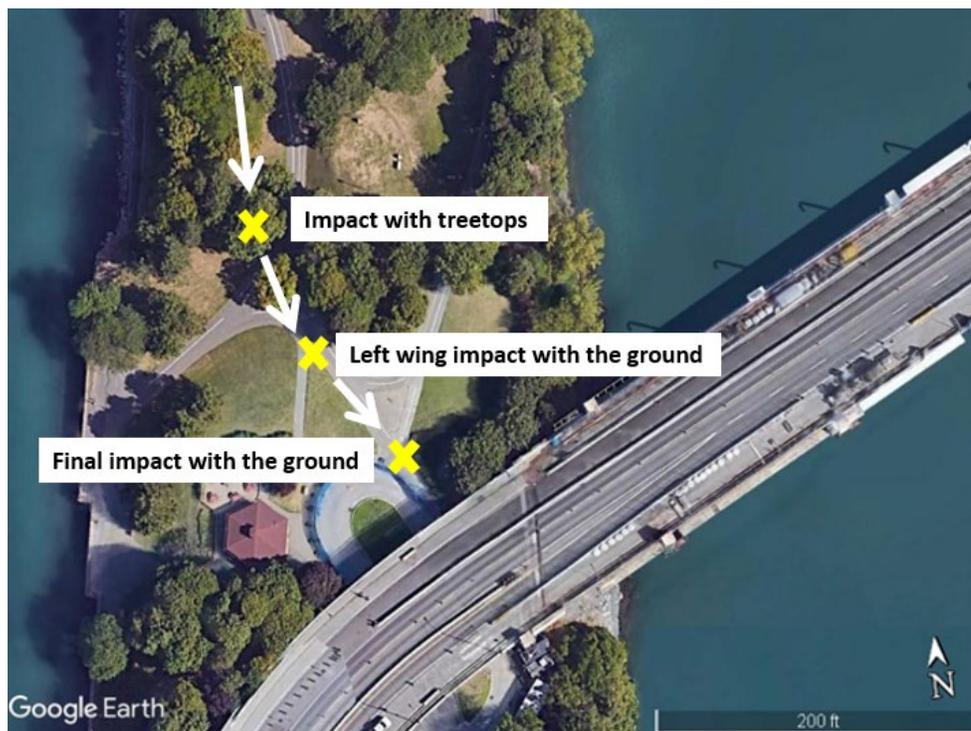
Broken branches on 2 trees near the west bank of Dieppe Park identified where the aircraft’s initial impact took place, just north of the bend that connects the west tip of the Concorde Bridge to the start of Pierre-Dupuy Avenue. There was a short distance between the damaged trees and the ground scars left by the left wing and propeller, which were found in a section of the park where there were no trees. Based on the wreckage distribution pattern, the aircraft was flying southward when it made initial contact with the trees before quickly deviating to the southeast. The aircraft came to rest on a concrete flower bed, about 10 m from the ground scar left by the propeller. At the end of the impact sequence, the aircraft was resting in one piece, on its nose, with its belly lying on the concrete flower bed, facing southwest (Figure 2).

Figure 2. Image showing the occurrence aircraft's impact sequence (Source: Google Earth, with TSB annotations)

The fire that broke out consumed the aircraft's entire fuselage, sparing parts of the wings and the empennage, which had fallen to the ground. The damage to the left wing was consistent with the impact with the trees and the ground. Although there was a fuel leak after the impact, there was still fuel in the wing tanks. Given the amount of damage to the wreckage, the investigation was unable to determine the position of the ancillary controls (carburetor heat and mixture) or the throttle.

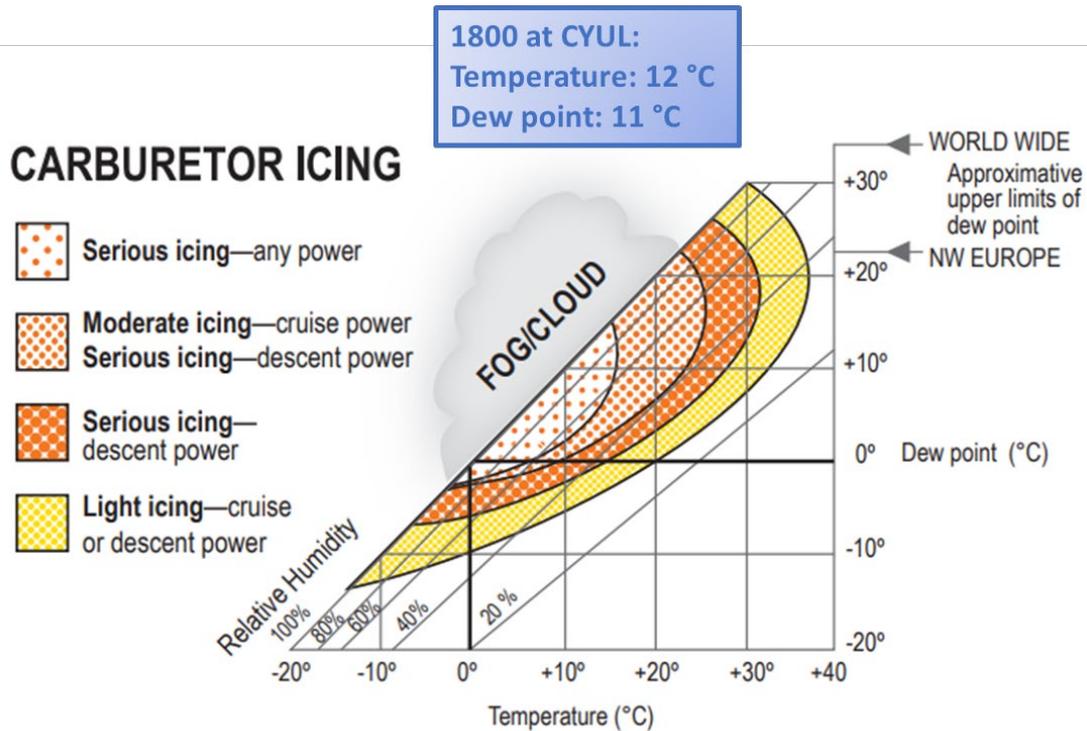
Figure 5. Diagram showing carburetor icing in relation to atmospheric conditions (Source: Transport Canada, TP 14371, Transport Canada Aeronautical Information Manual [TC AIM], AIR – Airmanship [25 March 2021], section 2.3, with TSB annotations.)

According to the above diagram, the temperature and dew point in the Montréal area at the time of the occurrence were conducive to serious carburetor icing at any power.
