# AIR TRANSPORTATION SAFETY INVESTIGATION REPORT A22A0067

## COLLISION WITH TERRAIN

Privately registered  
Piper PA-46-350P, N5EQ  
Goose Bay Airport, Newfoundland and Labrador, 2.5 NM SW  
14 December 2022

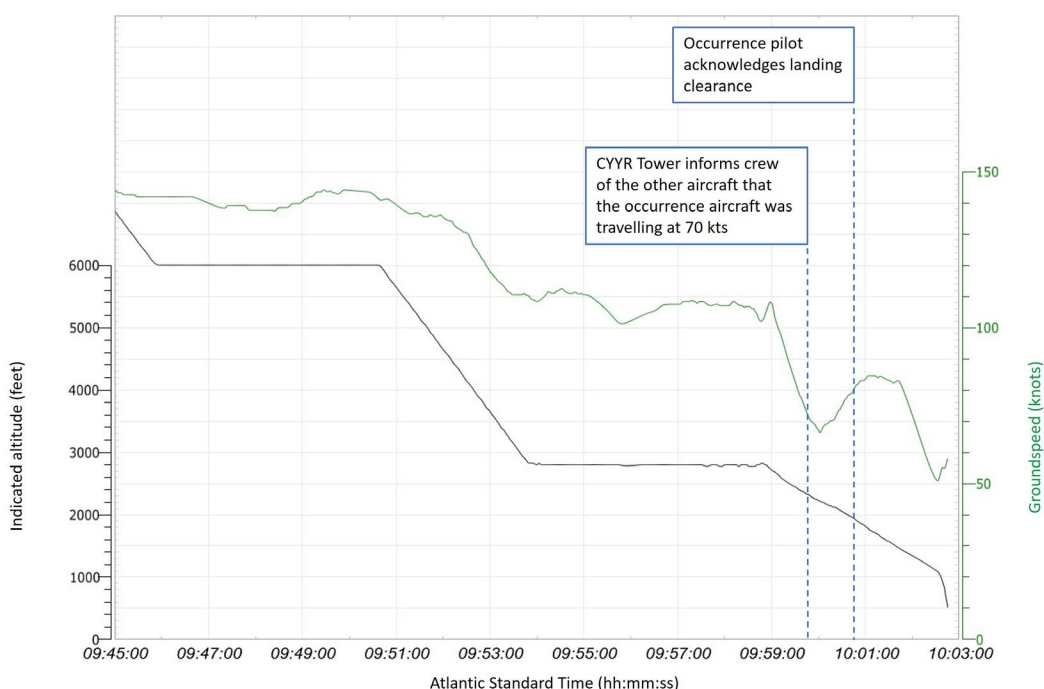
At about 0958, the aircraft crossed the final approach fix / final approach waypoint FAFKO at 2800 feet ASL, travelling at a ground speed<sup>4</sup> of 104 knots, and began the final descent. Although the descent remained steady on a 3° profile, the ground speed decreased continuously for about 60 seconds. At 0959:50, CYR tower informed the crew of another aircraft that they were number 2 for Runway 08 following the occurrence aircraft, which was 7 miles on final at 70 knots. That crew replied that they would reduce their speed. The occurrence aircraft's ground speed, which had decreased to 67 knots, then began to increase while the aircraft remained on a steady 3° approach profile (Figure 1).

**Figure 1. Plot of automatic dependent surveillance – broadcast data obtained from NAV CANADA, with annotations identifying timing of air traffic services communications (Source: TSB)**

At 1000:31, the occurrence pilot reported at waypoint SATAK, and the ground speed had increased to above 80 knots. The tower provided the pilot with updated wind information<sup>5</sup> and cleared the aircraft to land on Runway 08. The pilot acknowledged the clearance at 1000:49. Soon after, the ground speed began to decrease at a rate similar to the previous rate. At 1002:47, it had

decreased to 51 knots. The aircraft departed controlled flight and impacted terrain when it was about 2.5 NM southwest of the airport along the extended centreline for Runway 08.

As part of a stable approach, it is important that airspeed is stabilized early so that only small changes are required. This allows more time and attention for monitoring and maintaining situational awareness.

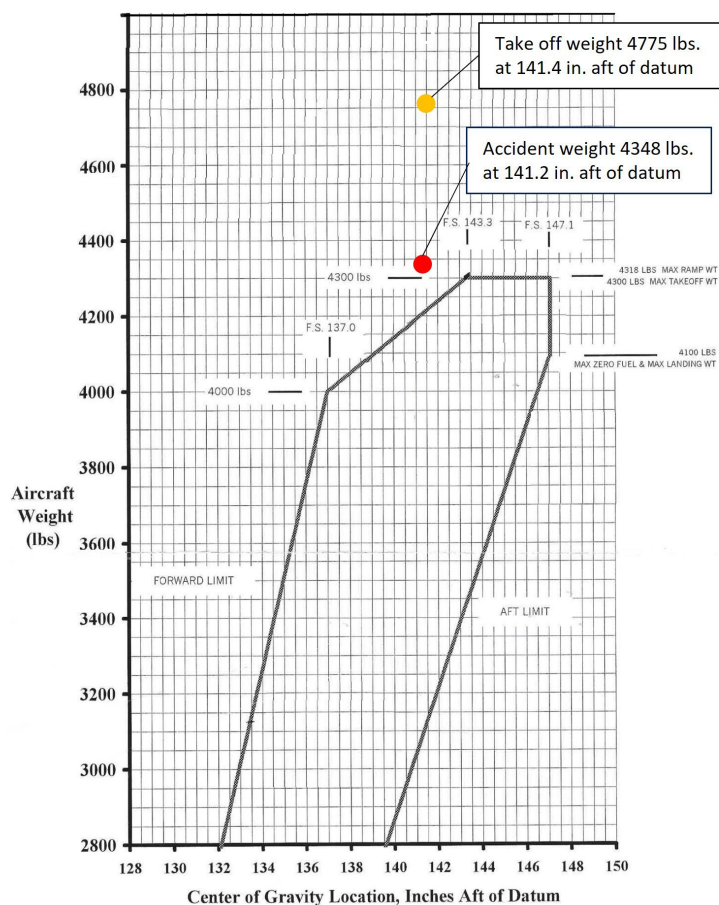
Records show that the aircraft departed CYZV with full fuel. The weight and balance report for the occurrence aircraft listed the useful load as 1216.73 pounds. With full fuel, there would have been about 160 pounds of available capacity for occupants, baggage, and cargo. All on-board items were weighed, and the aircraft total weight was about 4775 pounds at takeoff, with the centre of gravity estimated to be 141.4 inches aft of the datum. The aircraft weight at the time of the accident was calculated to be about 4348 pounds with an estimated centre of gravity 141.2 inches aft of the datum (Figure 2).

Figure 2. Graph showing the aircraft weight and balance at takeoff and at the time of the accident compared with the manufacturer's reference weight and balance envelope (Source: JetPROP, LLC, JetProp DLX Pilot's Operating Handbook and FAA Approved Airplane Flight Manual [01 July 2014], last page of Section 6: Weight and balance, with TSB annotations)

The aircraft's weight was above the maximum take-off weight limitation; however, it could not be determined whether the aircraft loading contributed to the loss of control in this occurrence.

If an aircraft is loaded above the maximum take-off weight, it will have lower overall performance than what would normally be expected. In particular, an overweight condition will increase take-off and landing distances, increase the stall speed, decrease the rate of climb and the cruise speed, and reduce the aircraft's range. The TSB has previously identified the risks associated with operating above the maximum allowable gross weight and the effect that it can have on aircraft performance.<sup>14</sup>

Pilots are reminded that loading an aircraft outside the approved limits can adversely affect its handling and performance.

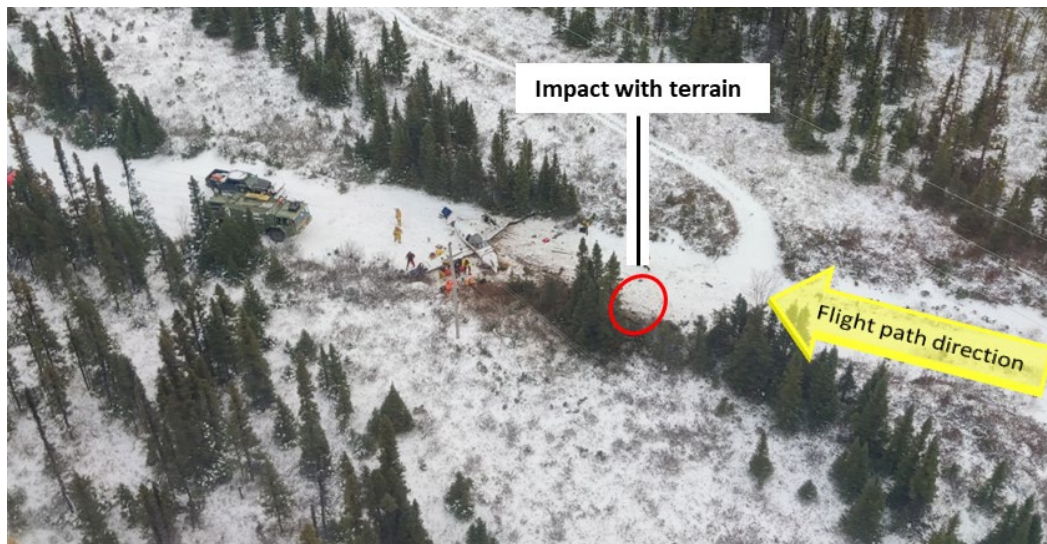
Strike damage on trees indicates the aircraft was on a final descent angle of 37° to the point of ground impact. Ground impact marks indicate the aircraft initially struck the road aligned with the extended centreline of CYR Runway 08; aircraft damage indicates impact at a relatively level attitude. The left wing struck the base of a tree and the aircraft yawed, and travelled tail-first along the road. It came to rest about 14 m from the initial ground impact. The damage is consistent with a low-speed loss of control (Figure 3).

Figure 3. Aerial view of the accident site showing the flight path direction and where the aircraft impacted terrain and came to a rest (Source: Department of National Defence, with TSB annotations)

The aircraft landing gear was in the extended position at impact. The wing flaps were between the 0° and 10° positions, and the flap motor circuit breaker had tripped.<sup>21</sup> Damage to the engine and propeller indicates that significant power was being produced during the impact sequence. There was no indication that a component or system failure contributed to the aircraft loss of control. First responders did not note any signs of accumulated ice on the aircraft wings, vertical and horizontal stabilizers, or antenna leading edges.
