AIR TRANSPORTATION SAFETY INVESTIGATION REPORT A22O0046

COLLISION WITH TERRAIN

Privately registered
Piper PA24-250 (Comanche), C-GEWK
Wawa, Ontario, 11.5 NM SSW
14 April 2022

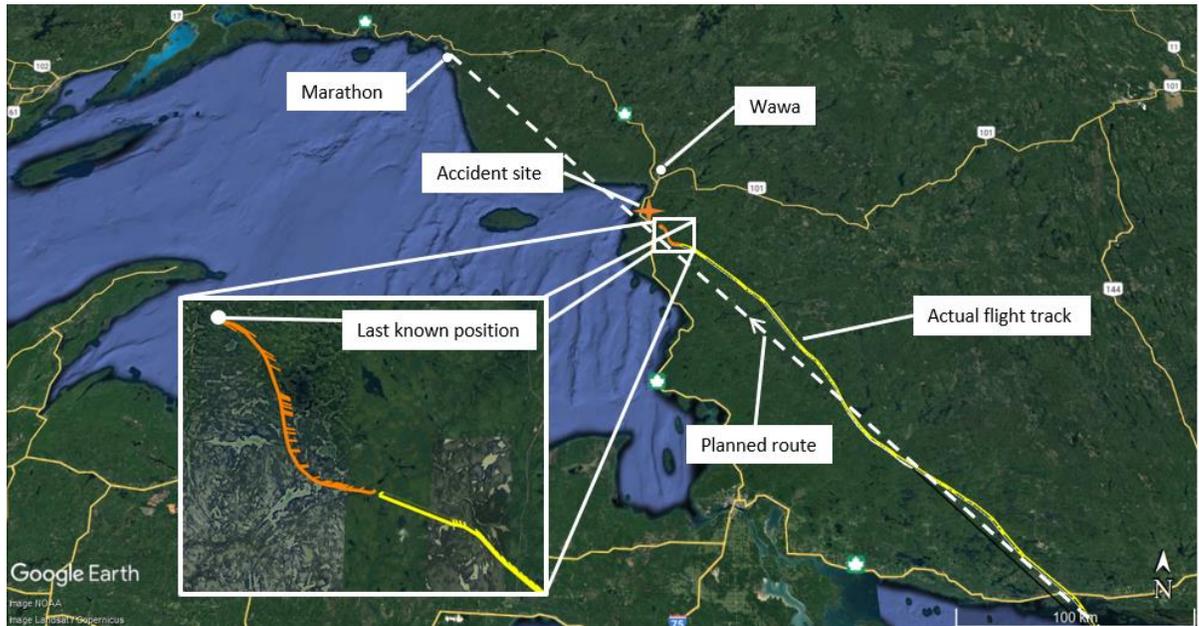
On 21 May 2022, a helicopter operator involved in a private search identified what seemed to be aircraft parts in an open swampy area and notified the OPP. An OPP helicopter that was also conducting search operations in the area landed near the site and identified the parts as those of the occurrence aircraft. The crash site was 6 NM northwest of the aircraft's last known position (Figure 1). The 2 occupants had been fatally injured. The aircraft was destroyed.

Figure 1. Map showing the planned route, the actual flight track, and the accident site, with an inset showing the aircraft's heading changes and last known position (Source of main image and inset: Google Earth, with TSB annotations)

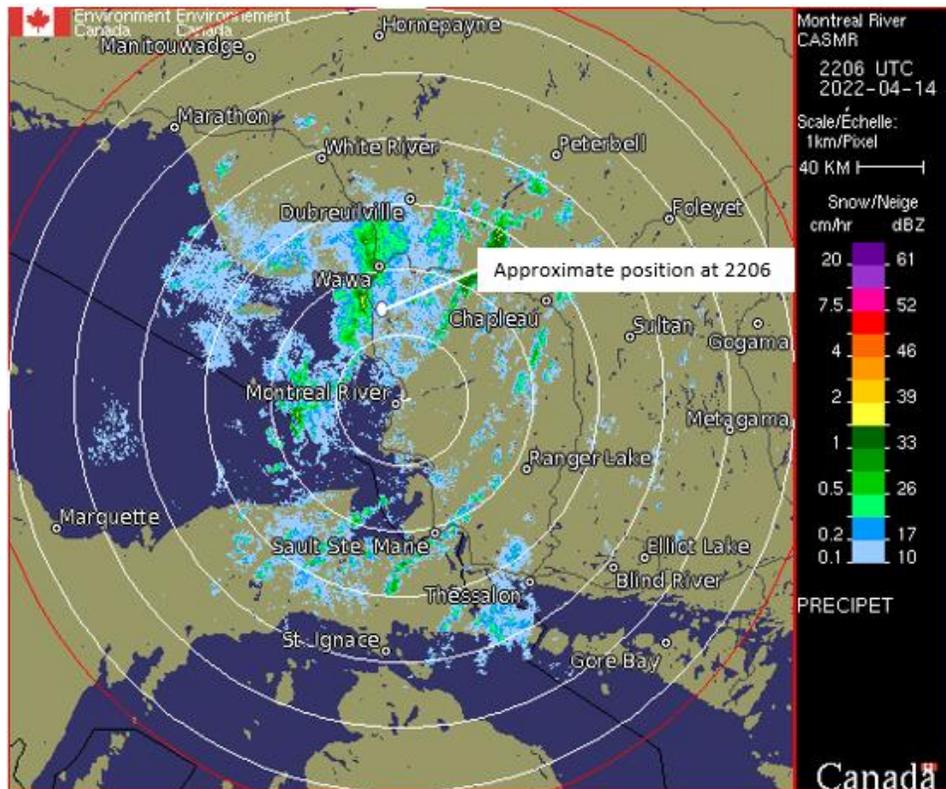
Figure 2. Weather radar information of the area, with the aircraft's approximate position at 2206 Eastern Daylight Time (Source: Environment and Climate Change Canada, with TSB annotations)

The Environment and Climate Change Canada weather radar showed snow precipitation moving over the occurrence area from the southwest at the time the last known position was recorded (Figure 2).
