# AIR TRANSPORTATION SAFETY INVESTIGATION REPORT A22O0165

## COLLISION WITH TERRAIN

Privately registered  
Cessna 150G, C-FQCS  
Bainsville, Ontario  
05 December 2022

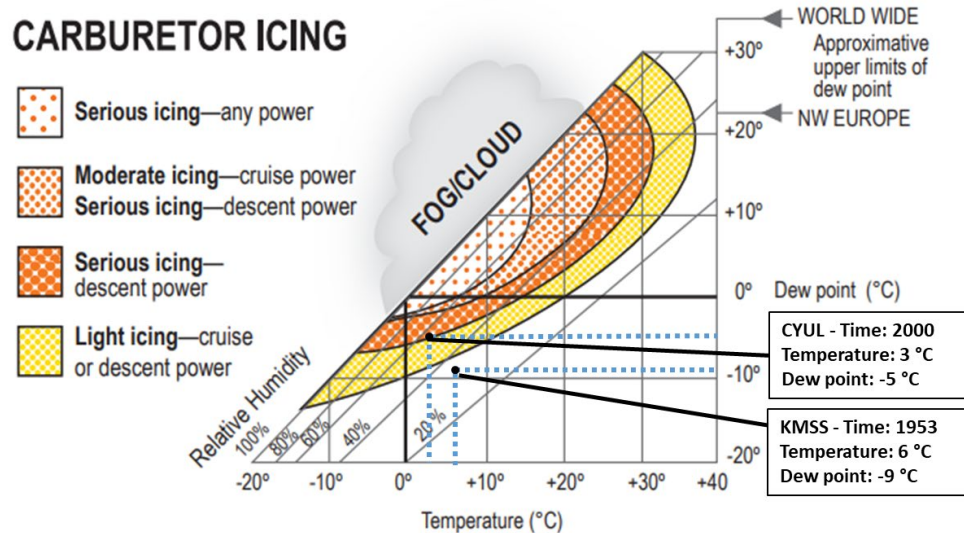
Figure 3. Carburetor icing potential based on ground-level weather conditions near Montréal/Pierre Elliott Trudeau International Airport, and Massena International-Richards Field Airport (Source: Transport Canada, TP 14371, Transport Canada Aeronautical Information Manual [TC AIM], AIR – Airmanship [06 October 2022], section 2.3, with TSB annotations)

Although the chart indicates that the temperature and dew point at KMSS were not conducive to carburetor icing at the time of the occurrence, it indicates that there was potential for serious carburetor icing at descent power in the CYUL area.

Based on the conditions at the time of the occurrence, there was a potential for serious carburetor icing with descent power. Even though the investigation was unable to determine if carburetor icing was a factor in this occurrence, pilots are reminded that carburetor icing can occur at various temperatures and all engine power settings.
