AIR TRANSPORTATION SAFETY INVESTIGATION REPORT A22W0027

IN-FLIGHT ICING AND COLLISION WITH TERRAIN

Privately registered
Mooney M20K, C-GQMS
Calgary/Springbank Airport, Alberta, 0.6 NM S
22 April 2022

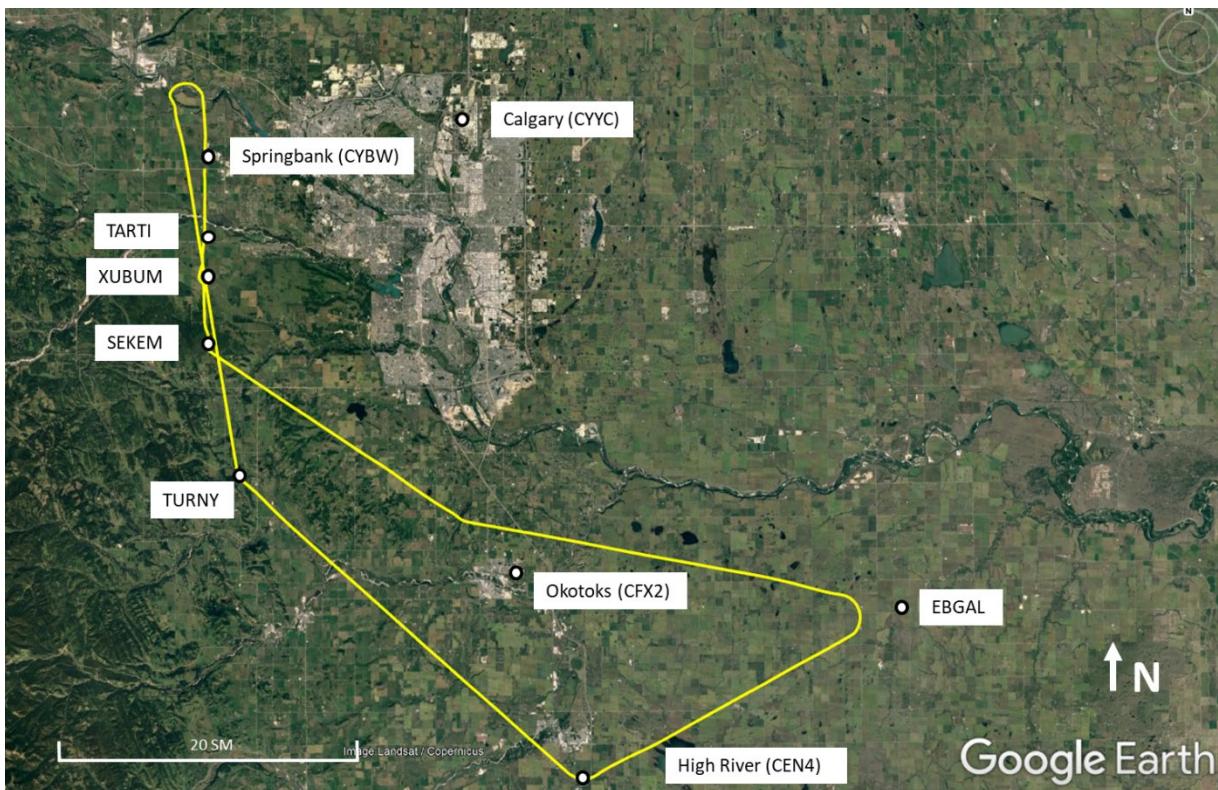
of approximately 8000 feet ASL, it turned slightly to the right to cross the initial approach waypoint (SEKEM) and return to CYBW for an instrument approach and landing on Runway 35 (Figure 1).

Figure 1. Area map showing the occurrence flight path (yellow line) (Source: Google Earth, with TSB annotations)

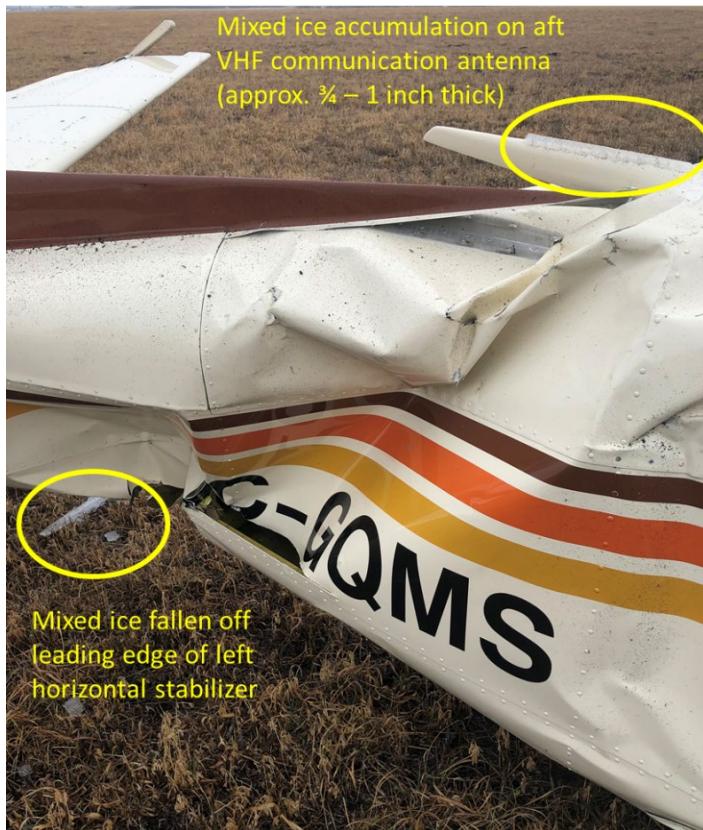
Figure 3. Mixed ice accumulation on aft VHF (very high frequency) communication antenna (Source: Royal Canadian Mounted Police, with TSB annotations)

RCMP (Royal Canadian Mounted Police) officers from the Cochrane detachment responded shortly after the accident. Several photos were taken of the exterior of the aircraft and shared with the TSB. The photos revealed a build-up of mixed ice on the aft VHF (very high frequency) communication antenna, the leading edges of the horizontal stabilizer, and the leading edge of the left wing (figures 3 and 4). The investigation estimated the build-up of the mixed ice on the VHF communication antenna to be between $\frac{3}{4}$ and 1 inch thick.

Weather conditions that are conducive to icing are difficult to predict. If icing is encountered when flying aircraft that are not certified for icing conditions, it is imperative that pilots exit the icing conditions immediately. Additionally, pilots should treat this situation as an emergency and declare it as such in order to obtain all available assistance.

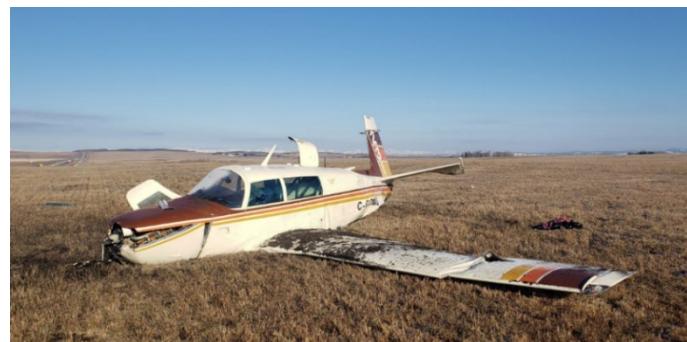
The aircraft collided with the bank of a ditch on the north side of the westbound lanes of the Trans-Canada Highway. The aircraft hit the ground in right-wing-low, nose-down attitude, went through a barbed wire fence, and came to rest 68 feet north of the ditch, facing a southerly direction (Figure 2).

During the impact sequence, the right wing broke off the aircraft, the crankshaft propeller flange and propeller broke free, the left main landing gear was torn from the left wing, and the left elevator contacted the field, resulting in significant damage and distortion to the aft fuselage. After the aircraft came to rest, the engine continued to run at high speed because there was no longer any propeller load on the engine. Bystanders turned off the ignition to the engine and provided assistance to the aircraft occupants.

Figure 2. Accident site looking northwest (Source: TSB)

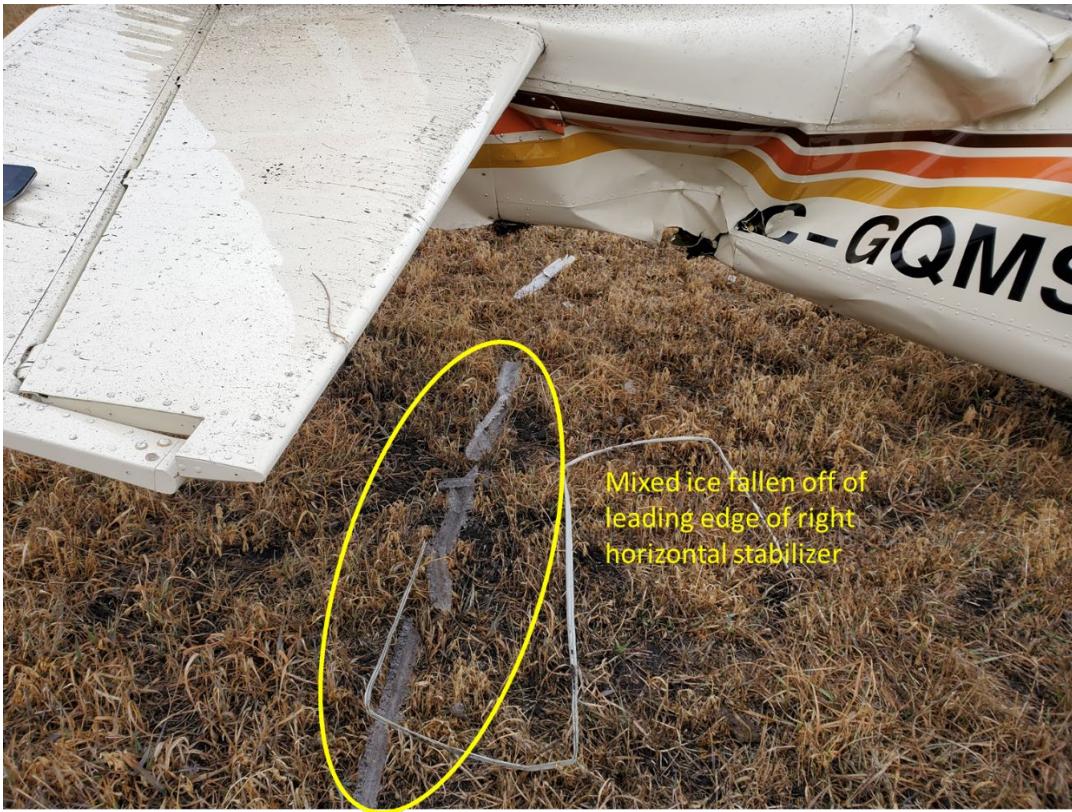
Figure 4. Horizontal stabilizer mixed ice (Source: Royal Canadian Mounted Police, with TSB annotations)
