AIR TRANSPORTATION SAFETY INVESTIGATION REPORT A22W0057

COLLISION WITH TERRAIN

Privately registered
Zlin Aviation s.r.o. Savage Cub (advanced ultralight), C-IILH
Didsbury, Alberta, 7 NM E
13 July 2022

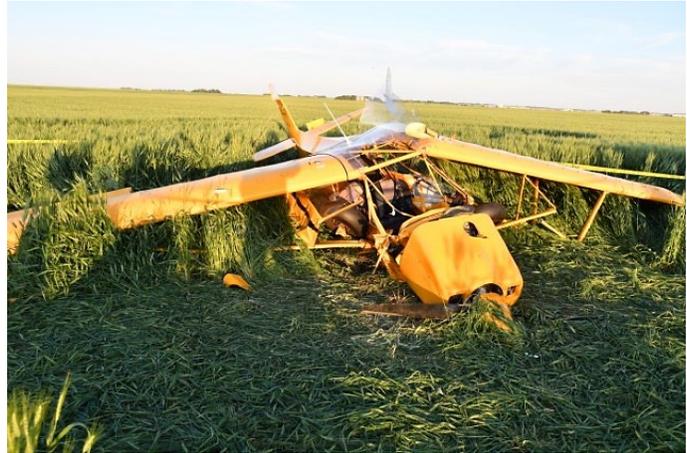
Figure 2. Aircraft accident site, looking east (Source: TSB)

The aircraft struck the ground with little-to-no forward speed in a shallow, nose-down attitude with a slight right-wing-low bank angle. The right main gear was pushed up into the aft cabin area. The left main gear was bent to the left of the fuselage. Both wing struts failed from downward bending, with the left wing tip resting on the ground (Figure 2). Continuity of all flight and engine controls was confirmed.
