# AIR TRANSPORTATION SAFETY INVESTIGATION REPORT A23C0048

## COLLISION WITH TERRAIN

Custom Helicopters Ltd.  
Bell 206L (helicopter), C-FQHB  
Grise Fiord, Nunavut, 52 NM S (Devon Island)  
28 June 2023

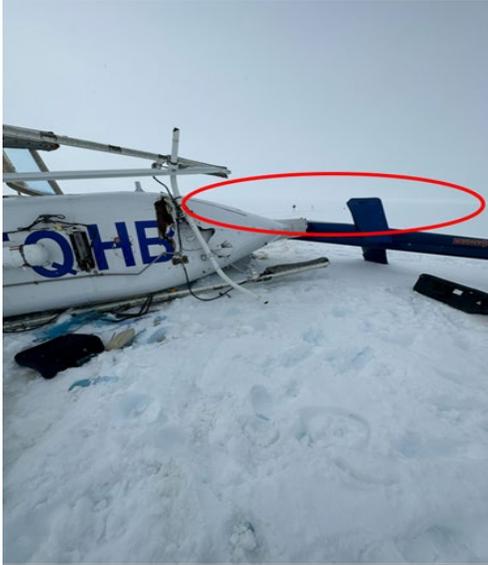
This accident occurred while the helicopter was crossing a glacier at low altitude. Once the helicopter had passed the rocks being used as visual reference, the pilot lost visual reference to the surface in flat-light conditions.

Photos taken shortly after the occurrence show that flat-light conditions were prevalent at the time of the accident (figures 1 and 2).

Figure 1. Photo taken shortly after the occurrence, showing flat-light conditions with the lack of surface definition (Source: Custom Helicopters Ltd.)

In response to this occurrence, Custom Helicopters Ltd. added flat-light training to its *Company Operations Manual* and now provides arctic meteorological training for pilots who are assigned to remote locations. A Flight Operations Instruction was also issued for arctic, glacier, and winter operations with instructions and training for establishing, using, and maintaining staking/flagging in remote landing areas. Improvements have been made to its flight monitoring and operational support via structured use of satellite communications for flight planning/following and weather reporting. Custom Helicopters Ltd. also made enhancements to pilot training by including the correct set-up and use of ForeFlight's synthetic vision system.

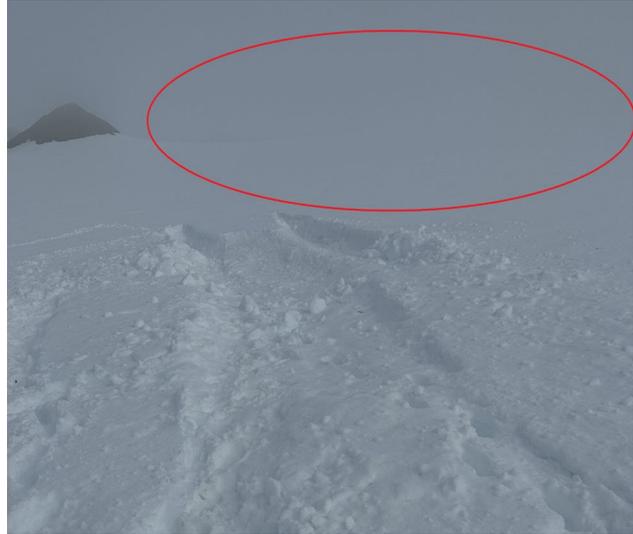
Once the helicopter passed the rocks, the pilot lost visual reference to the surface and entered an inadvertent descent. At 1039, the helicopter collided with the rising terrain. It struck the snow-covered surface with a slight lateral motion to the right. This motion progressed to a dynamic rollover. The helicopter came to rest on its right side and the engine shut down on its own. The helicopter was destroyed by impact forces. There was no fuel spill or post-impact fire.

Figure 2. Photo taken shortly after the occurrence, showing the point of impact and flat-light conditions with the lack of surface definition (Source: Custom Helicopters Ltd.)
