Marine Occurrence Report

Grounding

of the Small Lobster Vessel "STUMP JUMPER"
Long Island, Nova Scotia
30 November 1993

Report Number M93M0008

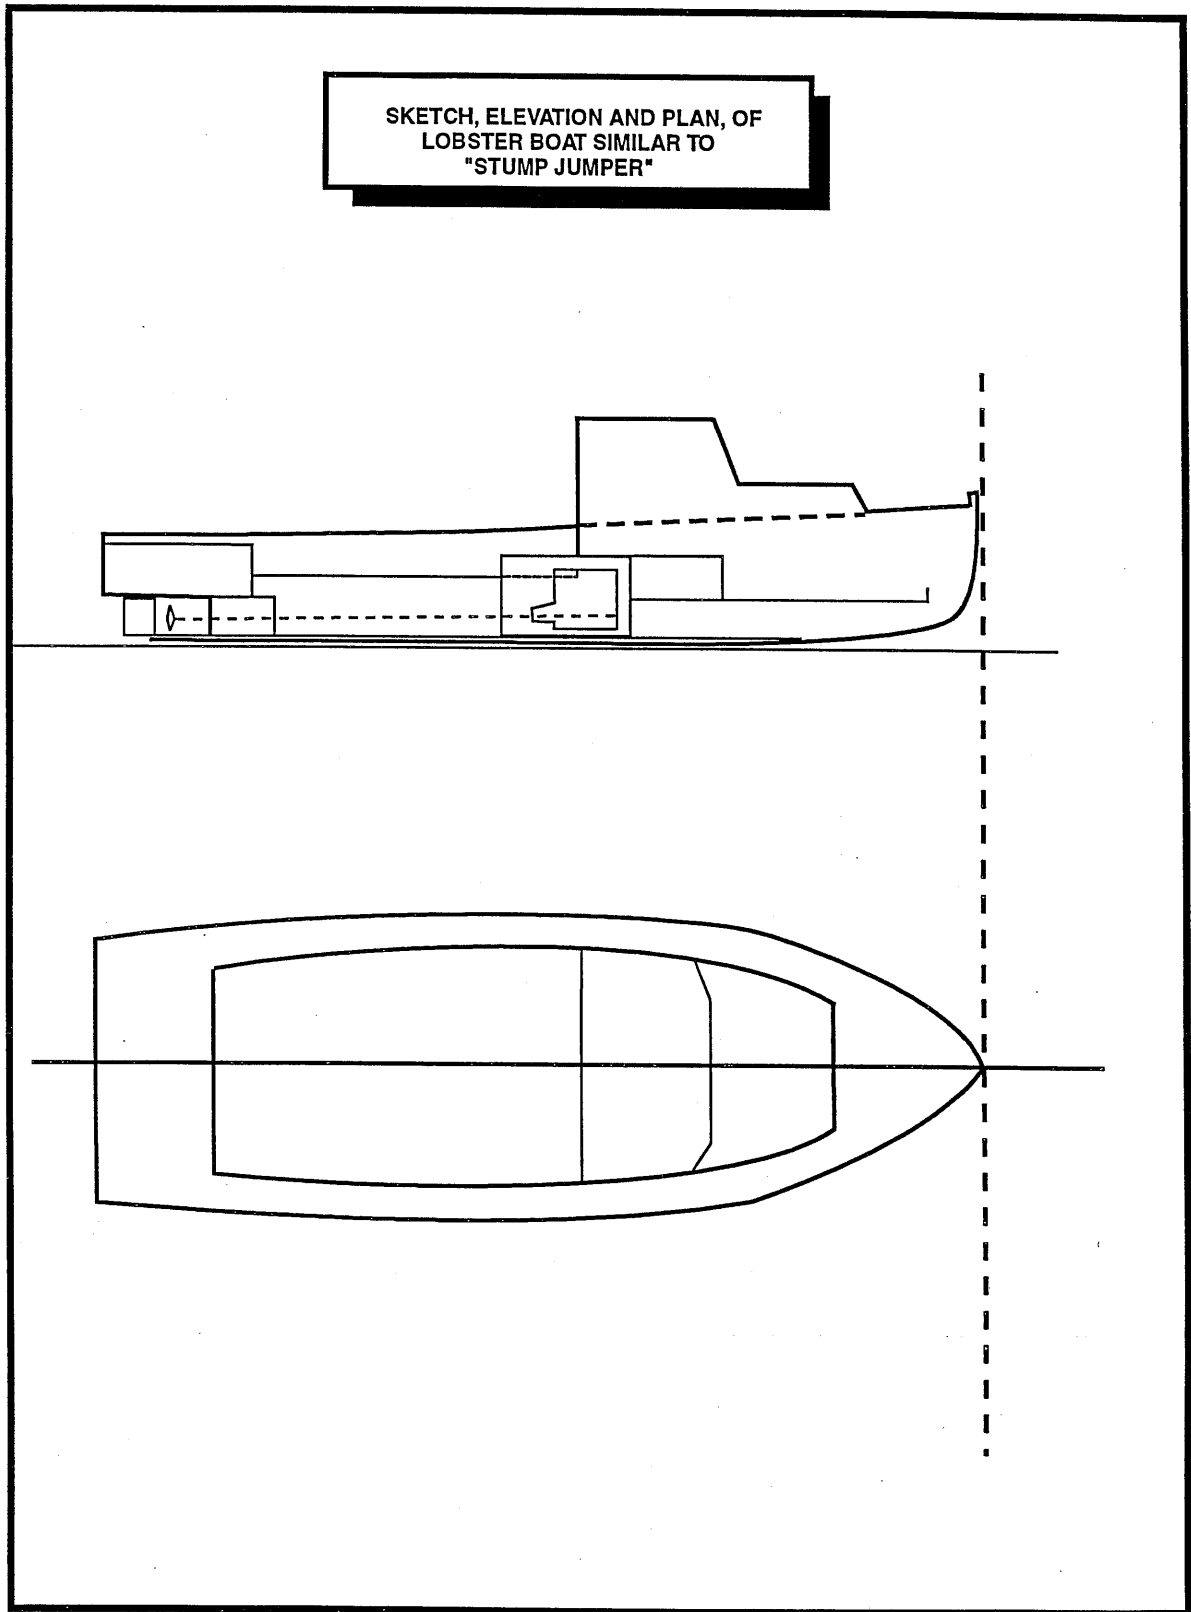
Appendix A - Sketch of a Cape Islander

The "STUMP JUMPER" was of wooden, open construction, built to the Cape Island design and rigged for lobster fishing (see Appendix A). The hull had been sheathed with glass-reinforced plastic (GRP) and was subdivided by three transverse bulkheads below the main deck. The wheel-house/navigation position was in the forward part of the vessel, and the after open deck work area was fitted with a bulwark some 80 cm high.

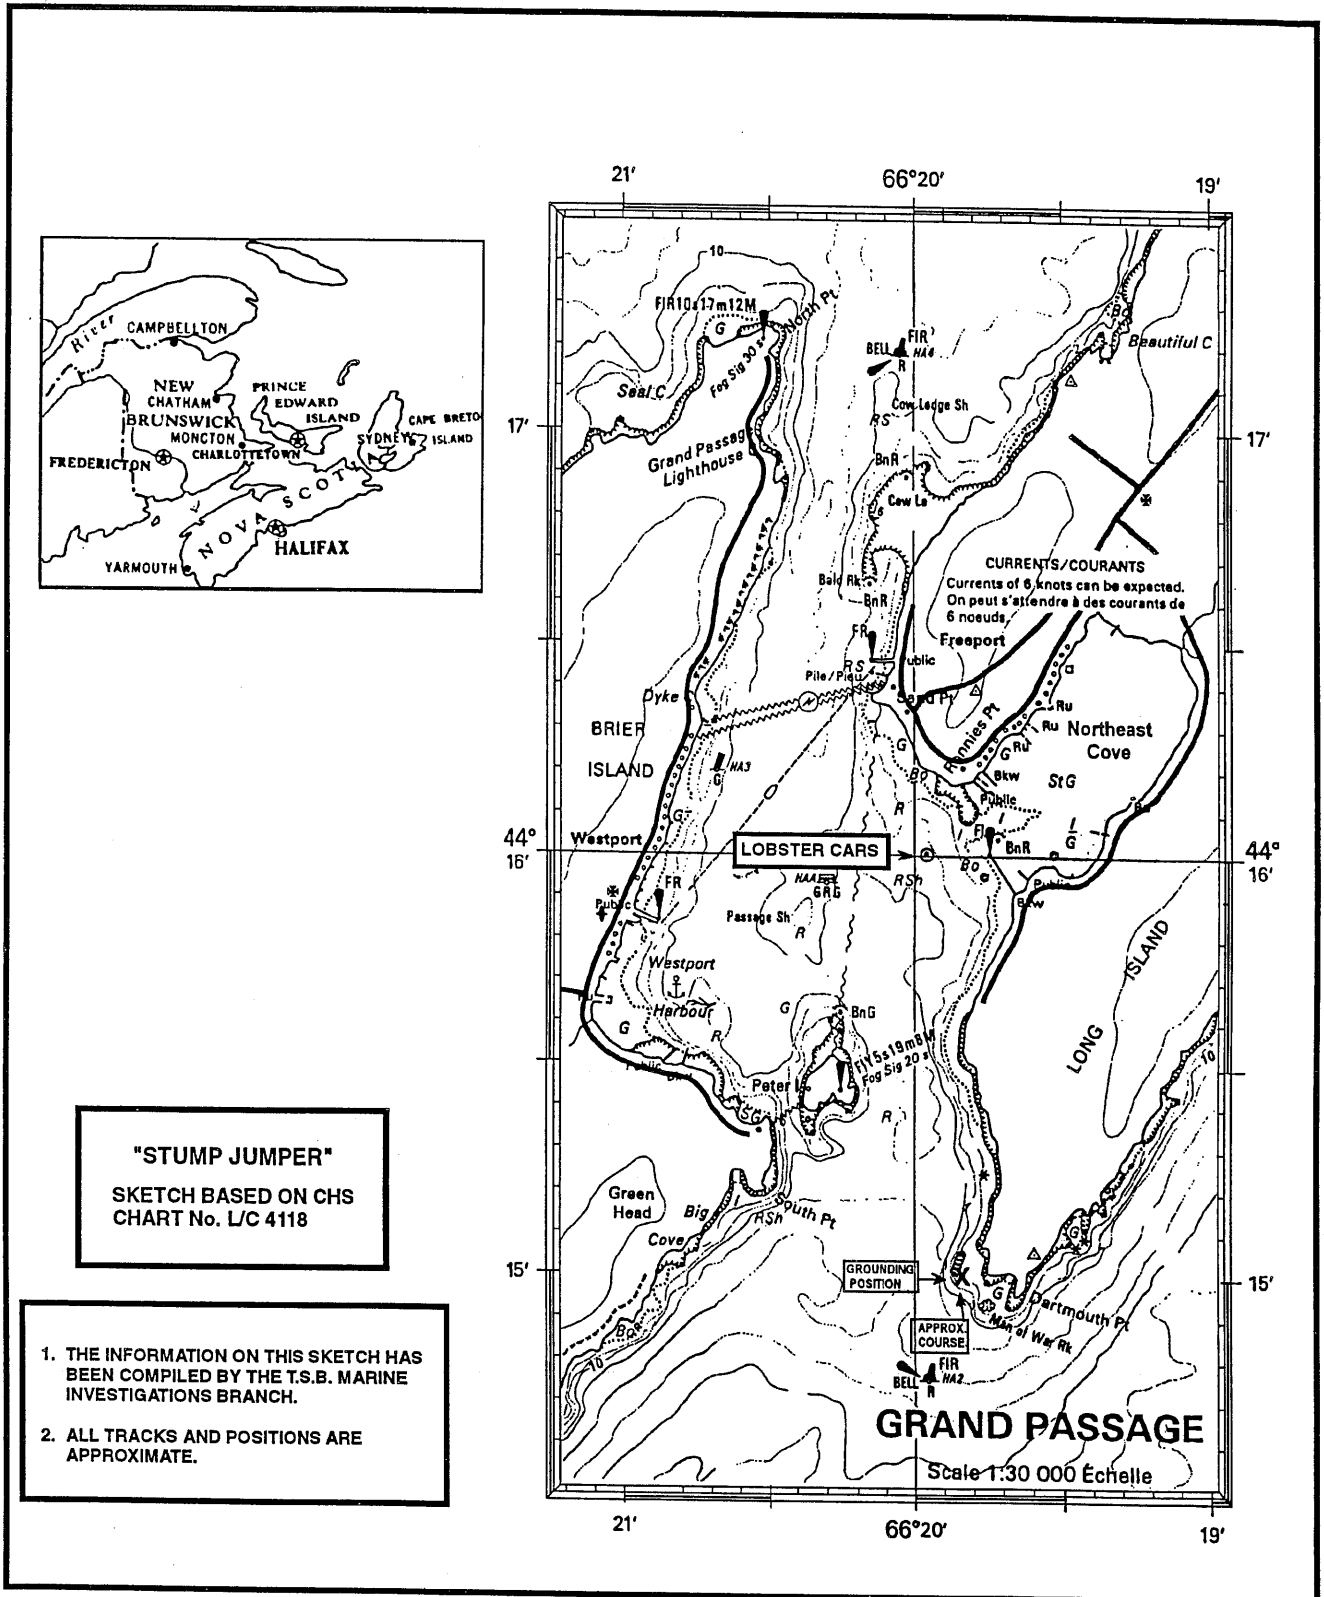
Appendix B - Sketch of the Area of the Grounding

After passing between buoy HA2 and Dartmouth Point and while proceeding at an estimated speed of 10 knots in darkness but in good visibility, the vessel unexpectedly grounded on Dartmouth Point Ledge at 1815 (see Appendix B). The vessel rode up on to the edge of the ledge, exposing her port side to a south-westerly swell which caused her to work heavily against the rocky ledge.

Following the grounding, the position of light and bell-buoy HA2 was checked; the buoy was found to be 5.5 cables south of its charted position. The buoy, which exhibited a red flashing light, was required to be left on the starboard side of the vessel. Reportedly, as in this instance, some of the local lobster vessel operators do not use this buoy as intended but prefer to pass between the buoy and Dartmouth Point when navigating the entrance to the channel. The distance between the 10 m contour off Dartmouth Point Ledge and the charted position of buoy HA2 is approximately two cables.

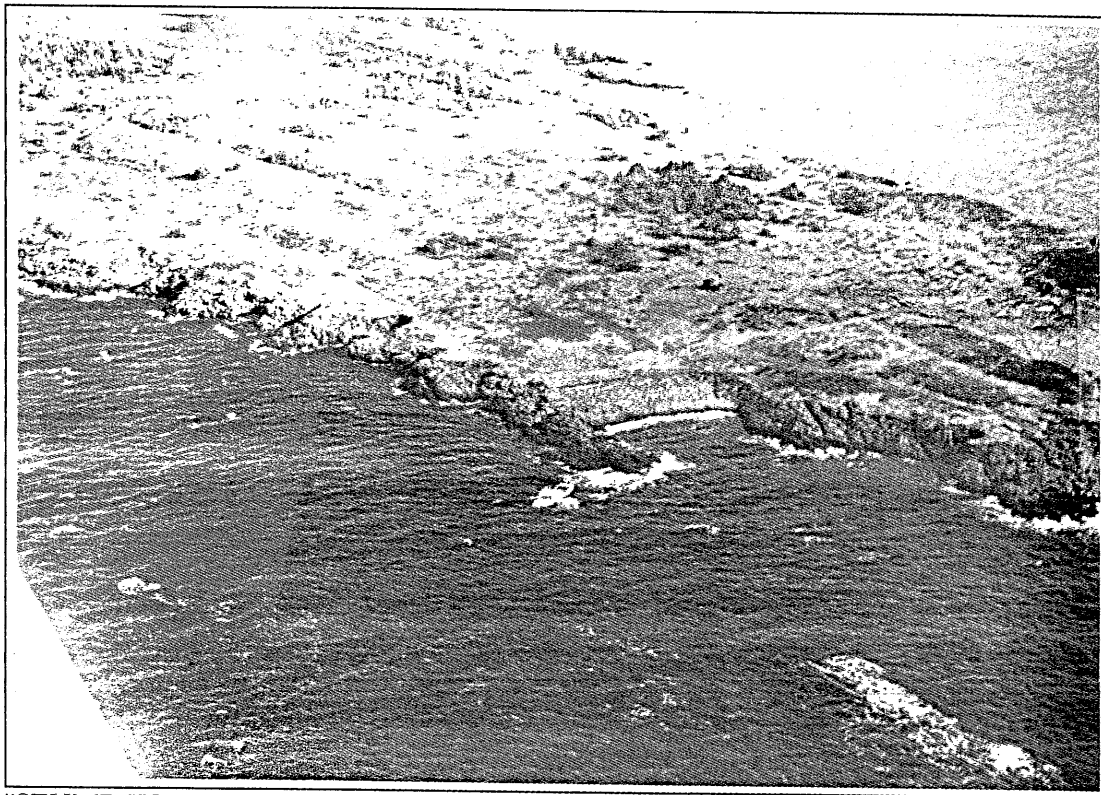
The "STUMP JUMPER" sustained extensive hull damage and some equipment was salvaged before she eventually broke up.

"STUMP JUMPER" aground on Dartmouth Ledge the following morning.
