## MARINE INVESTIGATION REPORT

M04W0235

**SINKING AND LOSS OF LIFE**

**THE TUG *MANSON* TOWING THE  
CRANE BARGE *MCKENZIE* AND DECK BARGE *M.B.D. 32***

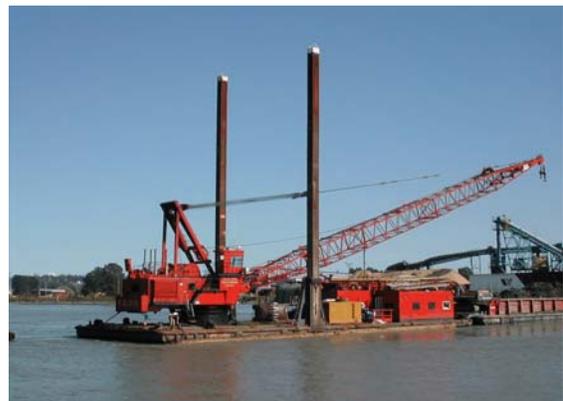
**Photo 2.** *McKenzie*

The *McKenzie* is a dedicated crane barge with a large-capacity, pedestal-mounted crane permanently fixed to its deck. Spuds, used for keeping the barge in position, are fitted near the barge's mid-length. In Photo 2, the spuds are seen in the raised position – as they were when the barge was being towed. The crane is situated near the bow, where the towing bridles were attached.

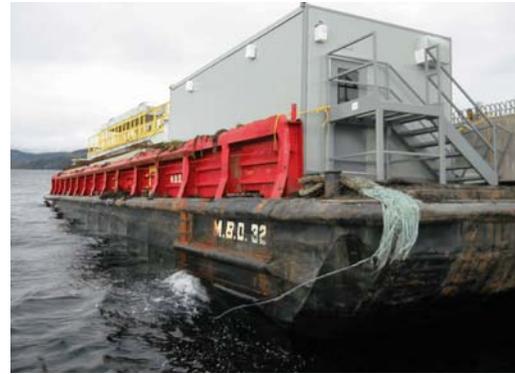
The barge *M.B.D. 32* is an open-deck barge used for the carriage of deck cargo. Bulwarks approximately 1.8 m high are erected to port and starboard of the main deck. The barge was loaded with construction material and was trimmed significantly by the stern (see Photo 3).

**Photo 3.** *M.B.D. 32* (note the parted rope coupler at bow)
