**MARINE INVESTIGATION REPORT**  
**M06W0052**

**STRIKING AND SUBSEQUENT SINKING**

**PASSENGER AND VEHICLE FERRY *QUEEN OF THE NORTH***  
**GIL ISLAND, WRIGHT SOUND, BRITISH COLUMBIA**  
**22 MARCH 2006**

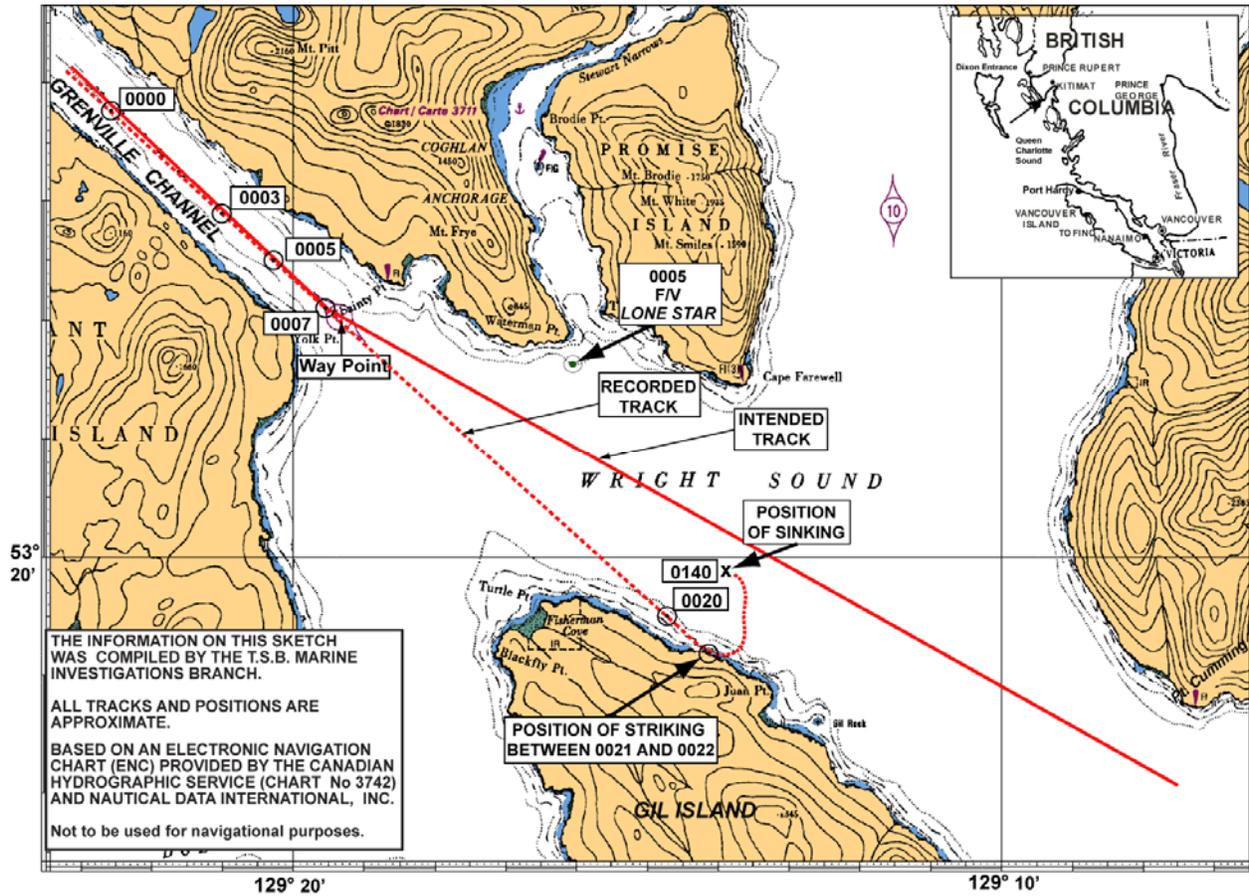
Figure 3. Track of the *Queen of the North*

Having entered the less difficult portion of the voyage through Wright Sound and believing he had made the course alteration at Sainty Point, the 4/O did not monitor the vessel's progress and failed to determine that the vessel was on an improper course.

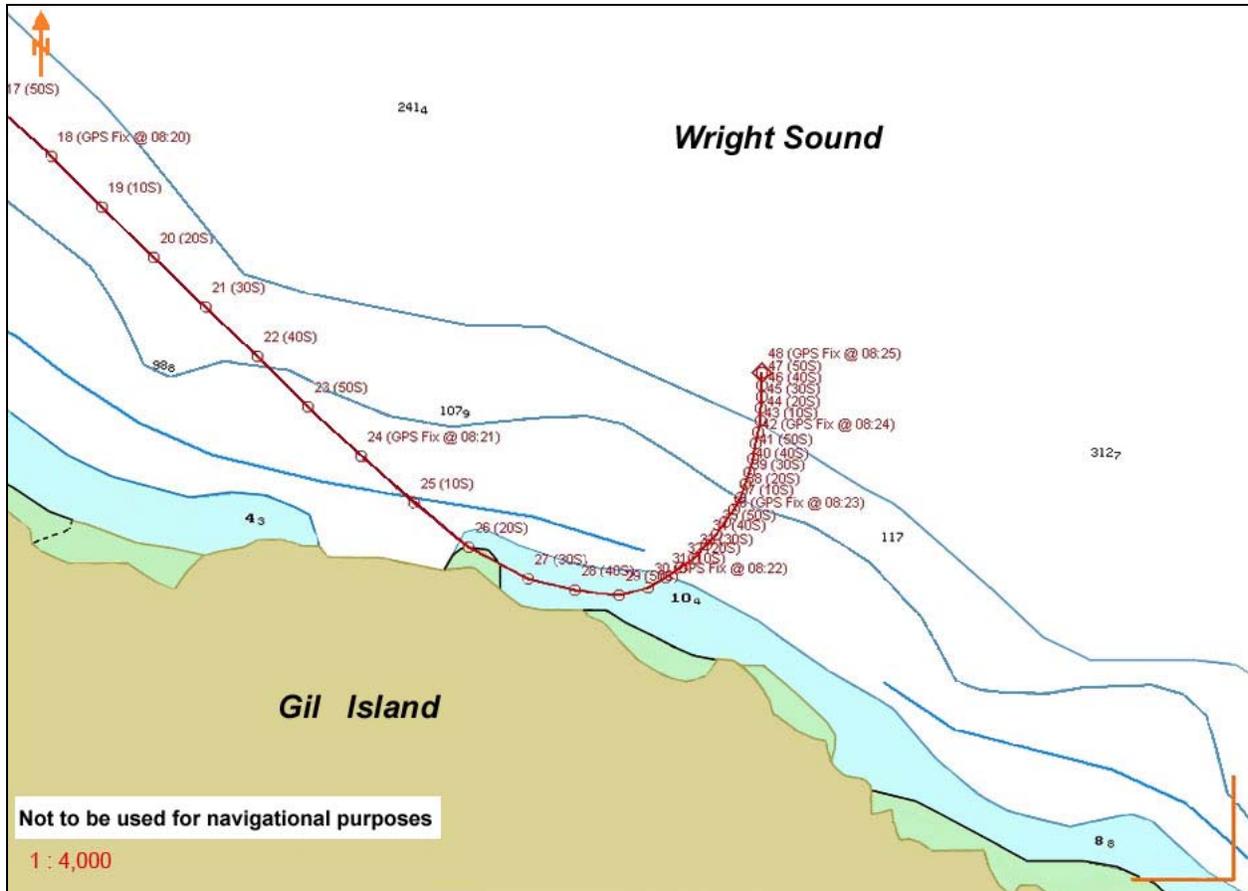
Figure 4. Course as it would have appeared on a vector chart

The above graphic shows the track of the *Queen of the North* as it would have appeared on a vector chart, which, while not available at the time of the accident, clearly shows the vessel’s course both across Wright Sound before and after the striking. The fixes in the electronic chart system data log were updated every minute for the following: date, time, latitude, longitude, heading, course over ground, and speed over ground. Ten-second positions of latitude and longitude depict the vessel’s track moments after the striking.
