MARINE INVESTIGATION REPORT
M08M0010

CAPSIZING WHILE UNDER TOW

SMALL FISHING VESSEL *L'ACADIEN II*
18 nm SOUTHEAST OF CAPE NORTH
CAPE BRETON ISLAND, NOVA SCOTIA
29 MARCH 2008

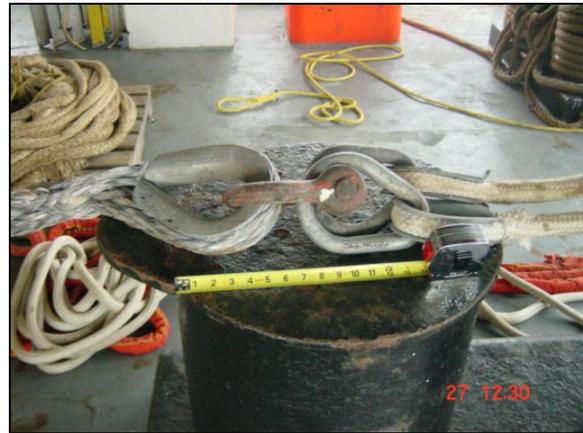
In keeping with normal marine practices for towing in ice, the towline was kept short. The towline consisted of a two-legged bridle, each 15 m in length, shackled to a 38-mm, double-braided nylon towing hawser 12 m in length (see Photo 3). Each of the eyes of the 29 mm braided nylon bridle were passed through fairleads and secured over the mooring bitts on the bow (port and starboard) of *L'Acadien II*.

Photo 3. Towline to bridle connection arrangement

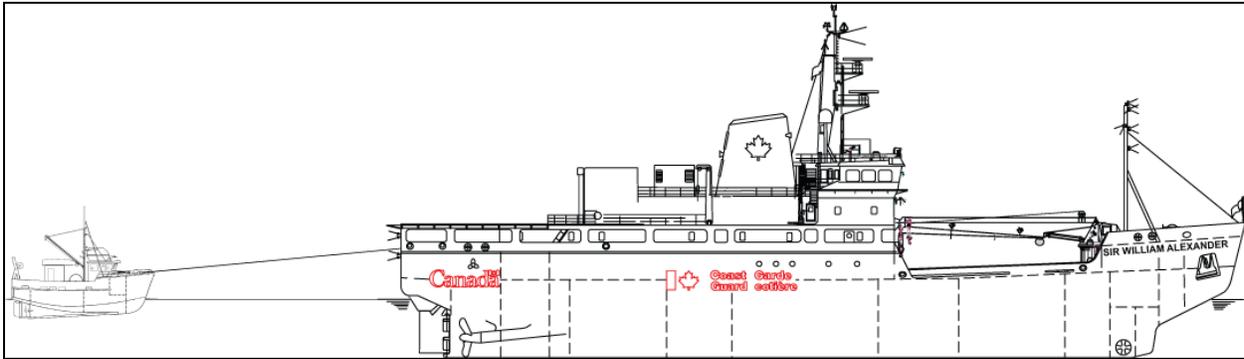
Figure 1. Profile view of towing arrangement

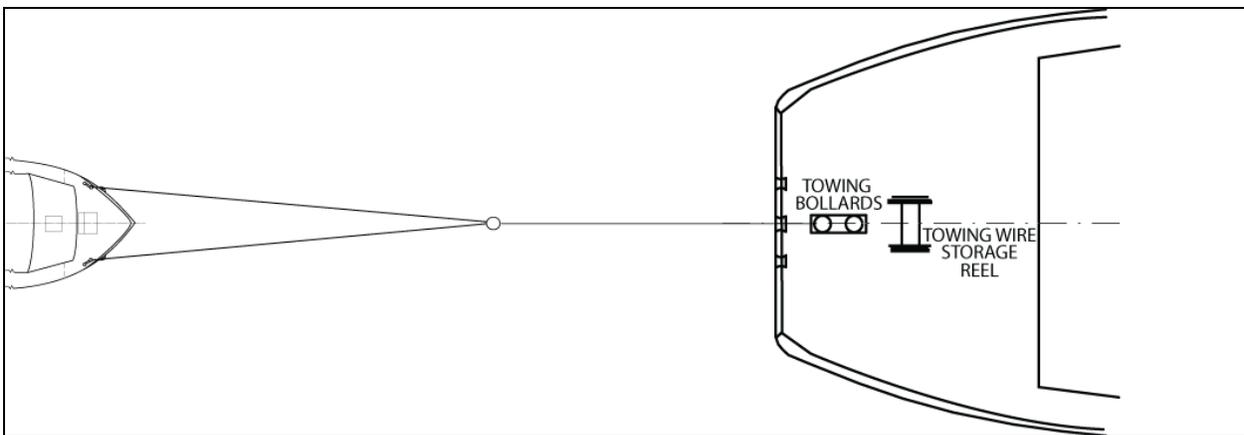
Figure 2. Plan view of towing arrangement

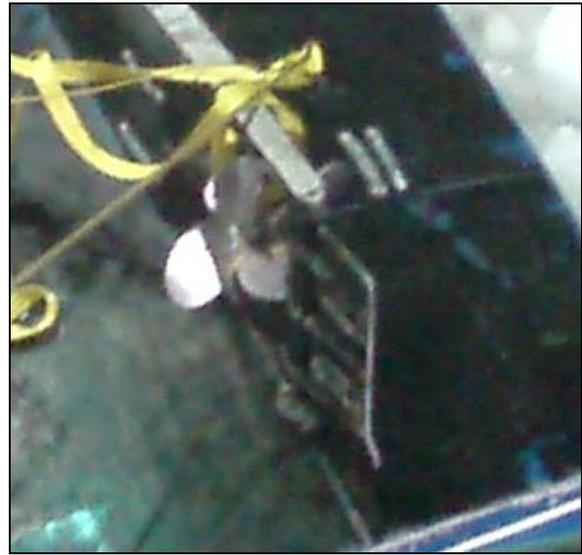
The damage to the steering system (see Photo 4) was such that the vessel could not be steered on a steady course or turn to starboard. The rudder movement was reported to be from 45° port to 5° port¹¹, and this caused a natural tendency to turn to port, even when full starboard helm was applied. It was also observed that the uppermost part of the rudder was bent to port.

Photo 4. Close-up view of the overturned vessel, showing rudder

¹¹ Although not verified during this investigation, such limited rudder movement is indicative of a twisted rudder stock.

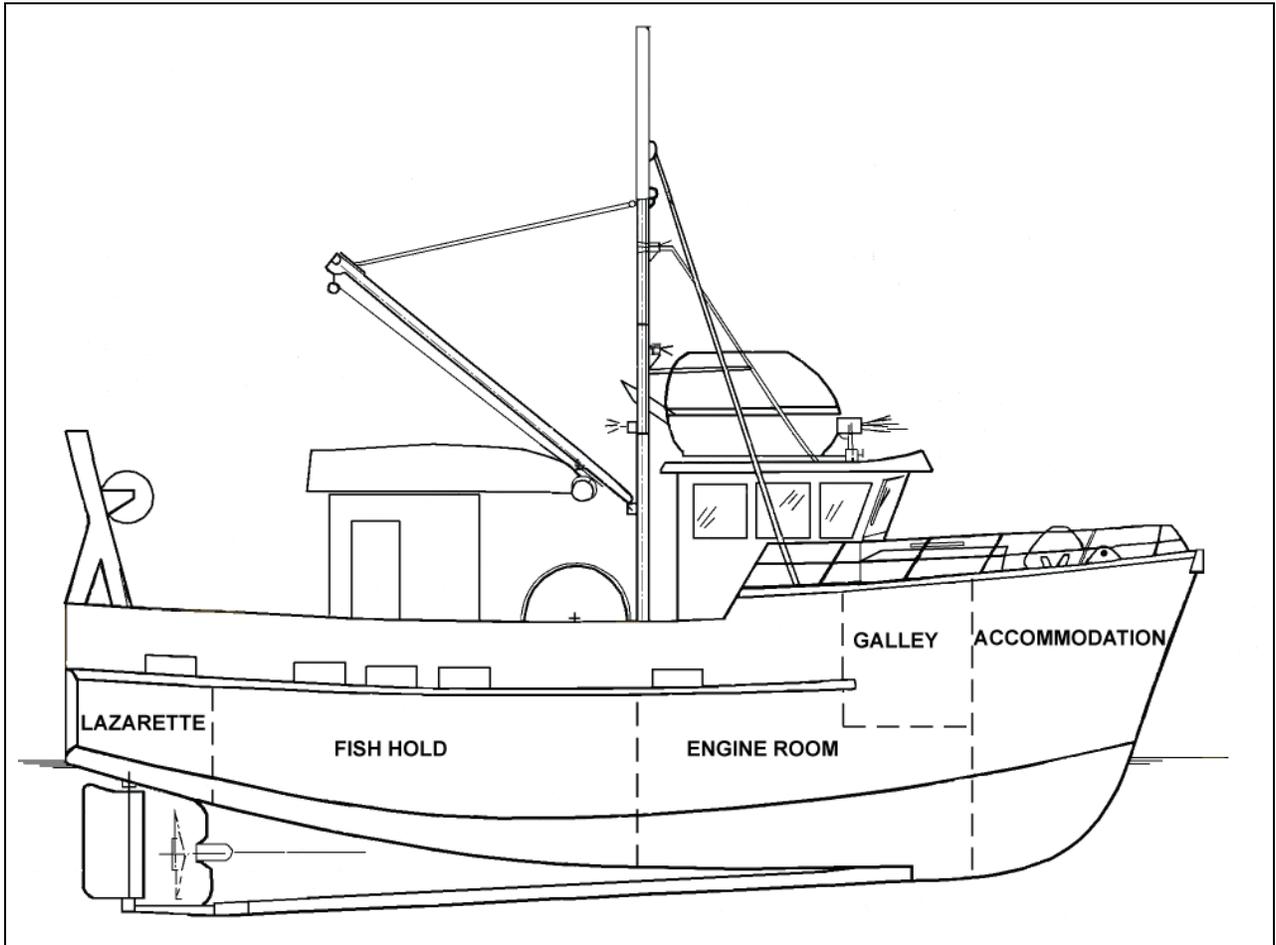
Appendix A – Profile of L'Acadien II

L'Acadien II was a small fishing vessel of closed construction, with an all-aluminum, welded hard-chine hull. The hull below the main deck was subdivided by three transverse watertight bulkheads enclosing (from forward) the crew accommodation, the galley and the engine room, the fish hold, and a lazarette containing the hydraulic steering gear, and a pair of fuel tanks and ballast tanks. The wheelhouse was located in a deckhouse forward of midships, and a single weathertight door on the starboard side led from the wheelhouse onto the main deck aft. In 2004, the shell was reinforced with 12.7 mm aluminum doubling plate fitted over the existing plating in way of the waterline for navigating in ice during the seal hunt (see Appendix A).
