MARINE INVESTIGATION REPORT

M08W0236

NEAR CAPSIZING WITH LOSS OF LIFE

SEALANDER 37 LANDING CRAFT *JUMBO B*
BURKE CHANNEL, RESTORATION BAY, BRITISH COLUMBIA
30 OCTOBER 2008

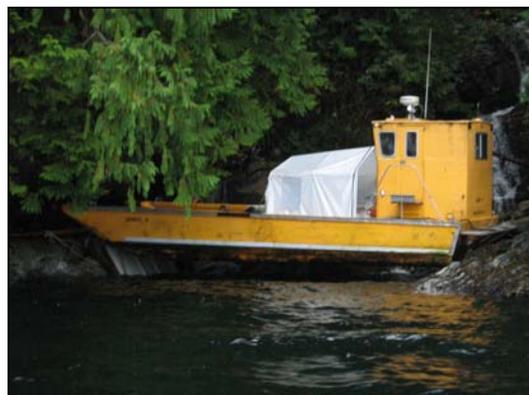
Photo 1. The *Jumbo B* beached after the occurrence

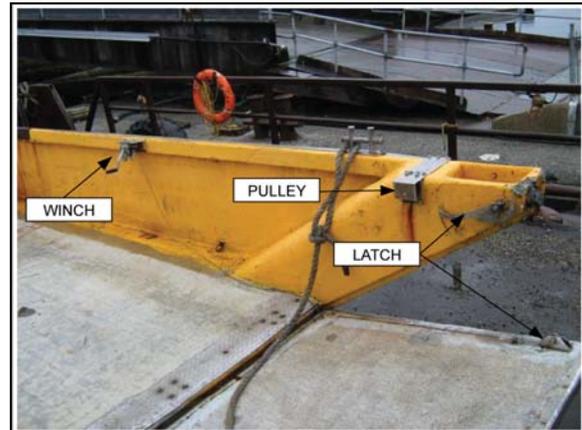
The bow ramp is hinged along the bottom edge (see Photo 2). The two winches, each with a capacity of 682 kg, were installed on either side of the vessel in 2007. They are used in conjunction with wires and steel pulleys to open and close the bow ramp, but are not designed to hold the door shut.

Each wire is 5 mm of 7 x 19 of galvanized carbon steel with a breaking strength of 1987 kg. The TSB Laboratory⁹ analysis found that both wires had parted where they passed over the pulleys¹⁰ and that the region around the fractured wires was visibly corroded.

Photo 2. Bow ramp and winching arrangement

The port pulley was corroded and did not rotate freely. The pulley had a diameter of 5 cm, approximately 13 times the diameter of the 5 mm wire. The pulley-to-cable ratio recommended in most literature is at least 30:1.¹¹

In this occurrence, although the winching system and its components had been modified only the previous year, the port pulley was corroded such that it did not rotate freely. The wire was also corroded where it passed over the pulley. Sections of the rubber gasket that sealed the bow ramp door to the landing craft were also missing, and the holes in the latch bracket were found ovalized, indicating that the bracket had been subject to strain.

The wire was weakened by a combination of fatigue, corrosion, and the abrasion from being in constant stress against the incorrectly sized pulley.²⁰ The resulting localized weak point²¹ fractured. The other wire then failed, leaving the ramp held closed only by the two non-locking latches. However, because the absence of portions of the watertight gasket meant the latches contained a great deal of freeplay, these were able to work their way open. This allowed the ramp to fall completely open and permitted water to flood the well deck.

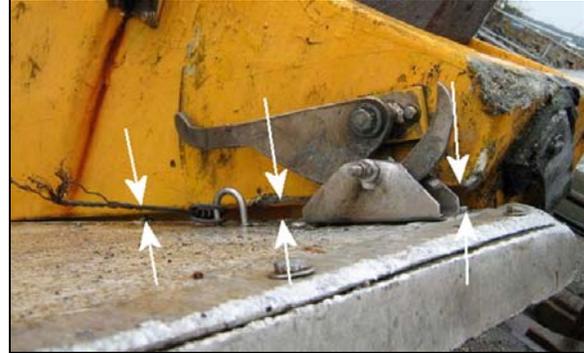
A latch on each side of the vessel was designed to keep the bow ramp secured when closed. Both latches were worn, the bearing surface of the latch hook having been polished smooth by wear. The hinge pin of the latch hook also had considerable freeplay within the bushing.

The pin, against which the latch engages to complete the locking process, is mounted within a bracket on the bow door. This bracket's holes were found ovalized by wear. The latch design does not include any locking mechanism to keep the latch handle in the closed position.

Photo 3. Bow ramp latch, port side

Additionally, the ramp's design was such that there was no locking mechanism to keep the latch closed once the ramp was up; instead, this was accomplished by maintaining continuous tension on the winch wire. This wire, which had originally been intended only to raise and lower the ramp, was further subjected to a cyclical loading component from wave action pushing against the door.

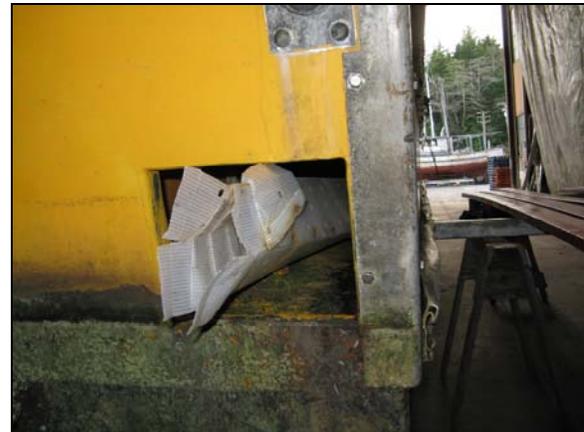
The vessel was normally trimmed by the stern to the extent that the waterline was approximately 50 mm above the lower edge of the freeing ports and the main deck. Algae and marine growth were noted above the lower edge of the freeing ports and onto the after part of the main deck (see Photo 4).

Photo 4. Starboard freeing port with protruding cone

Once the bow ramp opened, water was shipped aboard. The blocked freeing ports restricted the vessel's ability to shed this water, and the accumulated weight caused a starboard list until the vessel slowed down, water was shed, and it righted itself.

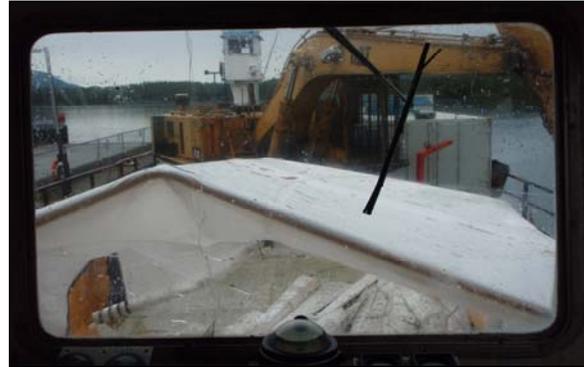
However, the canopy restricted the view forward. As a result, when the operator and the passengers inside the wheelhouse heard the banging from forward and observed water on deck, they were unable to determine the immediate cause – that the bow ramp door had failed.

Photo 5. View of bow from operator's position in wheelhouse
